## SERVICE BULLETIN

**APPLICABILITY:** 2015 and 2016MY WRX and STI Models

**NUMBER:** 12-201-16

**SUBJECT:** Paint Chipping between Hood Grille  
(Scoop) and Hood

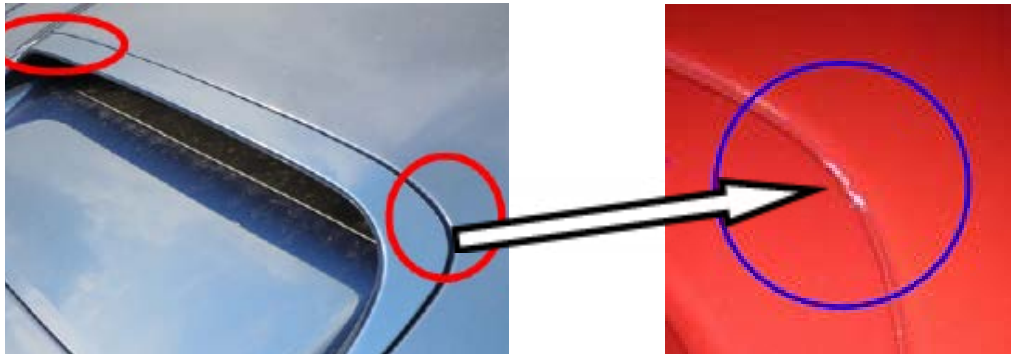
This new bulletin replaces TSB 12-186-15 and announces a new repair procedure to address customer concerns of the hood scoop scrubbing the finish of the hood panel in the areas shown in the photo below. Due to different expansion rates between the metal hood panel and the resin material used for the hood scoop, the edges of the scoop's rear corners may come in contact with the hood panel and abrade the finish.

1. **CAREFULLY** remove the hood grille (scoop) from the hood panel following the procedure in the applicable Service Manual.
2. Repair any abraded paint on the hood using touch-up paint. If the damage is too severe for the use of touch-up paint, a body shop spot repair may be necessary. If repairs will exceed \$500.00, an Authorization Request Entry must be completed and submitted to Techline before proceeding.
