SERVICE BULLETIN

APPLICABILITY: 2013-14MY BRZ

NUMBER: 12-200-16

SUBJECT: Rear Combination Lamp and Related Enhancements

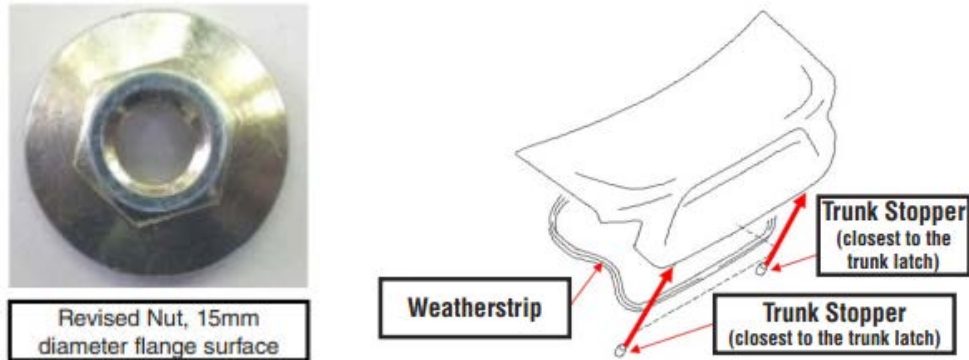
- Flange surface dimension of retaining nuts increased from 12mm to 15mm.
- Thickness of the combination lamp gaskets increased for improved sealing.
- The “height” of the trunk stoppers has been increased by 2.7mm and a liner added to the trunk weatherstrip intended to improve crush resistance and keep the trunk lid from contacting (and in a small number of cases, cracking) the tops of the combination lamps when closing.

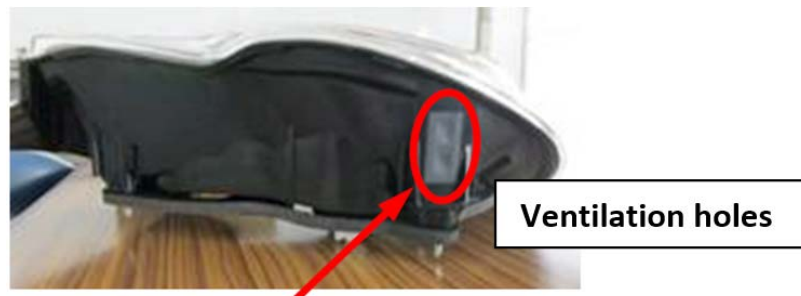
- Application of an anti-fog coating to the inside of the combination lamp lens at production to prevent “clouding”.
- Additional ventilation holes have been added to prevent condensation build-up.

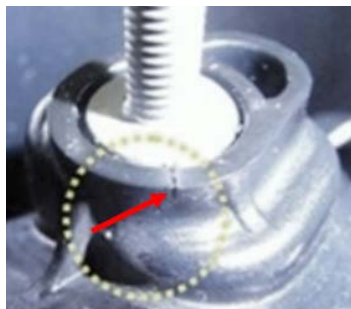
- Inspect the retaining stud boss areas of the housings for any cracking as shown below. If cracking is confirmed, the lamp assy. must be replaced.

NOTE: Unless the most recent combination lamp assemblies are already installed, when replacement is required, replace **BOTH** assemblies with the new parts.

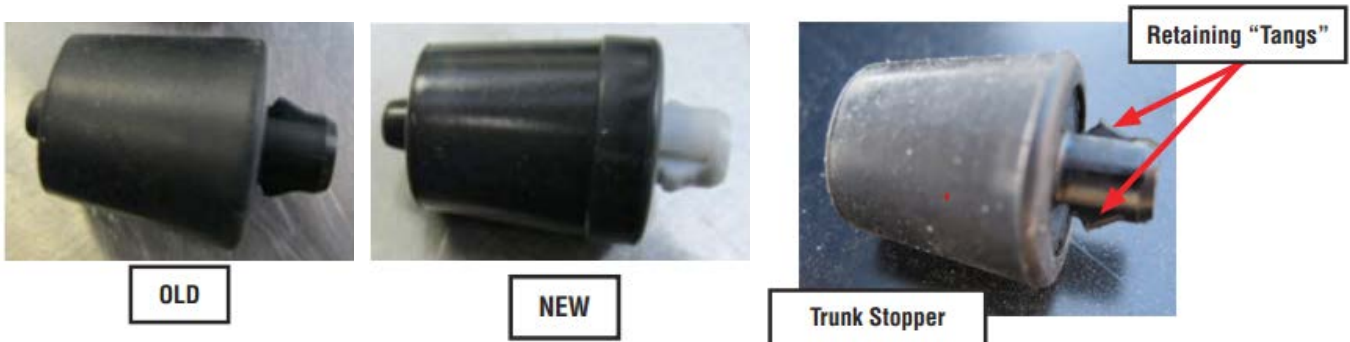
The photos below show the differences between the “OLD” and “NEW” trunk stoppers and the retaining tangs which secure them to the trunk lid.
