REPAIR PROCEDURE

APPLICABILITY: 2016-2017MY Legacy and Outback
SUBJECT: Inspection and Repair Procedure for Stop Sale / Recall Campaign
 WTD-65: Steering Column

NUMBER: WTD-65R
DATE: 05/10/16
REVISED: 06/08/16

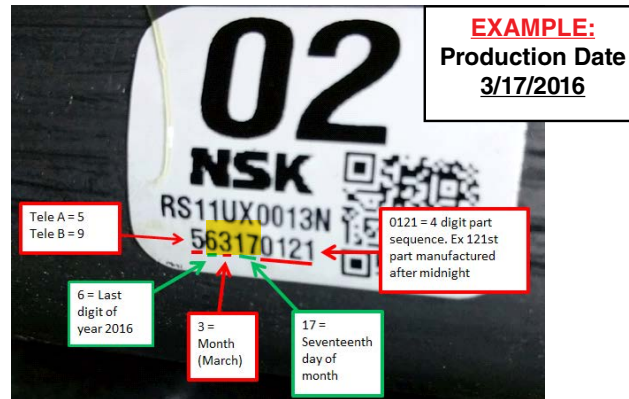
- Decode the lot number of the steering column using the illustration below.
- Affected steering columns will have a lot number label indicating the column was produced **on or between** 6228 (February 28, 2016) and 6416 (April 16, 2016), the steering column assembly must be replaced.
- If the lot number is illegible or otherwise cannot be determined, it must be noted on the repair order and the steering column assembly must be replaced.

- **IMPORTANT:** Always record the original lot number on the Repair Order even if it is outside the affected range. The **ORIGINAL** 4-digit lot number must also be entered in the Miscellaneous Detail field when submitting for claim reimbursement. If illegible, enter “**ILLEGIBLE**” in that field.
