NUMBER: 05-60-15R

# SERVICE INFORMATION

**APPLICABILITY:** 2006-2009MY Legacy Spec B and

Rattling Sound from Front Suspension While SUBJECT:

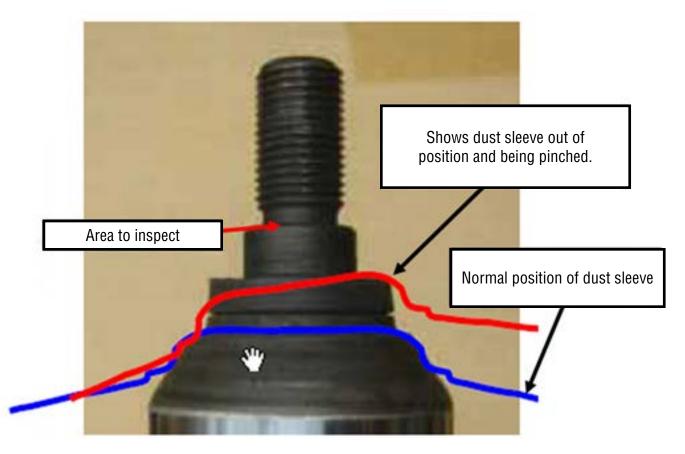
3. Once the strut has been disassembled, the area indicated in the photo above will need to be inspected closely for cracking.

- (3-6) If the penetrant inspection reveals no cracking, wash away any remaining penetrant materials thoroughly with the cleaner and wipe dry with a clean shop cloth. If a crack is found, replace the strut.
  - 4. Reassemble the strut assembly following the procedure in the applicable Service Manual. **NOTE:** be sure to use a **NEW** self-locking top nut, part number 902350027 and torque it to 70 Nm (51.6 ft. lbs.).

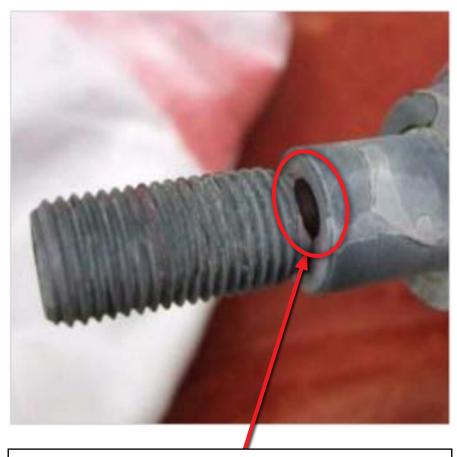
(3-5) Check the developer for penetrant seepage. The strut in the photo below requires replacement.

The base of the threads as shown below is the focal point of the penetrant inspection. After applying the developer, watch carefully for a red line to appear indicating the presence of a crack. If a crack is present, the penetrant indication will eventually widen and blur as it appears in the photo.

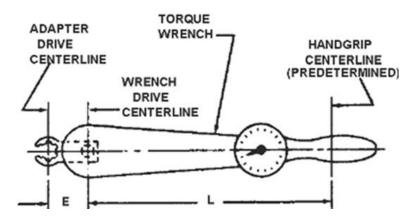
**IMPORTANT NOTE**: When using an extension which increases the overall "length" of the torque wrench, the torque values applied will change. Refer to the illustration and calculation formula provided on the last page of this bulletin for determining the revised torque specification when using an extension like a Crow's Foot wrench shown in the example photo above.

Calculation Formula:  $TxL \div L + E = Y$

The "New" Torque Specification is 44.9 ft. lbs.
