SERVICE PROGRAM BULLETIN

APPLICABILITY: 2017 MY Forester (non-Turbo) with CVT **NUMBERS:** WTJ-70
SUBJECT: Service Campaign – Forester CVT Low Fluid Level **DATE:** 10/03/16

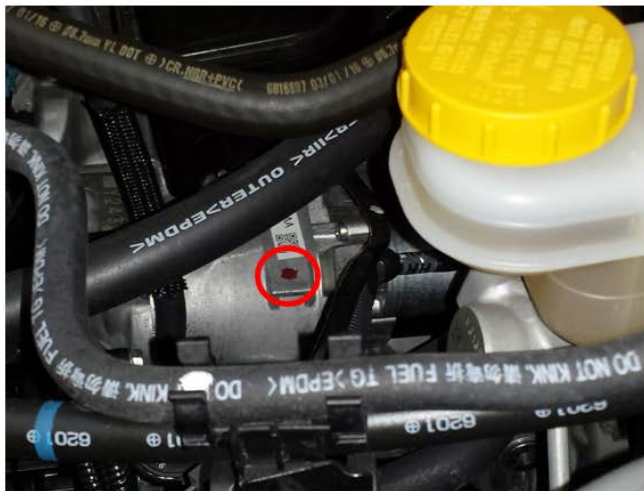
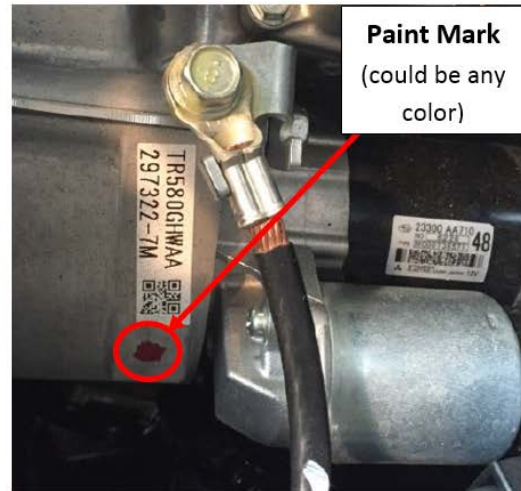
- Campaign applicability by performing a Vehicle Coverage Inquiry on subarunet.com.
- Inspect the vehicle transmission ID label area for a paint mark as shown in the photos below.
- If you find a paint mark in this area, this procedure has already been completed. **STOP**. No further action is required.
- If there is not a paint mark, proceed with the balance of this Service Procedure.

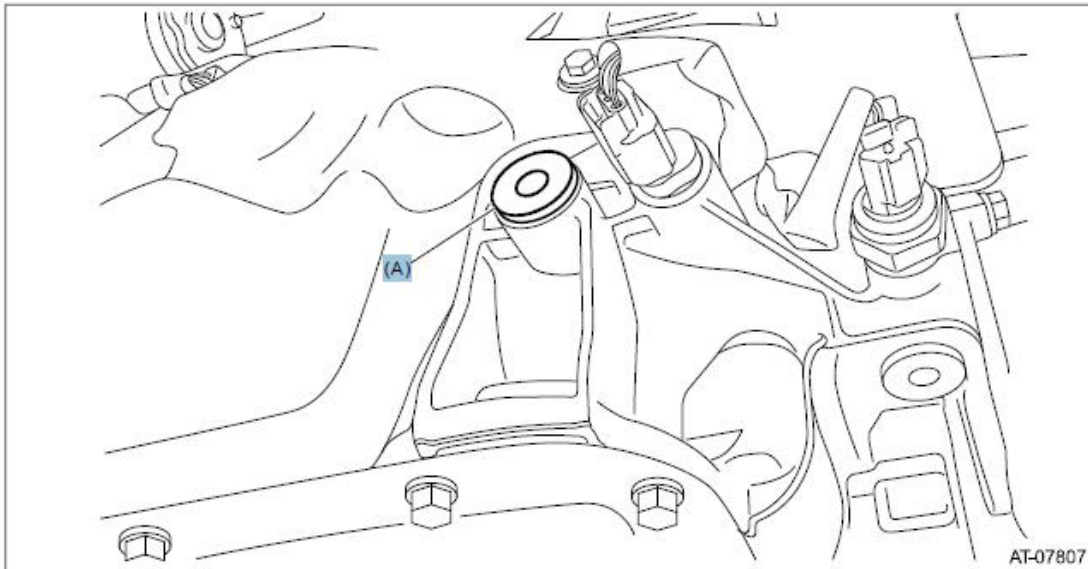
(A) Filler plug

NOTE: The CVT is full when the fluid level is at the bottom of the filler plug hole.

- When there is no CVTFII leakage, add the specified fluid up to the filler plug hole lower section. A small amount of CVTFII may drain initially from the filler plug hole due to the presence of residual fluid in the access port. It is expected 700 ml of fluid will need to be added to achieve correct fill in all cases. If the CVT appears to need significantly more or less than 700ml, confirm the fluid temperature is still correct for inspection and that the engine is running.

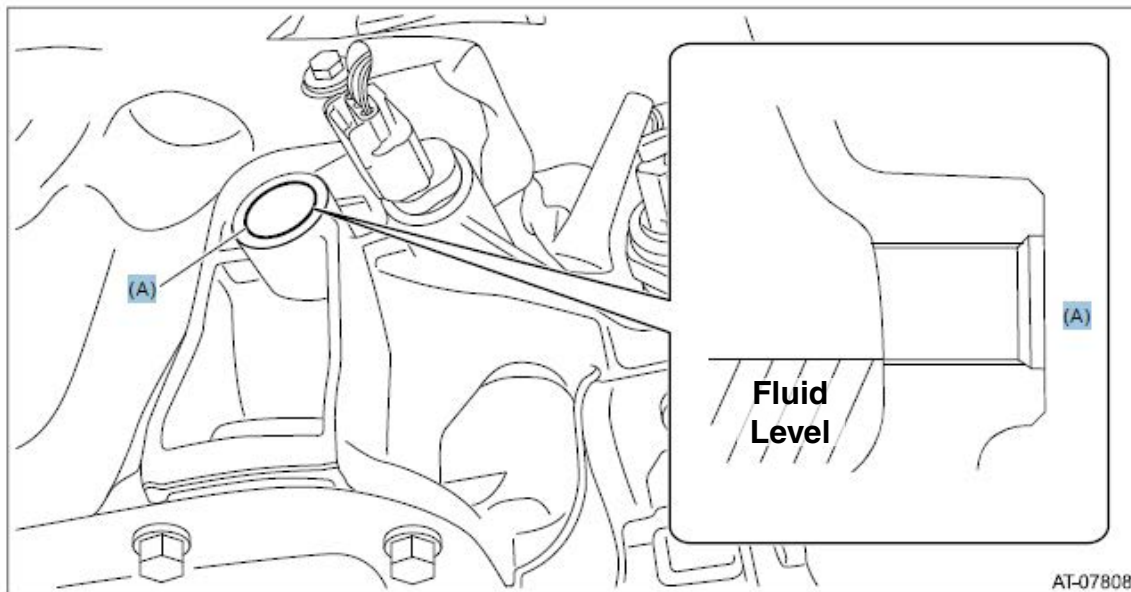
(A) Filler plug hole

If CVTFII is added up to the lower section of filler plug hole while the transmission is in cold condition, overfilling of CVTFII occurs, causing the oil to spill out.

7. Install the filler plug.
NOTE: Always use a new filler plug gasket, part number: 803918060.
Tightening torque:
50 N·m (36.9 ftlb)
8. Reinstall the under cover front - transmission.
Tightening torque:
18 N·m (13.3 ftlb)

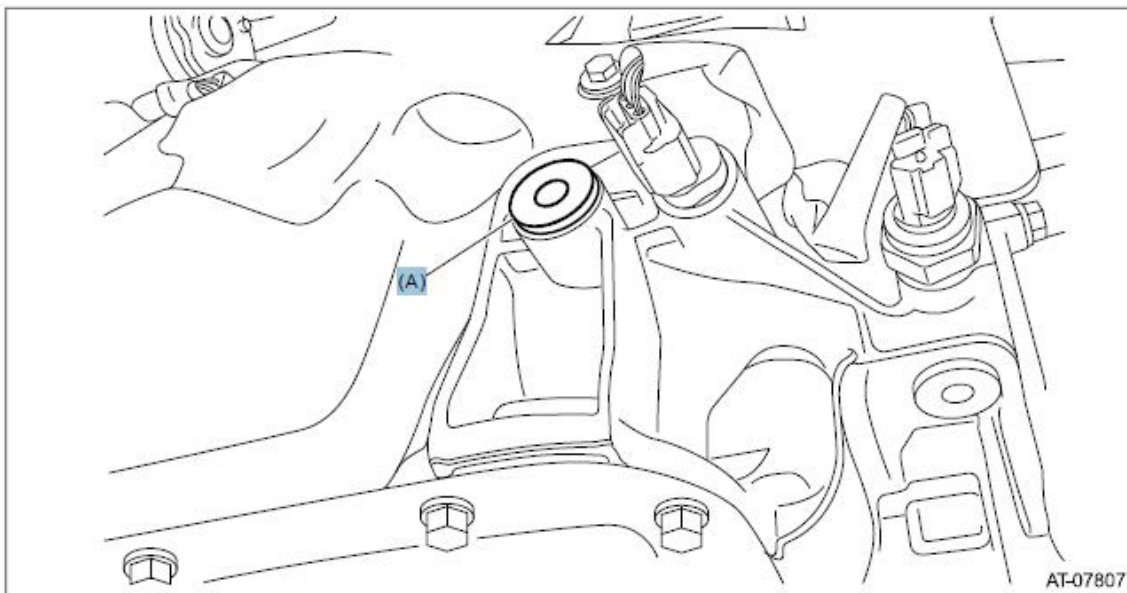
(A) Filler plug

NOTE: The CVT is full when the fluid level is at the bottom of the filler plug hole.

12. When there is no CVTFII leakage, add the specified fluid up to the filler plug hole lower section. A small amount of CVTFII may drain initially from the filler plug hole due to the presence of residual fluid in the access port. It is expected 700 ml of fluid will need to be added to achieve correct fill in all cases. If the CVT appears to need significantly more or less than 700ml, confirm the fluid temperature is still correct for inspection and that the engine is running.

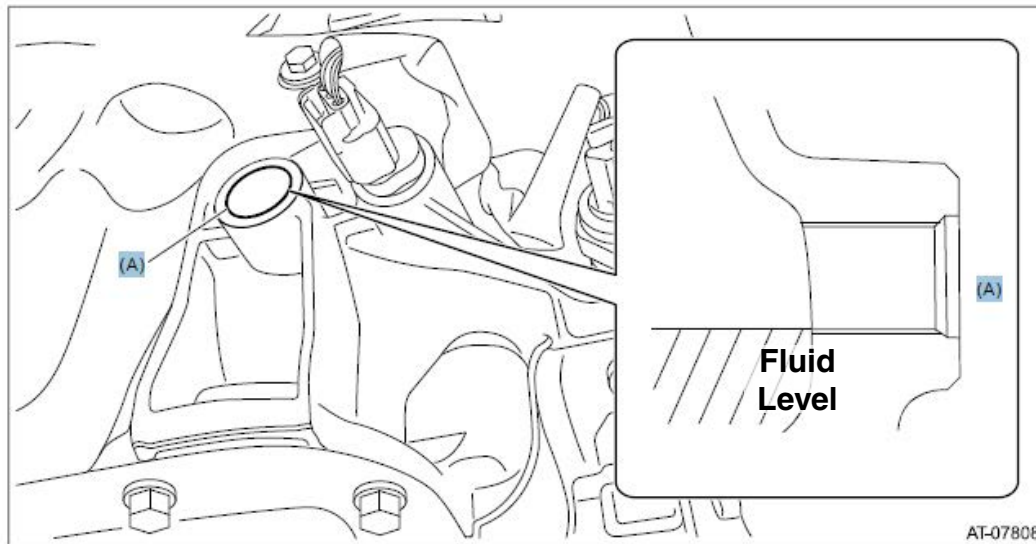
(A) Filler plug hole

If CVTFII is added up to the lower section of filler plug hole while the transmission is in cold condition, overfilling of CVTFII occurs, causing the oil to spill out.

13. Install the filler plug.

NOTE: Always use a new filler plug gasket, part number: 803918060.
