SERVICE BULLETIN

APPLICABILITY: 2013-14MY Legacy and Outback Models with 2.5L FB Engines
 2011-14MY Forester Models with 2.5L FB Engines
 2015 MY Forester (Manual Transmissions Only) with 2.5L FB Engines
 2012-13 MY Impreza and XV Crosstrek Models with 2.0 FB Engines
 2014-15 MY Impreza and XV Crosstrek Models (Manual Transmissions Only) with 2.0 FB Engines

NUMBER: 02-157-14R

SUBJECT: Engine Oil Consumption

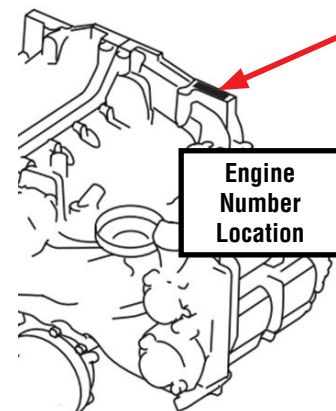
*** NOTE:** When determining the engine number, use the **LAST 8** characters of the number stamped into the boss on top of the block adjacent to the starter and shown in the illustration. The engine number range for the FA1 assembly line is 800000 to 930025 and the FB2 range is 000000 to 652640.

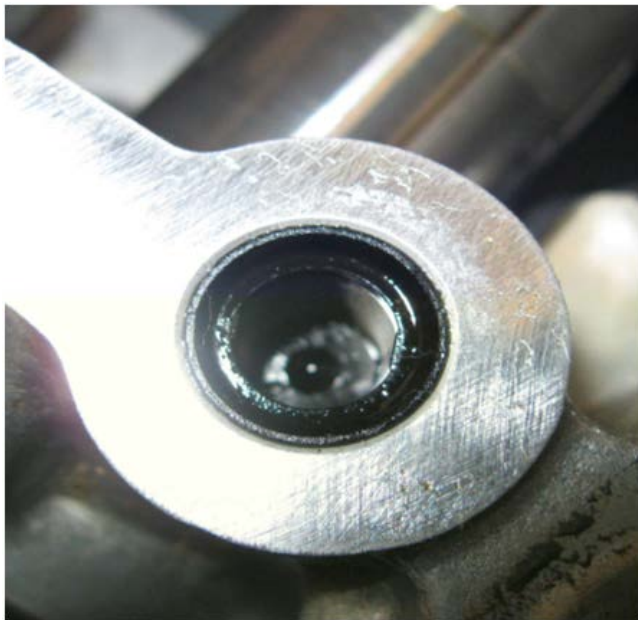
Cam Carrier Filter Screen

- Don’t forget to replace (**one-time use**) the filter screens in the cam carriers. In addition, always be sure to do a thorough inspection and cleaning of the oil pan, pick-up tube and screen as shown in the photos below before reassembly.

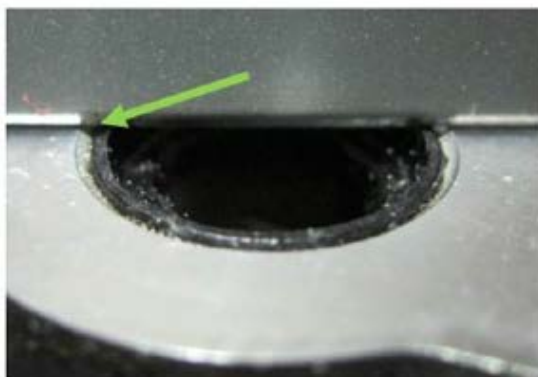
OK- Filter Screen flush with machined surface of camshaft carrier.

- **IMPORTANT:** The **one-time use** AVCS filter screens in the cam carriers are available separately (p.n. 14451AA050). **NOTE:** Although the filter screens are not directional, they must be installed flush with the machined surface of the cam carrier as shown in the OK photo below. The NG photo shows the screen installed too deep into the camshaft carrier. Engines with AVCS on both intake and exhaust will have 2 filters in each carrier as opposed to just one (intake only AVCS).

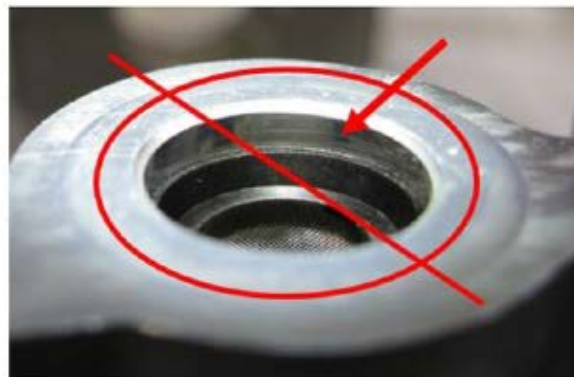
NG- Filter Screen installed too deep into the camshaft carrier bore.

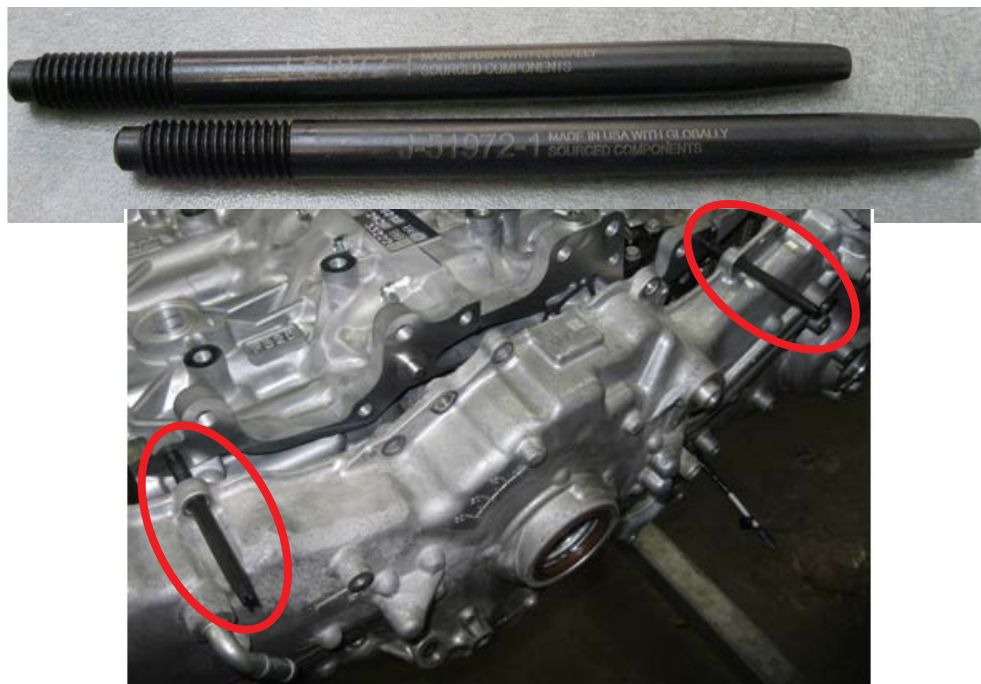
- IMPORTANT:** When re-installing the front cover assembly, be very careful to not allow it to contact any of the timing sprockets. If contact does occur, it will most likely be with the exhaust sprockets and it is almost a guarantee the fresh silicone sealer beads applied to the cover will be disturbed. To minimize the possibility of this happening, alignment pins as shown in the photos below have been developed to “guide” the cover into its proper position without disturbing the fresh sealer. The Subaru Special Tool number for the alignment pin kit is J-51972. Each kit includes 2 pins.

- If alignment pins are not used and the sealer gets disturbed during the cover installation, unless properly addressed, the affected area(s) will most likely be the source of an oil leak after reassembly. Don't hesitate to use a helper for the cover installation to prevent this from happening.
