**SERVICE PROGRAM BULLETIN**

**APPLICABILITY:** 2015 MY WRX 2.0L DIT Models  
 2014-2015 MY Forester 2.0L DIT Models

**NUMBER:** WQW-58R  
**DATE:** February 10, 2016

**SUBJECT:** Engine Control Module (ECM) Reprogramming  
**REVISED:** October 7, 2016

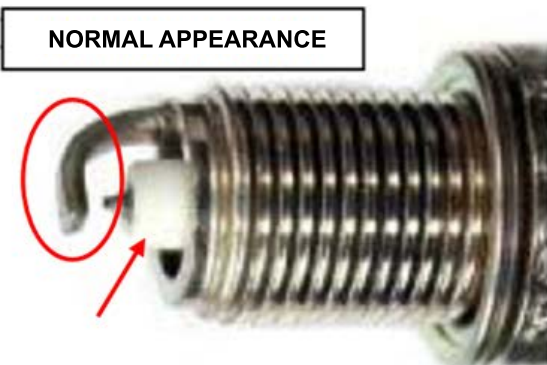
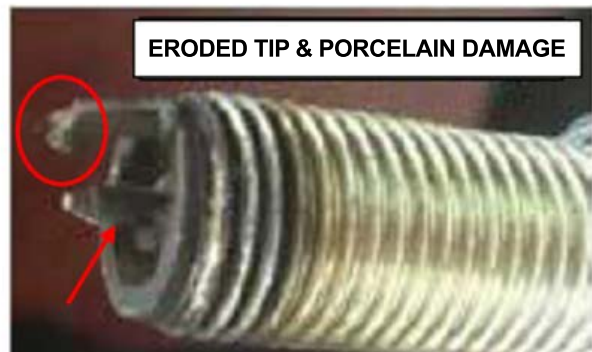
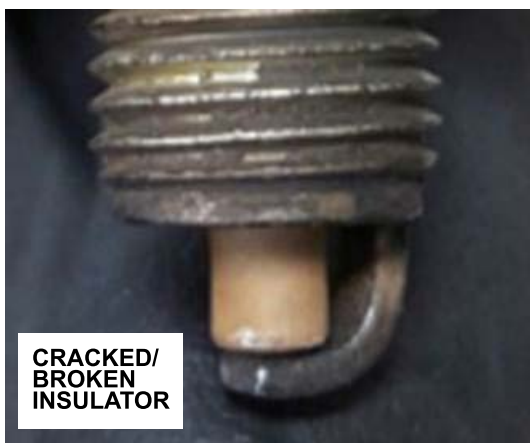
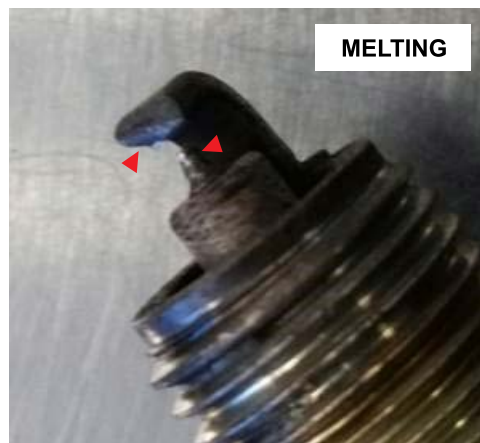
**Step 4:** Remove and inspect the spark plugs closely for any damage, erosion or melting. Inspect, rotate, turn upside-down and shake each spark plug to check for a cracked or loose porcelain insulator around the center electrode. Take note which cylinder(s) have spark plugs with verified damage and mark each plug, damaged or not, with the corresponding cylinder number.

**NOTE:** Any damage to the spark plug porcelain outside of the cylinder head is not a result of this condition.

- If the inspections performed in **Step 4** above revealed spark plug damage, the engine assembly must be replaced (refer to Part 3 of Flow Chart) following the procedure in the applicable Service Manual.
