INTRODUCTION:

This bulletin announces availability of new rear gate (PRG) stays designed to address customer concerns of other than expected PRG operation. The enhancement involves a change to the viscosity of the lubricant used for maintaining smooth operation of the 2 pressurized rear gate stays. If the PRG is left open for an extended period of time (longer than approximately 5 minutes), the stays may develop increased operating resistance. This increased resistance is transferred to the PRG mechanism during closing causing an increase to the motor's electrical current draw. As a result, the "anti-pinch" feature of the PRG activates, a beep sound occurs and the gate re-opens without input from the customer. These symptoms may continue to occur on subsequent attempts to close the PRG. The anti-pinch feature is designed to operate if the gate comes in contact with an obstruction while closing. When activated, the gate reverses direction and re-opens automatically.

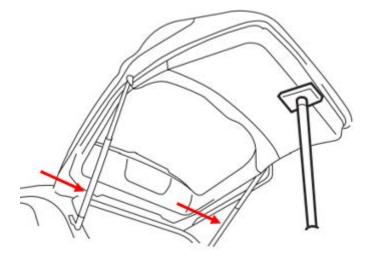
CAUTION: Whenever removing / replacing the rear gate stays, always work in teams of 2 or more people due to the weight of the rear gate assembly. Whenever a stay is removed, always use a securely positioned prop as shown in the illustration below to keep the rear gate open and supported. Vehicle damage and/or personal injury may occur should the prop become disengaged unexpectedly.

IMPORTANT NOTE: Always replace **both** rear gate stays as a set.

- Follow the service procedure outlined in the applicable Service Manual when replacing the rear gate stays.
- **DO NOT** disengage the power rear gate rod while performing this procedure. If the rod is disengaged for any reason, the stop ring(s) **MUST** be replaced.
- The top rear gate stay bolts are torqued to 16 Nm (11.8 ft. lbs.) and the lower ball stud to 20Nm (14.8 ft. lbs.).
- Always confirm proper PRG operation before releasing the vehicle.
