SERVICE BULLETIN

APPLICABILITY: 2013-14MY BRZ

NUMBER: 12-200-16R

SUBJECT: Rear Combination Lamp and Related
Enhancements

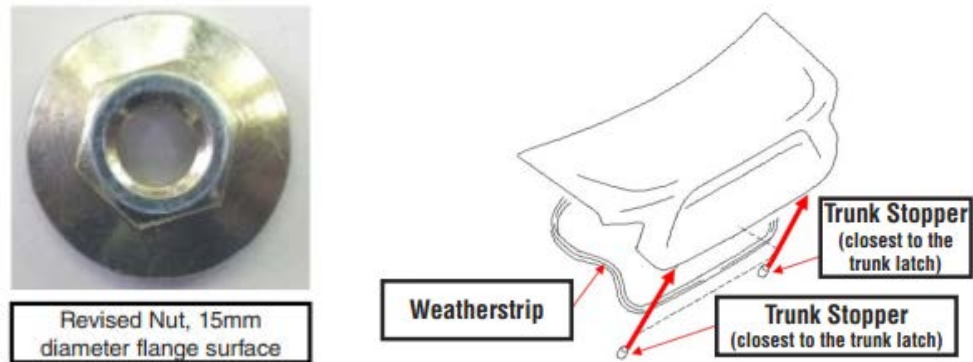
- Flange surface dimension of retaining nuts increased from 12mm to 15mm.
- Thickness of the combination lamp gaskets increased for improved sealing.
- The “height” of the trunk stoppers has been increased by 2.7mm and a liner added to the trunk weatherstrip intended to improve crush resistance and keep the trunk lid from contacting (and in a small number of cases, cracking) the tops of the combination lamps when closing.

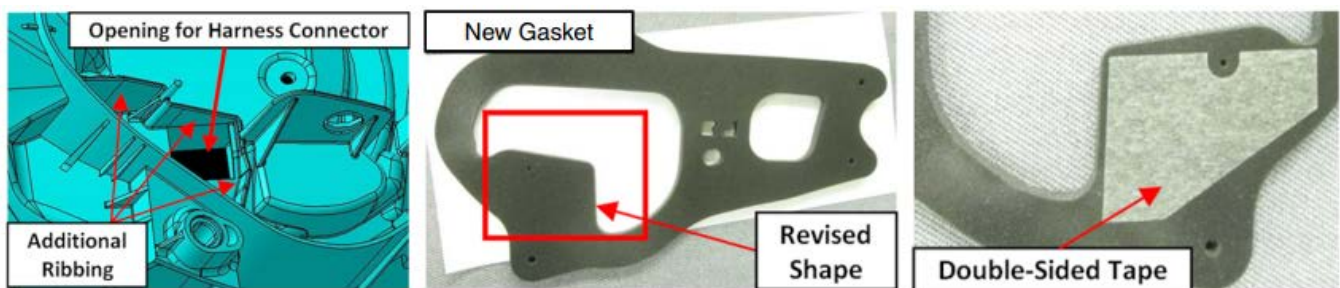
- Further revision of combination lamp assy. (additional ribbing) and further revision of the gasket shape along with addition of double-sided tape to the gasket for improved sealing.

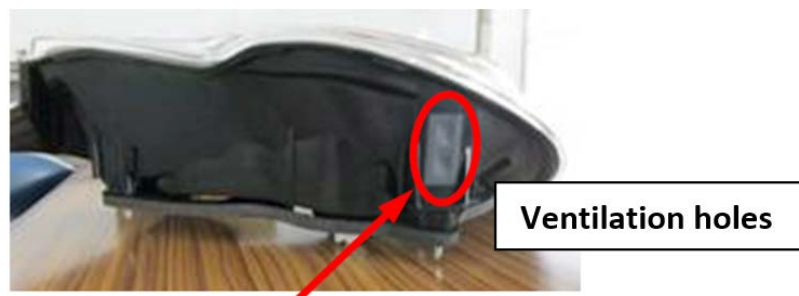
- Application of an anti-fog coating to the inside of the combination lamp lens at production to prevent “clouding”.
- Additional ventilation holes have been added to prevent condensation build-up.

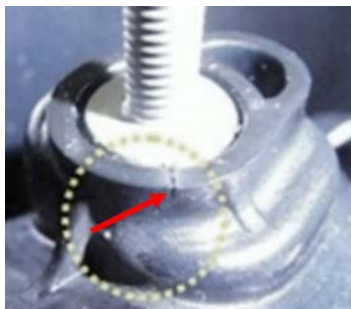
- Inspect the retaining stud boss areas of the housings for any cracking as shown below. If cracking is confirmed, the lamp assy. must be replaced.

NOTE: Unless the most recent combination lamp assemblies are already installed, when replacement is required, replace BOTH assemblies with the new parts.
