SERVICE BULLETIN

APPLICABILITY: 2014-16MY Forester 2.5L Models

NUMBER: 07-112-16R

SUBJECT: New Alternator Assembly to Address DTC P0300

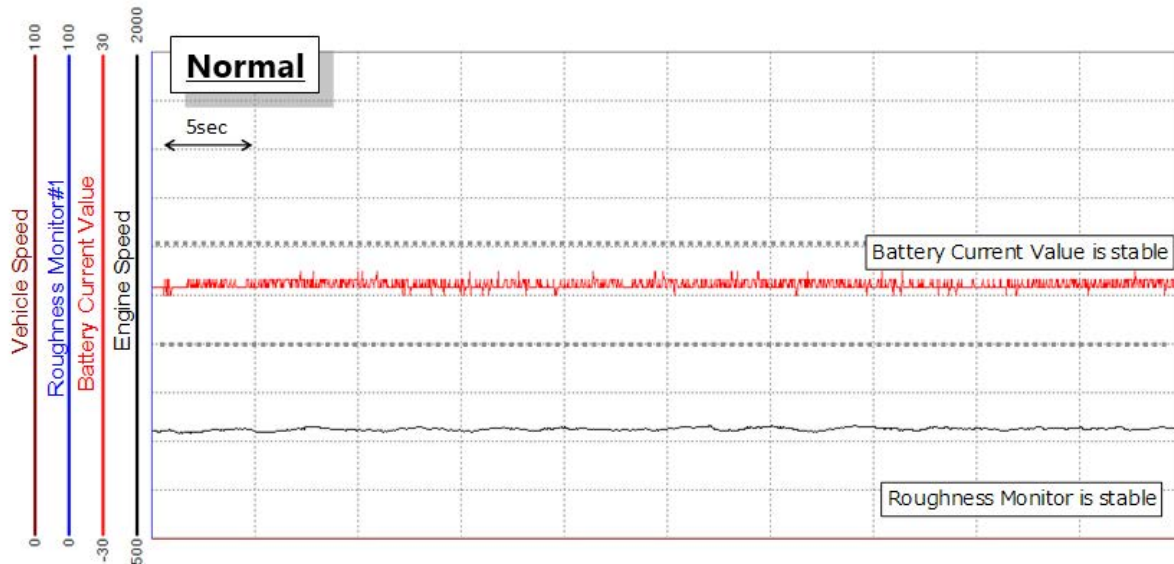
The reference illustrations below show examples of “Normal” and “Abnormal” SSM4 data.

The abnormalities shown above for the Roughness Monitor and Battery Current Value are a result of resonance originating in the alternator pulley assembly. Although a DTC P0300 can also be set, there is not an actual misfire of the engine.

- Connect the SSM4 and inspect for stored DTC(s).
- If any DTC(s) other than P0300 are stored, follow the corresponding diagnostic procedure(s) in the applicable Service Manual before proceeding further with these repairs.
- Select the data for Roughness Monitor and Battery Current values.
- Check for any increase in the Roughness Monitor value along with the Battery Current value. If a fluctuation of more than ± 3 A is confirmed, both the alternator assembly and belt tensioner assembly must be replaced **as a set** with the new parts listed in the table above.

- When determined necessary to replace the alternator and tensioner, follow the service procedures in the applicable Service Manual.
