SERVICE BULLETIN

APPLICABILITY: 2013-14MY Legacy and Outback Models with 2.5L FB Engines
 2011-14MY Forester Models with 2.5L FB Engines
 2015 MY Forester (Manual Transmissions Only) with 2.5L FB Engines
 2012-13 MY Impreza and XV Crosstrek Models with 2.0 FB Engines
 2014-15 MY Impreza and XV Crosstrek Models (Manual Transmissions Only) with 2.0 FB Engines

NUMBER: 02-157-14R
DATE: 08/28/14
REVISED: 11/21/16

SUBJECT: Engine Oil Consumption

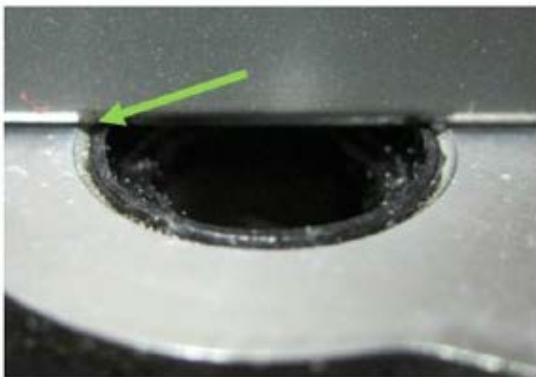
OK- Filter Screen flush with machined surface of camshaft carrier.

- **IMPORTANT:** The **one-time use** AVCS filter screens in the cam carriers are available separately (p.n. 14451AA050). **NOTE:** Although the filter screens are not directional, they must be installed flush with the machined surface of the cam carrier as shown in the OK photo below. The NG photo shows the screen installed too deep into the camshaft carrier. Engines with AVCS on both intake and exhaust will have 2 filters in each carrier as opposed to just one (intake only AVCS).

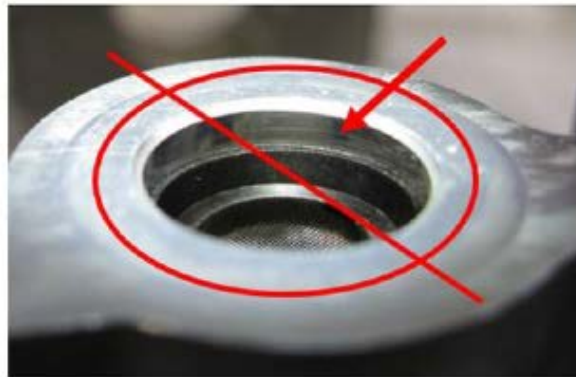
NG- Filter Screen installed too deep into the camshaft carrier bore.

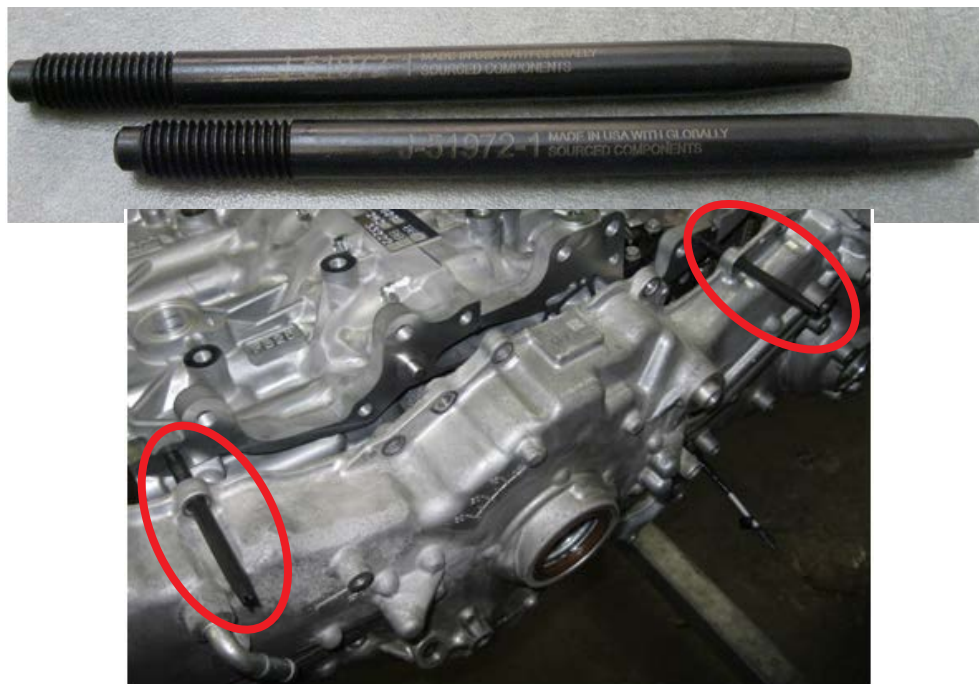
- If alignment pins are not used and the sealer gets disturbed during the cover installation, unless properly addressed, the affected area(s) will most likely be the source of an oil leak after reassembly. Don't hesitate to use a helper for the cover installation to prevent this from happening.

- IMPORTANT:** When re-installing the front cover assembly, be very careful to not allow it to contact any of the timing sprockets. If contact does occur, it will most likely be with the exhaust sprockets and it is almost a guarantee the fresh silicone sealer beads applied to the cover will be disturbed. To minimize the possibility of this happening, alignment pins as shown in the photos below have been developed to “guide” the cover into its proper position without disturbing the fresh sealer. The Subaru Special Tool number for the alignment pin kit is J-51972. Each kit includes 2 pins.
