SERVICE BULLETIN

APPLICABILITY: All 2012 to 2015 Models Equipped with Fujitsu Ten (F10) Generation 1 (Gen1) Audio / Navigation Systems

NUMBER: 15-193-16R

SUBJECT: New SD Card Software Update Procedure

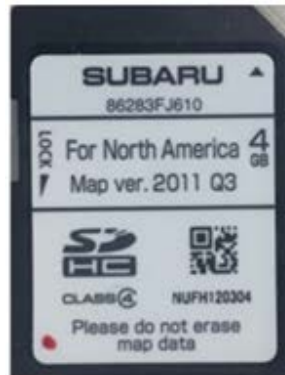
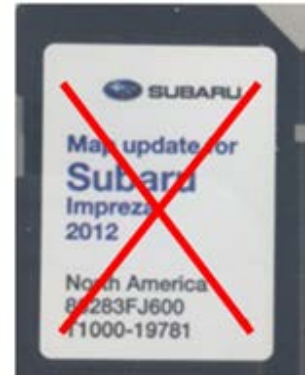
NOTE: This procedure is NOT to be used for updating Map update cards as shown here with a red "X". To update the software on a Map Update card, the customer must contact HERE for assistance at: 1-866-462-8837 (M-F 8AM-6PM CST).

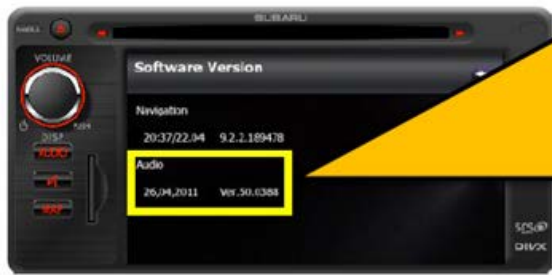
- Compare the displayed software version to the chart shown in the table below. Confirm the **last 4 digits** of the head unit’s software version number are **BEFORE** (lower than) the “After Reprogramming” version number shown in the table below.

- If the head unit’s version number is equal to or higher than the version number shown in the table, the procedure is complete as the system is already utilizing the latest version available.
- If the head unit’s version number is before (lower than) the version number shown in the table, proceed to **Step 2** and update the SD card using the new FTEN updating tool.

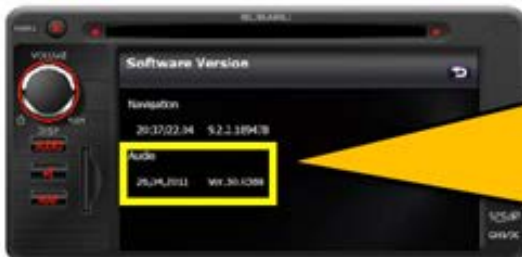
- Compare the displayed software version to the table shown in the illustration below. Confirm the **last 4 digits** of the head unit's software version number match the "after Reprogramming" version number shown in the table below to complete the procedure.
