SERVICE BULLETIN

APPLICABILITY: 2016MY Impreza, WRX and Crosstrek Models
 2016MY Forester Models

NUMBER: 15-206-16

SUBJECT: USB Device Not Recognized on Fujitsu-Ten (F10)
 7" Display Navigation and Display Audio Units

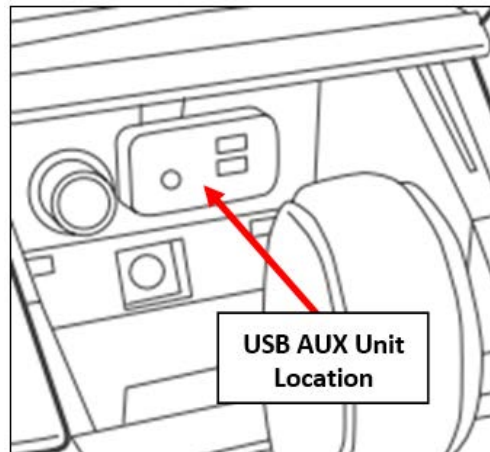
This bulletin announces availability of a new auxiliary USB unit to address customer concerns where the 7" Display Audio or Audio Navigation head unit will not recognize USB devices connected via the auxiliary unit.

The part number for the new USB AUX Unit assembly is **86257AL200**.

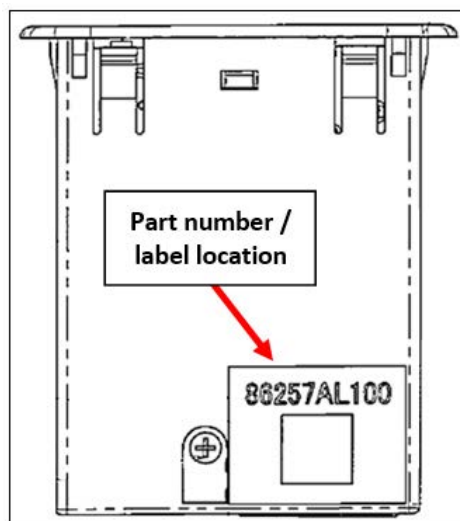
When a known-good USB device (device operates normally in another vehicle) is not recognized, it is likely due to damage of the USB connector portion of the USB auxiliary unit.

The damaged USB connector causes electrical “noise” to be generated and transferred into the audio unit resulting in internal damage. For this reason, whenever this condition has been diagnosed and confirmed, the USB AUX Unit must be replaced along with an exchange audio unit as a set following the applicable Service Manual and Audio Exchange Program procedures.

Remove the USB AUX Unit and verify the part number on the underside of the case as shown in the illustration below. If the part number is 86257AL100, replace it with a new **86257AL200** unit along with the applicable exchange audio unit.

REMINDER: The USB AUX Unit and the exchange audio unit must be replaced as a set.
