VW Elsa Newsletter

Edition 169: January 18, 2016

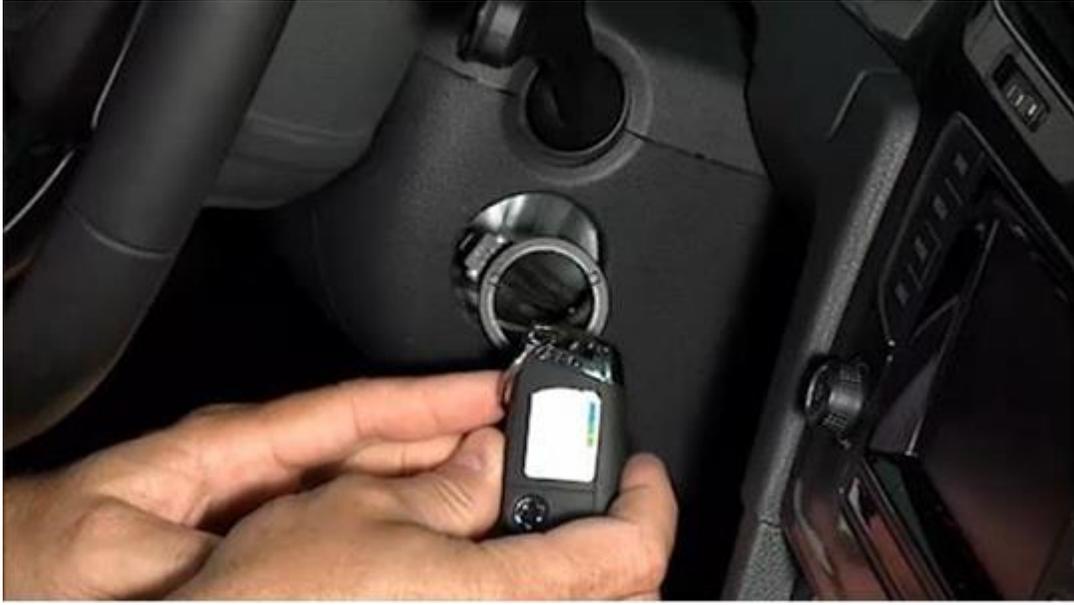
96-14-05 Immobilizer Key/Key Remote Adaptation Test Plan January 15, 2016: Update to model applicability. Date: August 22, 2014
January 15, 2016: Update to model applicability.

To adapt keys to a 2015-2016 Golf, GTI, Golf R or Sportwagen (MQB chassis,) it is necessary to complete the "Adapt Immobilizer" test plan. **Kessy Vehicles:** Verify that the reader coil (figure 1) is removed from the steering column and the key is touching the reader coil during key adaptation. Bladed key vehicle, it is not necessary to remove the reader coil. The test plan can be found under the ODIS Special Functions Tab (figure 2) or by navigating to "Immobilizer functions" under "Elect. Immobilizer 5A" after clicking the "Select self-test" button in the Test Plan tab (figure 3). This procedure adapts both the remote and immobilizer functions of the key.

Note: Vehicle may not start and or have warning lights on cluster after immobilizer / key adaptation is completed. See pg. 5 information in this tech tips after

immobilizer / key adaptation for further instructions.
