Technical Bulletin

Model(s)	Year	Eng. Code	Trans. Code	VIN Range From	VIN Range To
Golf, Golf GTI	2015 - 2016	All	All	All	All

60 16 03 February 25, 2016 **2043031** Supersedes Technical Bulletin V601602 dated February 5, 2016 to update damage code in warranty table.

Rattle or Creaking Noise from Panoramic Sunroof

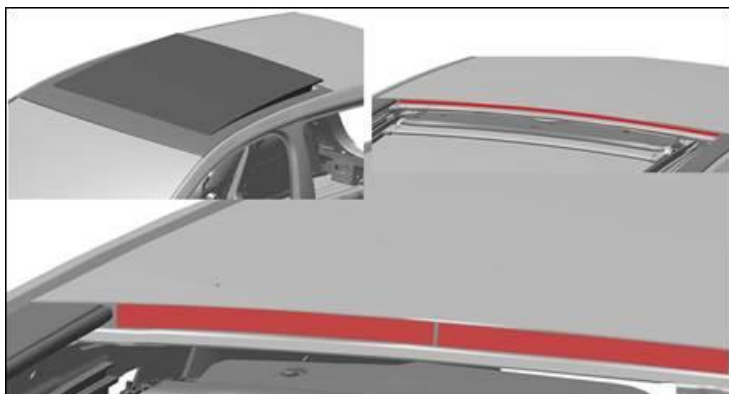
A rattle or creaking noise may be heard from the rear of the Panoramic Sunroof when driving on uneven roads with the sunroof closed.

Rattle or creaking noise is caused by the relative movement between the glass panel seal and body when the sunroof is closed.

Figure 1) Area to apply the self-adhesive film (glass panel removed for illustration purposes).

- Cut the protective film sheet (part number AKL 448 300 04) into 3 strips 12 mm wide x 290 mm (290 mm is the length of the long side of the protective film sheet).
- Move the glass panel to the tilt open position.
- Thoroughly clean the contact area between the rear glass panel seal and the body.
- Apply the self-adhesive protective film strip to the body (Figure 1, in red).
- Close the glass panel.
