# Tech Tips

TT 93-16-02

## 2015-2016 eGolf – Charging Cable Removal Tips

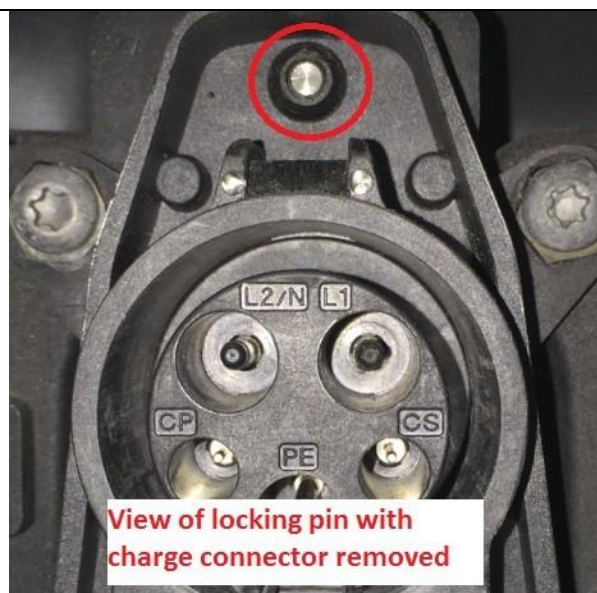
Figure 1

Customer is unable to remove the charging cable from the socket. Note: This only applies to 7.2kW chargers, with the DC fast charge connection. Refer to TT 93-15-02. The charging connector may not have been properly unlocked by the vehicle. Check that the following requirements have been met:

The last resort is too manually release the lock pin using a small pick or similar tool to push the lock pin back into the charge socket until it is flush with the socket housing (Figure 1). At that point, depress the charger release button and remove the cable.

Scan the vehicle for faults, verify wiring to the socket from the J966 control module and depending on diagnosis results, replace the charge socket/cable assembly and JX1 seal kit, the wiring to the J966 or the J966.
