# Technical Bulletin

Model(s)	Year	Eng. Code	Trans. Code	VIN Range From	VIN Range To
e-Golf	2015	All	All	All	All
e-Golf	2016	All	All	AU_GW900000	AU_GW909421

93 16 02 March 23, 2016 2041920 Supersedes Technical Bulletin V931601 dated January 8, 2016 to add DTC P168F00 and production VIN break.

Update Programming, DTC(s) Stored in AW C6 High-Voltage Charger including B200000, P31EA00, and P168F00 (U.S. Only)

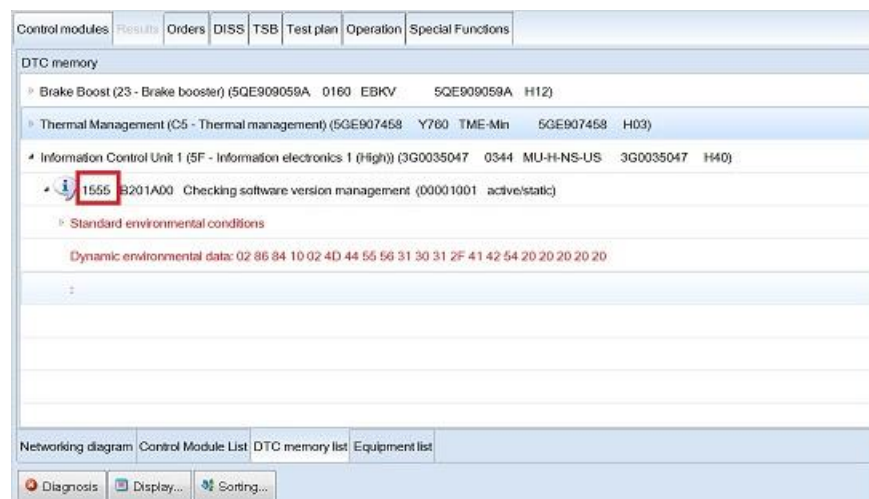
b. In Figure 1 (above), the symptom number shown inside the red box is 1555.

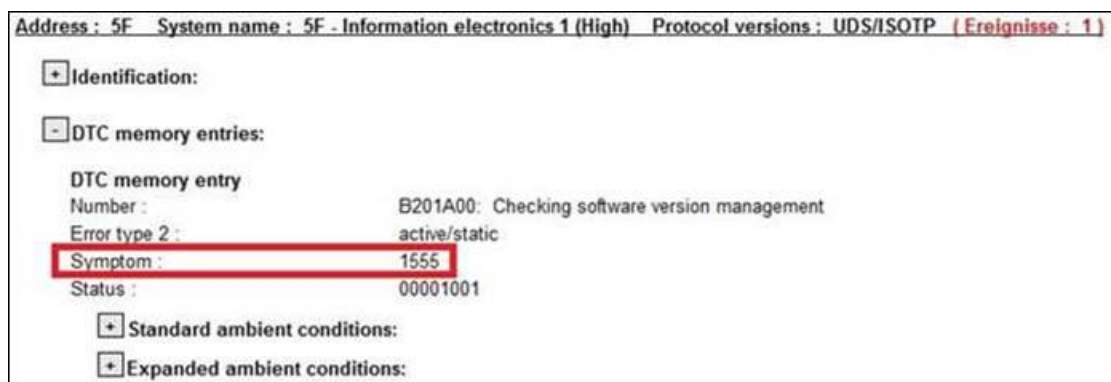
**Figure 2**

d. In Figure 2 (above), the symptom number shown inside the red box is 1555.
