Technical Bulletin

87 16 03 March 11 2016 **2037255** Supersedes Technical Bulletin V871502 dated March 5, 2015 to update additional time for TDI PTC heater harness and additional passenger side lever installation information.

Whistle Noise from Center Vent Area; Blower Set on 3 or 4 with Full Heat Selected

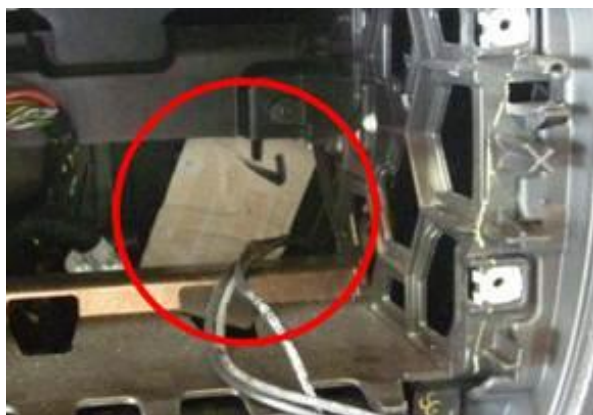
Figure 1

- Remove the radio, see Repair Group 91 in Elsa.
The label on the air distribution unit is located on the front of the distribution unit assembly (Figure 1).
Check the production date of the air distribution unit (Figure 2).

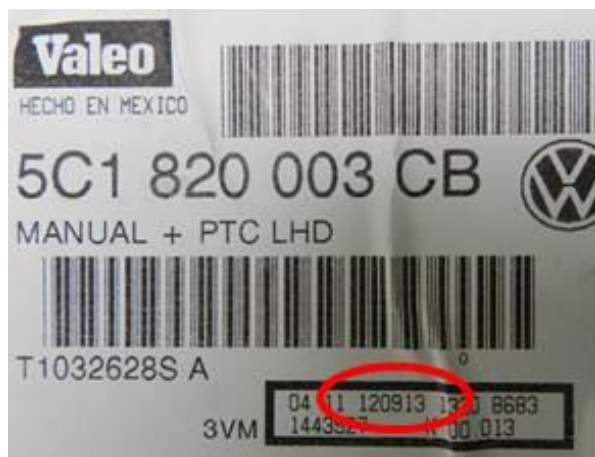
Figure 2

The production date is Day/Month/Year (120913 = Sep 12th 2013) (Figure 2).

All air distribution units built before 9/30/2013 will require both the left and the right temperature flap levers.

Air distribution boxes built between October 1st 2013 and March 20th 2014 will require only the right (Black) temperature flap lever.

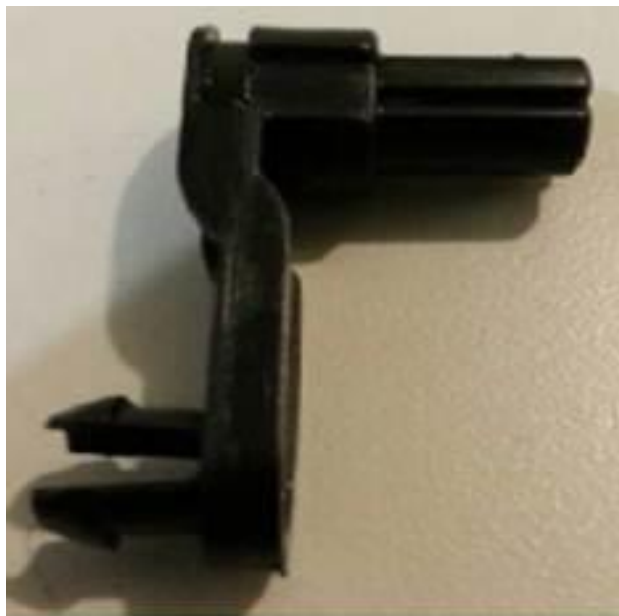
Figure 10

- **The lever position shown in Fig 10 is when the temperature flap is in the full heat position**

Installation of the passenger side temperature flap lever. (Black)
