Technical Bulletin

15 16 01 March 9, 2016 **2015153** Supersedes Technical Bulletin V151401 dated March 11, 2014 to include replacement High Pressure Fuel Pump part number ONLY to be used if the plunger tip is worn.

MIL ON, DTC P0087, P1093 or P2293 Stored in ECM Fault Memory

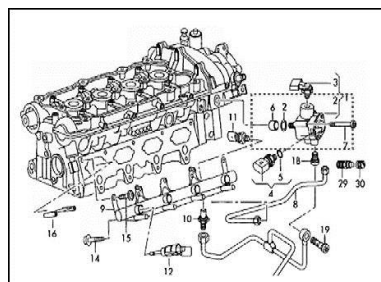
Figure 1

Remove the high pressure fuel pump and visually inspect:

1. Base surface of the cam follower -6- in contact with the camshaft lobe.
2. Tip of the high pressure fuel pump plunger.

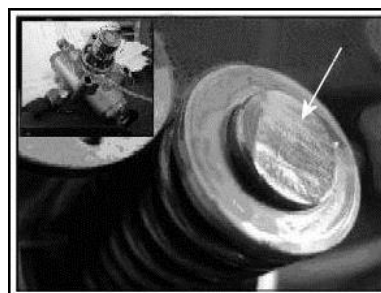
Figure 2

Inspect the tip of the high pressure fuel pump plunger (Figure 2) for excessive wear.

High pressure fuel pump plunger damage is only possible if the cam follower base has a hole in it as seen in figure 3 inset -A-, and the plunger tip has come in direct contact with the camshaft lobe (figure 4).

If plunger tip of fuel pump is **NOT WORN**, **DO NOT REPLACE** the fuel pump.

If excessive wear is found the high pressure pump must also be replaced, see Group 20 Fuel Supply in Elsa.
