NUMBER: 08-071-16

Water Intrusion In Dash To Front Fascia In-Line Connector

This bulletin involves rework on the dash wire harness in the left front wheel well and possible front fascia wiring harness replacement due to water intrusion.

2017 (RU) Chrysler Pacifica

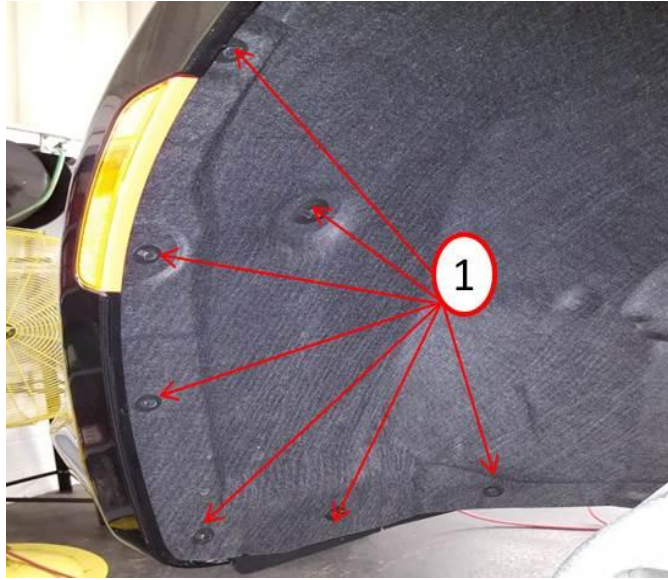
Fig. 1 Wheel Liner Fasteners

1 - Seven Fasteners

1. Raise and support the vehicle. Refer to the detailed service procedures available in DealerCONNECT> TechCONNECT under: 04 - Vehicle Quick Reference/Hoisting/Standard Procedure.
2. Remove the left front tire and wheel assembly. Refer to the detailed service procedures available in DealerCONNECT> TechCONNECT under: Service Info> 22 - Tires and Wheels/Removal and Installation.
3. Remove the front seven fasteners (Fig. 1) for the wheel well liner and fold back **Do not bend** the liner to gain access to the dash and fascia wire harness.

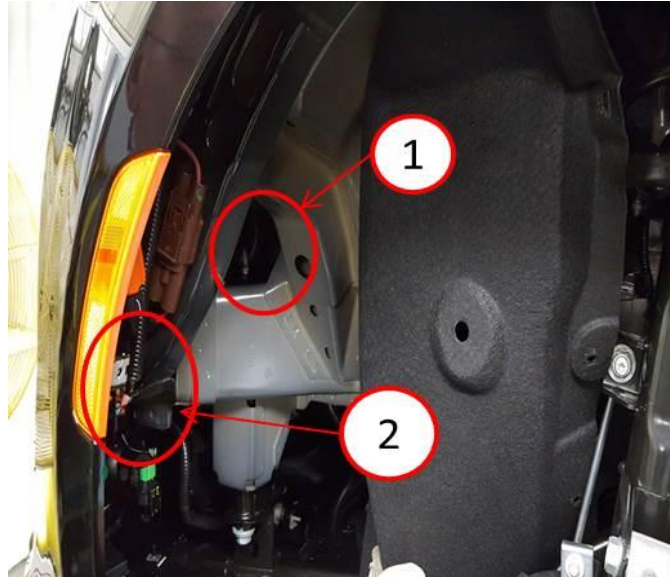
Fig. 2 Location Of Wiring

1 - Ground Location

2 - Dash To Fascia Inline Connector

4. Locate the wire harness inline connector (Fig. 2). Disconnect Dash to fascia in-line connector and spray with compressed air to dry it out. If no signs of corrosion, spray with electrical contact cleaner(Fig. 3).

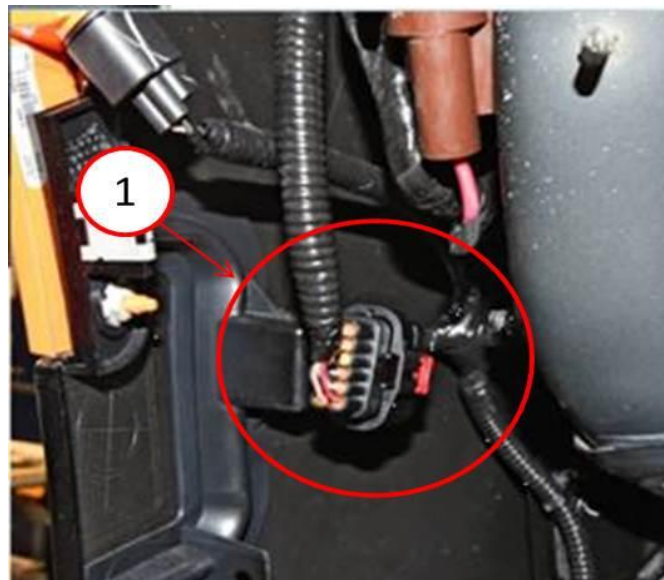
Fig. 3 Electrical Connector

1 - Fog Lamp Connector / Front Fascia Wiring Connector/Fascia to Dash Inline Connector

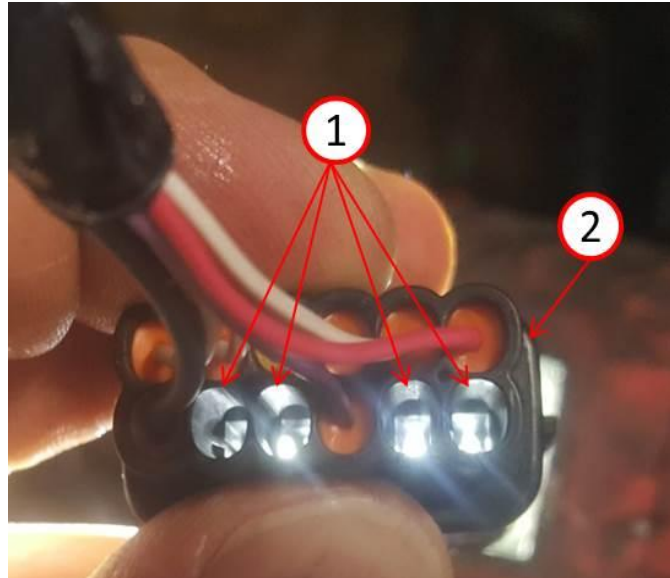
Fig. 4 Electrical Connector Plugs

NOTE: Ensure connectors plugs are not pushed out of connector when dried with compressed air. (Should be flush with back surface of connector, a light can be used on one side of the connector to view if all plugs are properly installed and seated) (Fig. 4).

1 - Missing Seal Plugs

2 - Electrical Connector

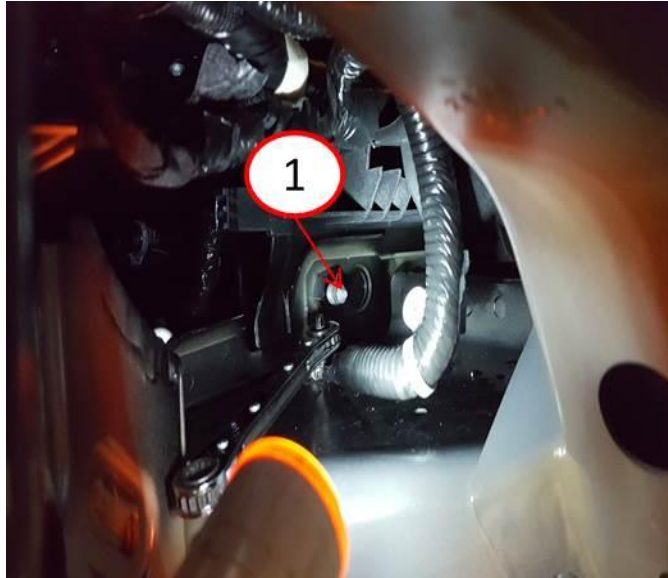
Fig. 5 Ground Nut

1 - Ground Nut

5. Locate and remove the ground nut (Fig. 5) to the body structure.

15. Apply terminal to stud with wings of terminal facing down, secure clip to hole in rail (Fig. 16). Apply nut to stud and tighten to 8 N-m (70 in. lbs) (Fig. 5).

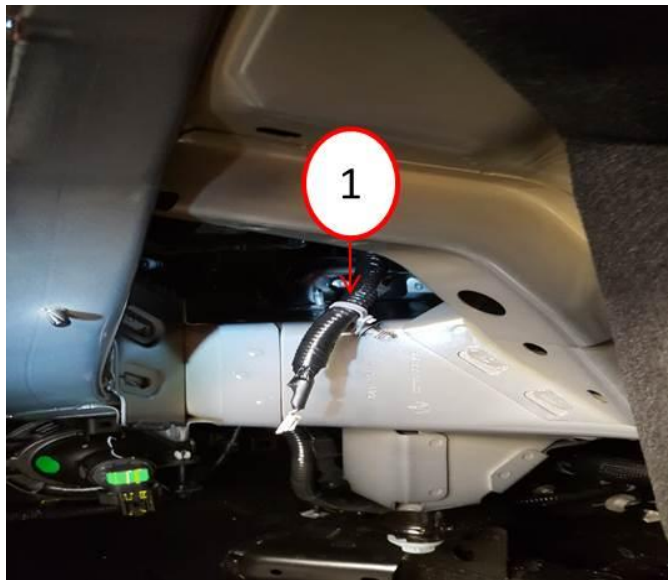
Fig. 6 Hold Down

1 - Hold Down

6. Remove the plastic hold down clip from the body (Fig. 6).

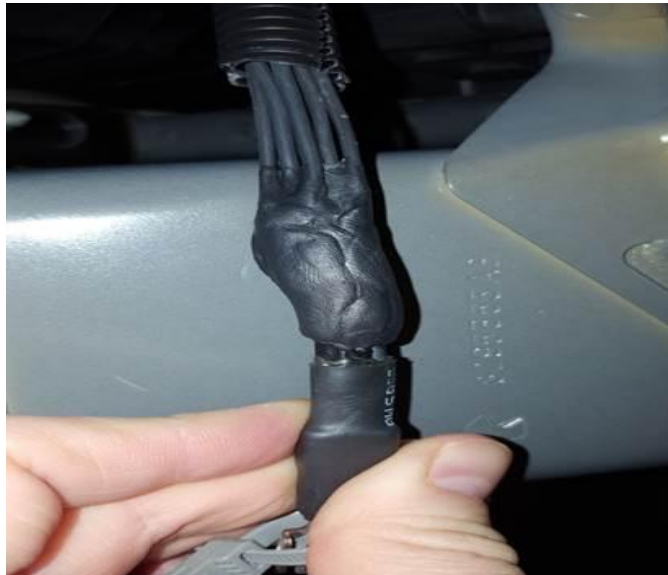
Fig. 12 Butyl Toward Heat Shrink

NOTE: Intent is to seal gap between wires and prevent water from getting into/under heat shrink.

11. Fold remaining butyl over, remove remaining backing and press firmly into wires. Work butyl down toward the heat shrink on the terminal ([Fig. 12](#)).

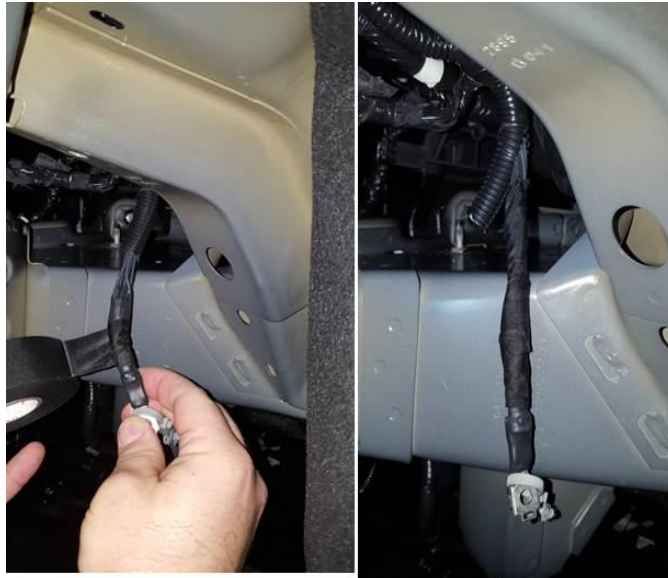
Fig. 13 Abrasion Tape

NOTE: Tape will go under new length of conduit 20 mm (1 in).

12. Start abrasion or vinyl tape over heat shrink and apply an overlapping wrap up branch to end 145 mm (6 in) from center of terminal (Fig. 13).

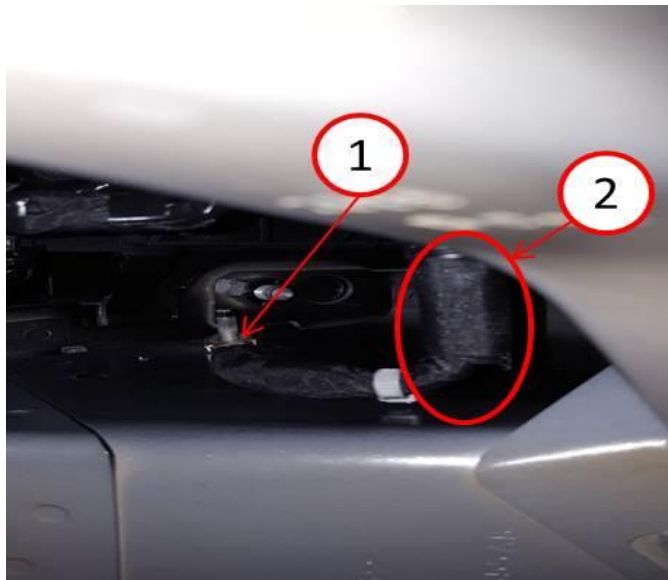
Fig. 16 Ground Nut Wings Up

- 1 - Ground Terminal Wings Up
2 - Open End Of Conduit To Allow For Water Drainage
-

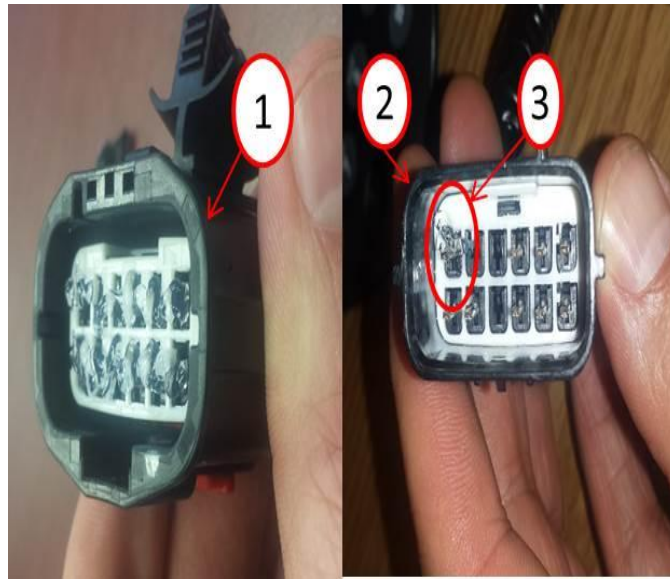
Fig. 17 Male And Female Connectors

- 1 - Female Connector
 - 2 - Male Connector
 - 3 - Ground Cavity
-

19. Replace the male electrical connector from the dash to the front fascia wiring ([Fig. 17](#)). Refer to the detailed service procedures available in DealerCONNECT> TechCONNECT under: Service Info>29 - Non-DTC Diagnostics/Circuit Testing Procedures/Standard Procedure>Wire Splicing.

20. Add small amount of Nyogel 760G to each cavity of the female connector (fascia) and to base of male ground pin (Black wire from Dash) ([Fig. 17](#)).

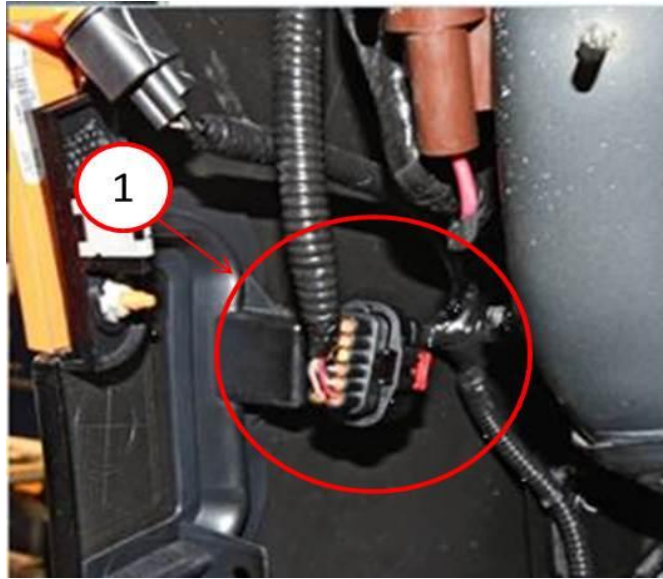
Fig. 18 Electrical Connector

1 - Fog Lamp Connector / Front Fascia Wiring Connector/Fascia to Dash Inline Connector

21. Reinstall connector and re-clip to fascia if connector is loose. Ensure Red CPA is re-locked ([Fig. 18](#)).

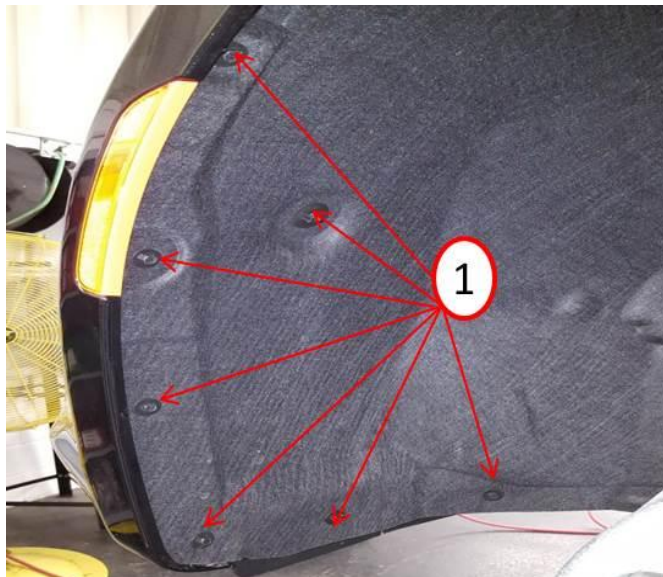
Fig. 19 Wheel Liner Fasteners

1 - 7 Fasteners

22. Install the front seven fasteners for the wheel well liner ([Fig. 19](#)).
