NUMBER: 23-036-16

Cargo Load Floor Lid Difficult to Open and Close

2016 (WD) Dodge Durango

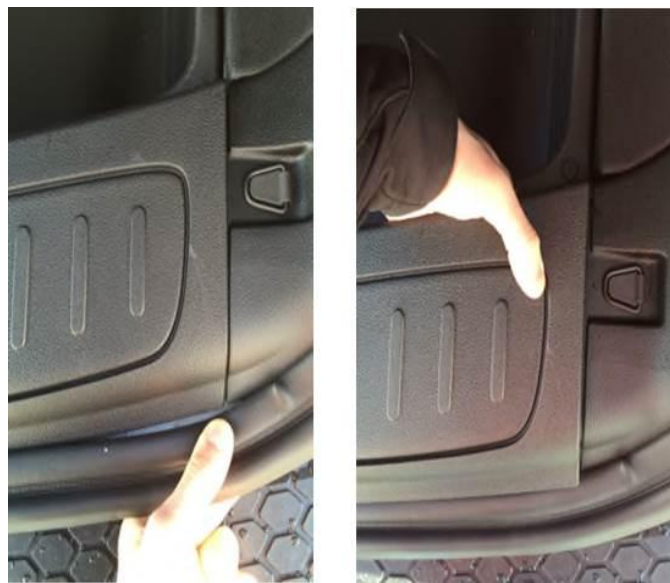
Fig. 1 Scuff Plate

The cargo load floor lid may have excessive effort (more than 15 lbs of force) when opening and closing due to interference between the rear edge of the cargo floor load lid and the tailgate scuff plate.

2. Move the weather strip at the corner of the liftgate scuff plate to unseat the retention clips at the corner ([Fig. 1](#)) and remove the scuff plate. Refer to the detailed service procedures available in DealerCONNECT> TechCONNECT under: Service Info>23 - Body/Interior/PLATE, Scuff, Liftgate/Removal.
