NUMBER: 23-040-16

Liftgate Tail Lamps Underflush To The Body Mounted Tail Lamps

2015 - 2016 (KL) Jeep Cherokee

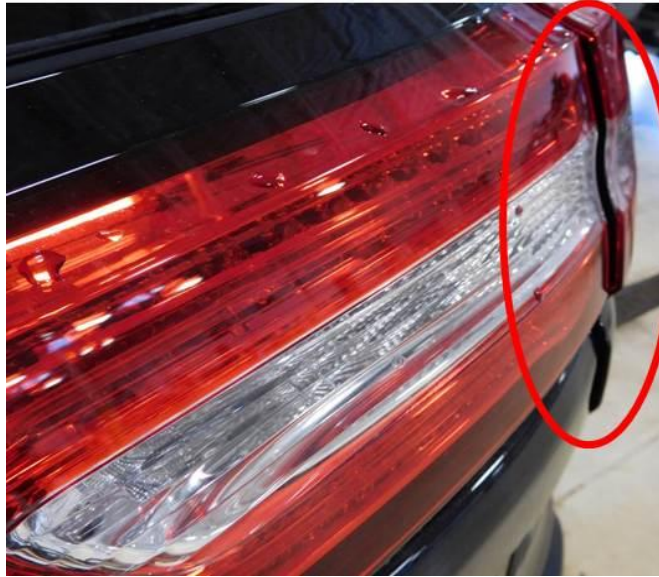
Liftgate tail lamps look underflush to body mounted tail lamps (Fig. 1).

Fig. 1 Underflush Tail Lamp

This bulletin involves adding washers behind the liftgate tail lamps to bring them flush to the body mounted tail lamps.

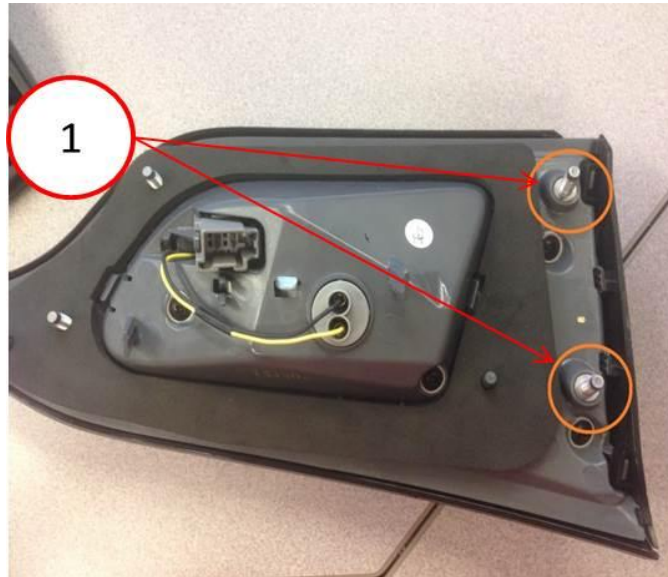
Fig. 2 Adding Washers To Studs

1 - Washers To Be Added To Outboard Studs

2. Add 1 washer to each outboard stud of the lift gate mounted tail lamps (Fig. 2).
