NUMBER: 23-052-16 REV. A

Missing Underbody Hole Plug

2016 - 2017 (JC) Dodge Journey

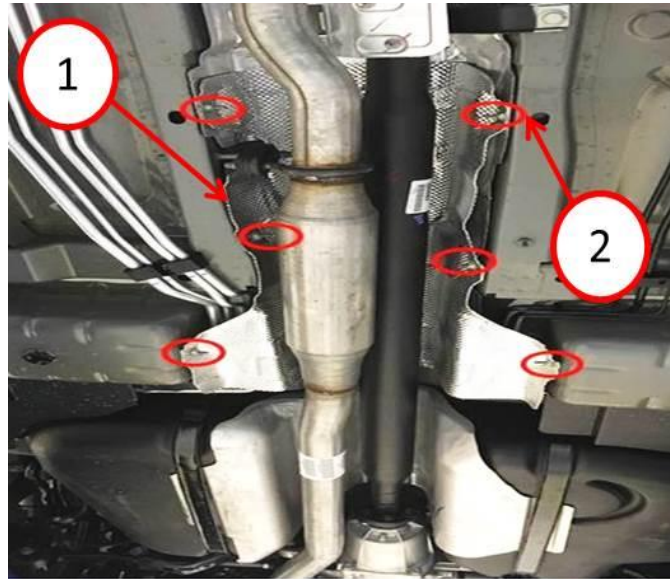
Fig. 1 Heat Shield

- 1 - Heat Shield
- 2 - Fasteners To Remove

1. Install underbody hole plug. Raise vehicle on hoist.
2. Remove the six fasteners holding the heat shield to the underbody (Fig. 1).

-
3. Slide the heat shield rearward and out of the way.

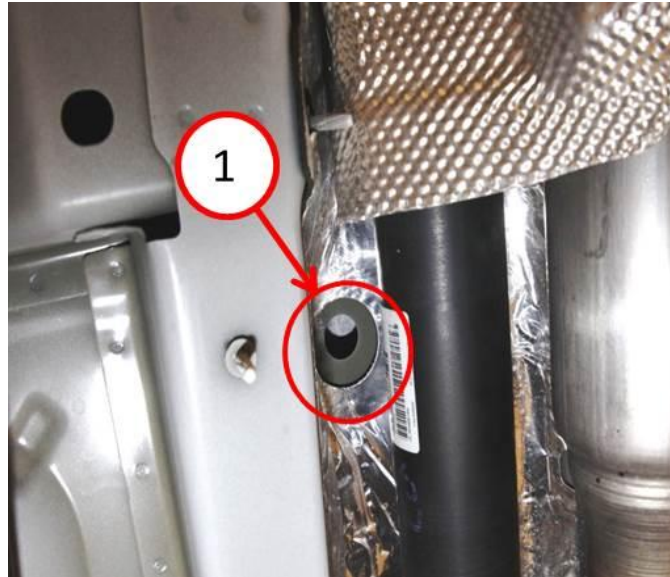
Fig. 2 Missing Underbody Plug Hole

Customers may experience wet carpet from water intrusion when fording through deep water due to a missing underbody hole plug.

1 - Underbody Plug Hole

4. Locate underbody hole missing plug (Fig. 2).
