**NUMBER:** 08-074-16 REV. B

Video Routing Module Enhancements For Rear Seat Entertainment System

2017 (RU) Chrysler Pacifica

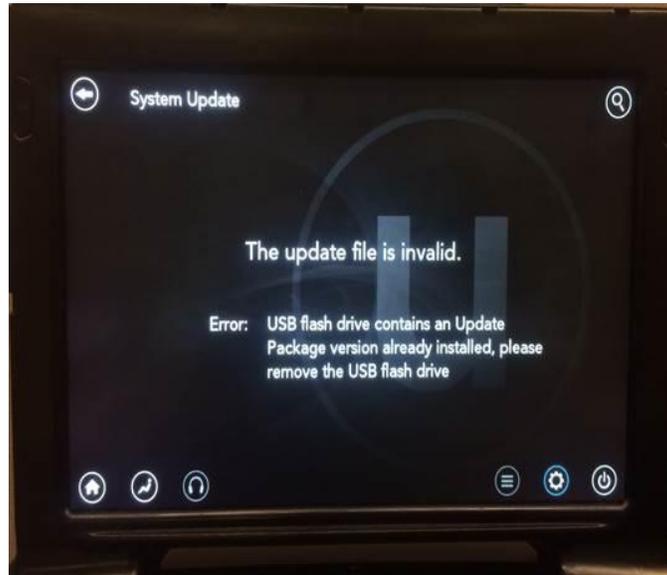
**Fig. 2 Error Screen**

**NOTE:** If USB stick is left in the port after system reboot, there will be a pop-up that states the file is invalid (**Fig. 2**). This is not a concern as the system is already up-to-date.
