NUMBER: 03-007-16

DATE: November 30, 2016

Front Of Vehicle Lateral Vibration During Low Speed Acceleration

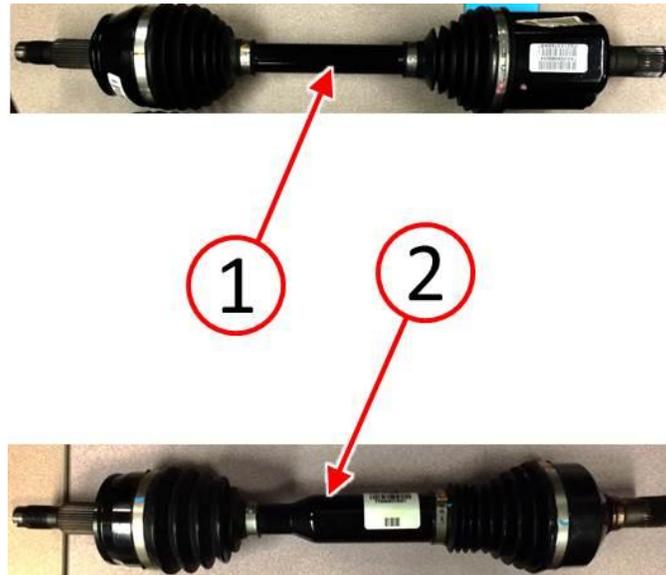
Fig. 1 Axle Half Shaft Identification

1. Inspect the front axle half shafts to identify which type is currently installed in the vehicle. Refer to (Fig. 1).
 - a. Straight Diameter Center Shaft (Fig. 1)>>> Continue with the Repair Procedure Step #2.
 - b. Stepped Diameter Center Shaft (Fig. 1)>>> This Bulletin does not apply. Normal diagnosis should be performed.

- 1 - Straight Diameter Center Shaft
- 2 - Stepped Diameter Center Shaft

2. Remove the front half shafts with straight diameter center shaft and replace with the stepped diameter center shaft half shafts listed in this bulletin. Refer to the detailed service procedures available in DealerCONNECT> TechCONNECT under: Service Info> 03 - Differential and Driveline> Half Shaft, Front> Removal/Installation.
