Technical Bulletin

60 16 10 December 6, 2016 **2045403** Supersedes Technical Bulletin V601608 dated November 22, 2016 due to updated title with applicable model clarification, clarification definition of Panoramic Sunroofs and corrected VIN range.

Water leak from the Sunroof (Panoramic Roof) on Golf and GTI models

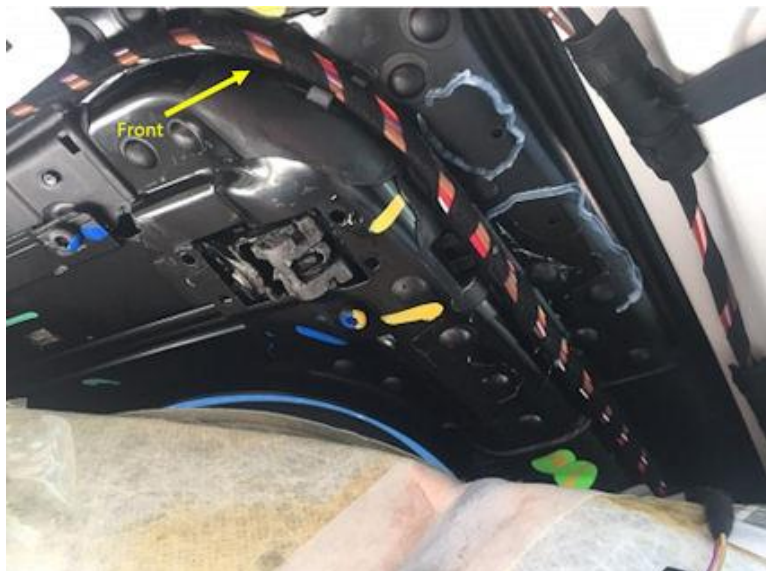
Verify the customer complaint. Water leaks occur near the A-Pillars in the corners of the sunroof water channel.

Figure 1 (Water leaking through corner of water channel)

Some of the plastic rivets/buttons may be missing from the steel reinforcement plate as illustrated by the white outline in Figure 1. This will not affect the structure of the water channel. DO NOT attempt to repair or seal the openings caused by the missing rivets.

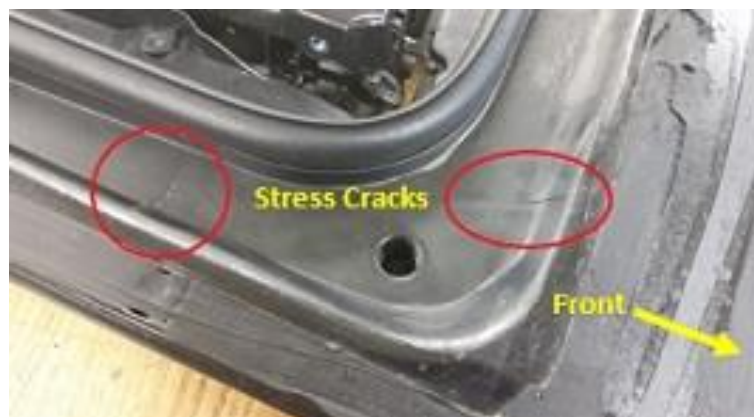
Inspect the sunroof water channel for stress cracks (see figure 2). There are a total of 8 areas to inspect for cracks which are outlined in Figure 3 below. (More than 1 crack may be found).

Figure 2 (Examples of stress cracks in water channel)

A difference in the expansion rate between the plastic water channel and steel reinforcement plates may cause stress cracks to occur at the edges of the reinforcement plates.

In most cases there will be stress cracks in multiple locations of the water channel. Care must be taken to ensure all cracks are identified, sealed and that all 8 foil patches are installed correctly. Failure to seal all cracks and install all 8 foil patches will result in a repeat failure.

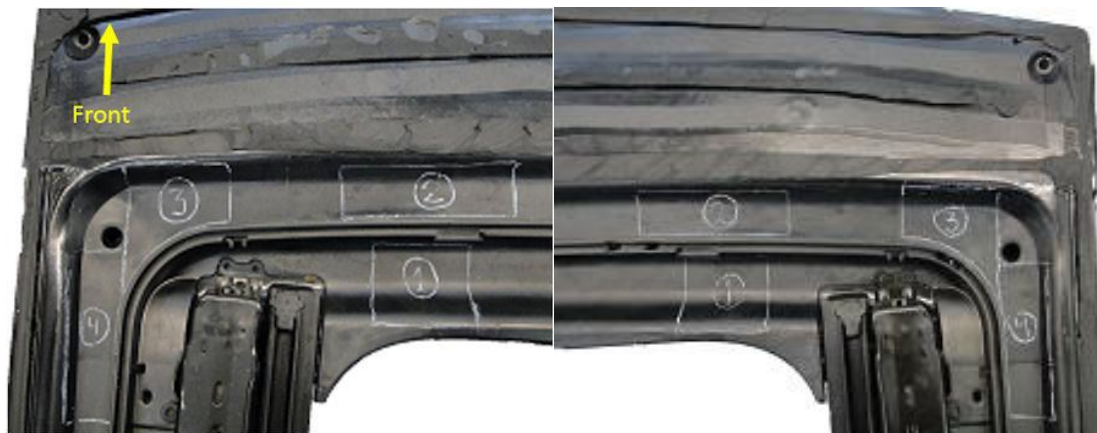
Figure 3 (Inspections zones for stress cracks / application zones and sequence for foil application)

12. Apply the foil tapes one at a time according to the sequence shown in Figure 14.

Foil tapes must be applied in all 8 positions regardless if there is a crack or not.

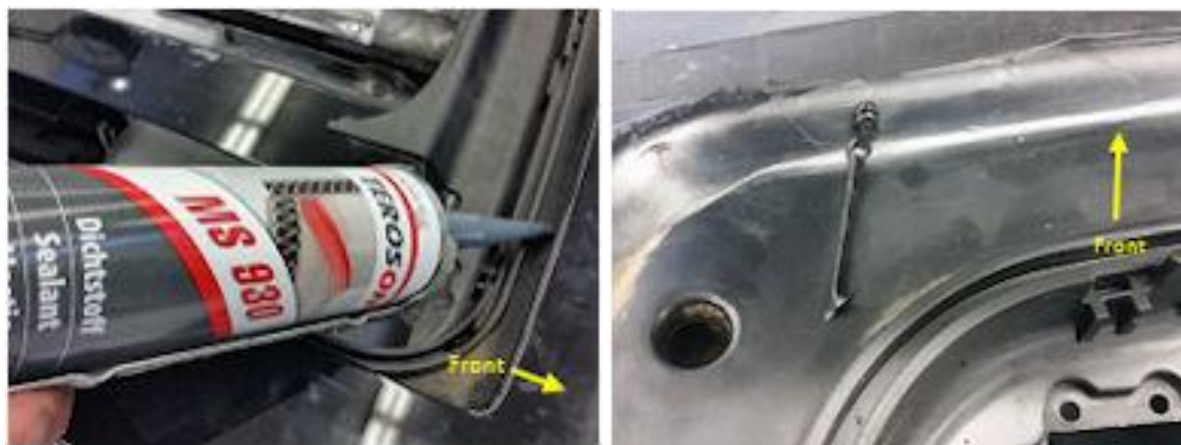
Figures 10 and 11 (Sealant application)

7. For all cracks, put a 1 mm bead of sealant (Teroson MS-930, part number D 172090A2) over any existing cracks, 1 at a time. Start the sealant bead as far under the sunroof trim as possible and pull the bead to the end of the crack.

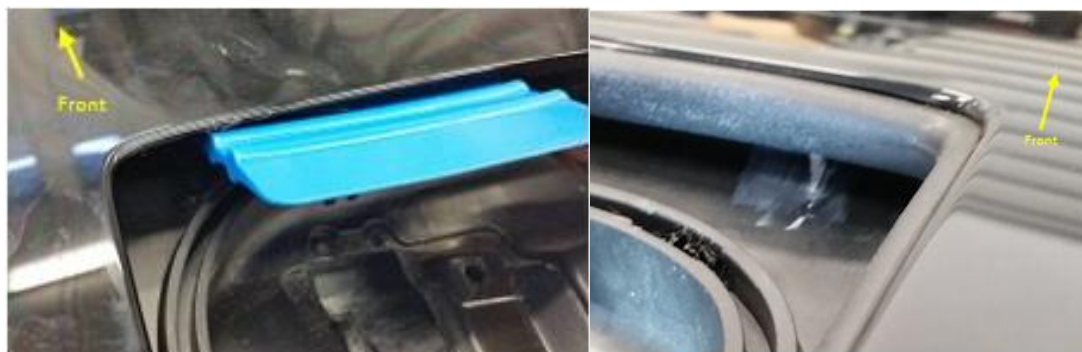
Figures 12 and 13 (Spread sealant working from sunroof opening to underneath the trim panel. Sealant should fill crack and there should be no excess sealant on the water channel.)

9. Remove all excess sealant from the water channel. There must not be any excess sealant that may prevent the foils from being applied completely flat to the water channel. The crack should be filled with sealant with no excess sealant around the crack (See figures 12 and 13).

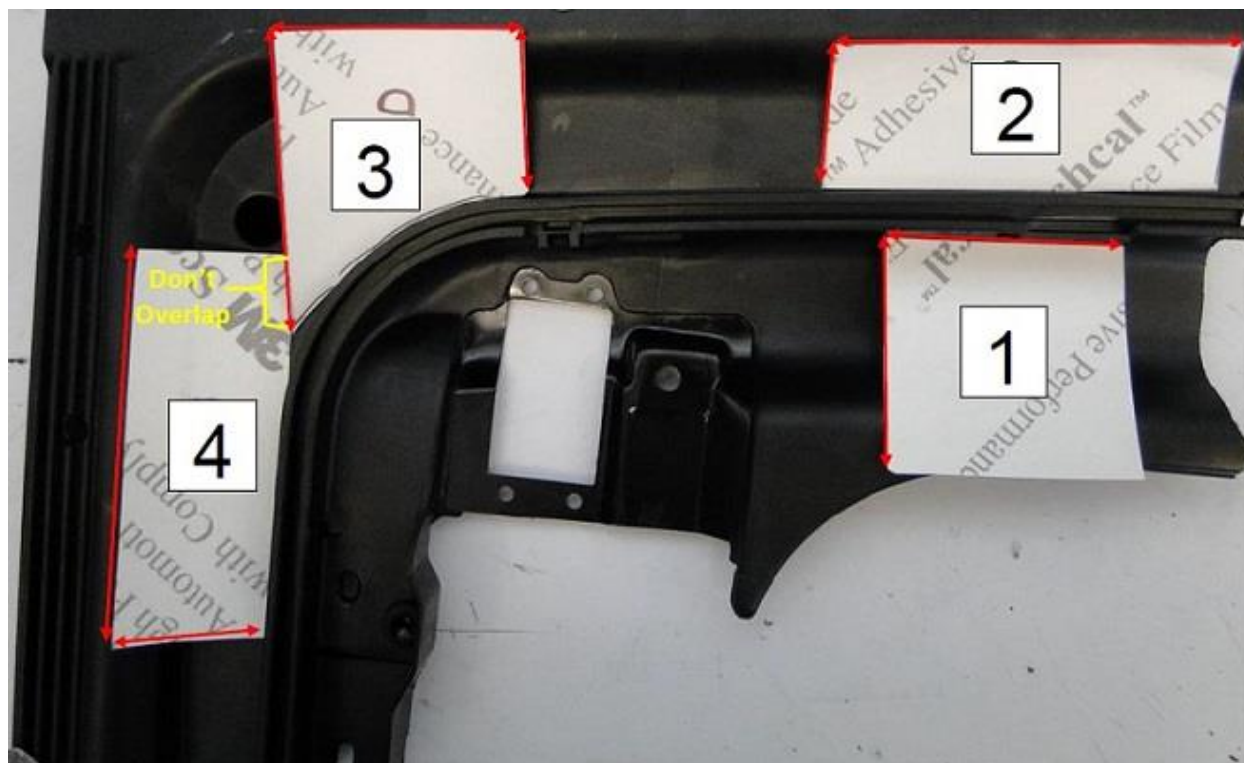
Figure 14 Foil application sequence (Both sides of water channel).

For foil positions 2 and 4, it is more important to apply the foil as far underneath the trim panel as possible then attempting to align the foil with the seal channel. Foil positions 3 and 4 should not overlap each other. DO NOT cover the water drain hole or the witness line around the water drain with the foil in positions 3 or 4 (See Figure 15).

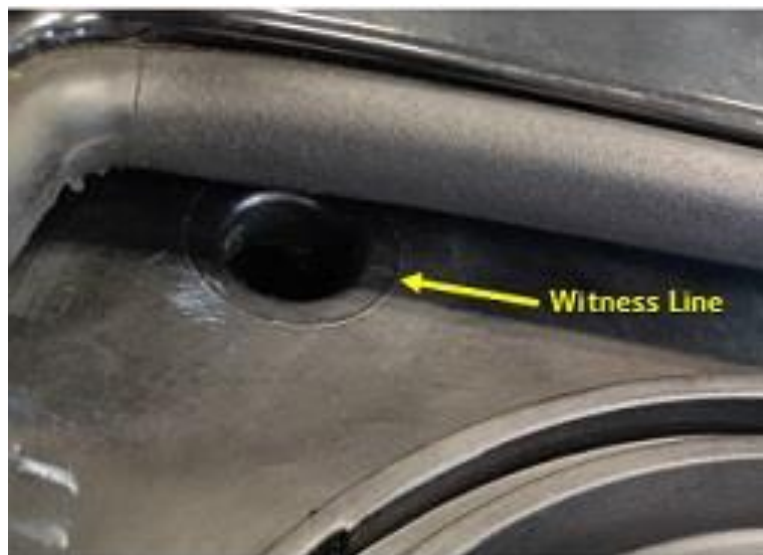
Figure 15 Drain hole and witness line.

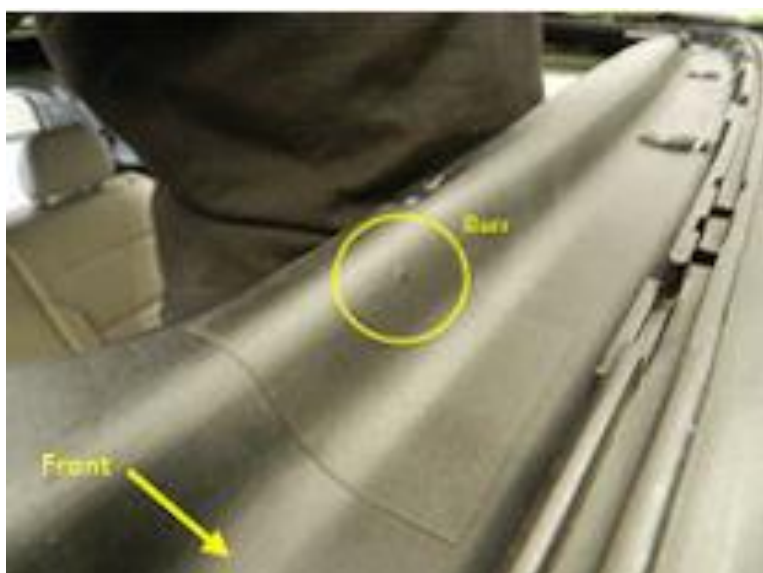
There may be a burr on the water channel in this location that appears to be an air bubble. This is normal and an acceptable condition after applying the foil (Figure 17).

Figure 17 Burr under foil position 1.

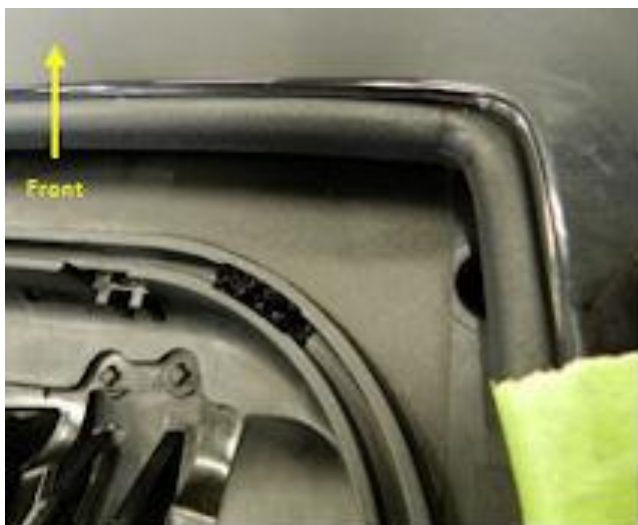
Figure 20 Foil position 3 incorrectly applied covering witness line around drain.

15. In position 3, peel half of the backing tape off starting at the pointed edge in the radius and fold it over to use to hold the foil during application. Carefully align the radius of the foil to the radius of the seal channel and ensure the drain hole and witness mark around the drain will not be covered. Apply the foil working it forward using the included squeegee to ensure there are no air bubbles or wrinkles and that there are no gaps under the foil. Peel backing tape off as you work. Use the squeegee to work the tape down smooth and as far underneath the trim panel as possible (Figure 19).

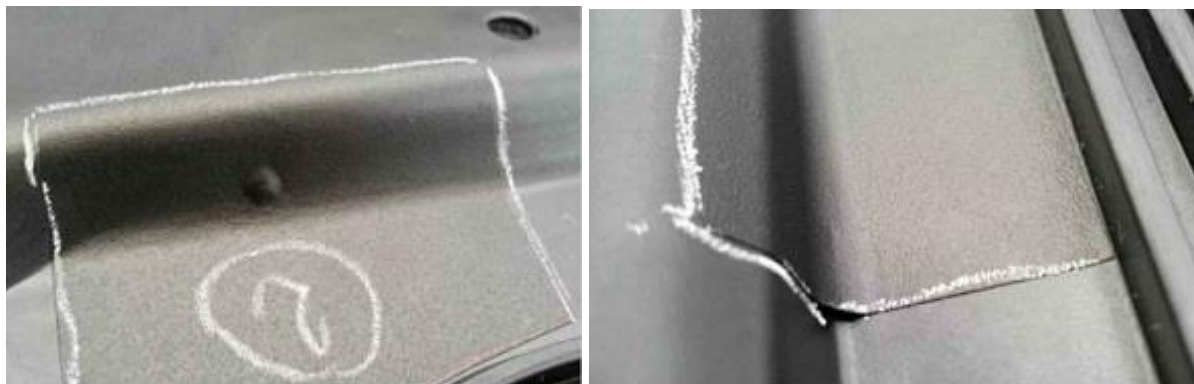
Figures 23 and 24 Air bubble under foil, air gap underneath foil.

18. Once all 8 foils have been applied to the water channel, inspect the foils to ensure they are completely flat to the water channel and that there are no air bubbles or gaps underneath the foil. Use the squeegee to help push out any defects (Figures 23 and 24).

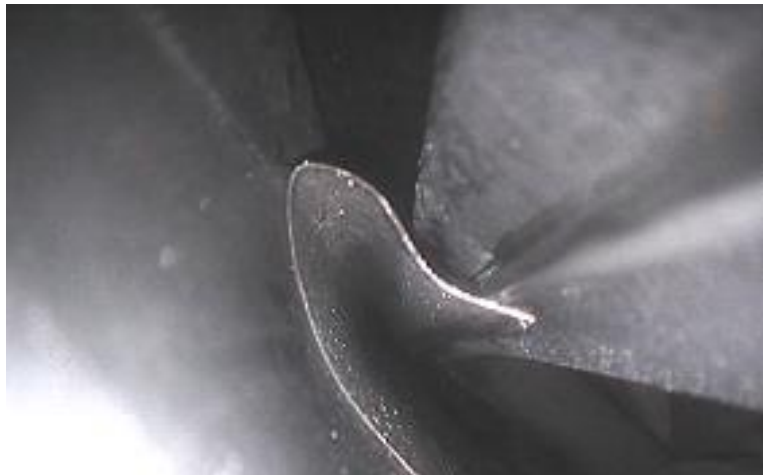
Figure 27 Foil folded and not adhered underneath trim panel

The foil must be fully applied underneath the trim panel. If the foil is folded over, it should be removed and a new piece applied (see figure 27). Use the squeegee to work the foil down on to the water channel as far underneath the trim panel as possible.
