## TECHNICAL SERVICE BULLETIN

TSB#: 16-042

2017 North Point FW

**Technical Service Bulletin Notification TSB #16-042**

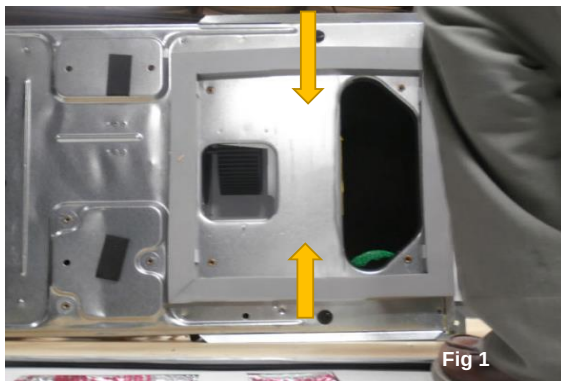
Fig 1

Jayco has determined that certain Model Year 2017 North Point fifth wheels require installation of a foam piece to the bottom of the roof air conditioner to ensure its proper function. The foam piece is required to prevent the hot and cold air from mixing.

- 2 **Fig 1:** Clean area between ducts of air conditioner with alcohol, dry.  
**Fig 2:** Remove air conditioner gasket, Clean surface with alcohol, dry.  
Install new air conditioner gasket.
