# TECHNICAL SERVICE BULLETIN

TSB#: **16-032**

## Action Required:

Inspect engine door actuator harness plugs for correct pin styles.  
Install new adapter harness when inspection finds incorrect pins.

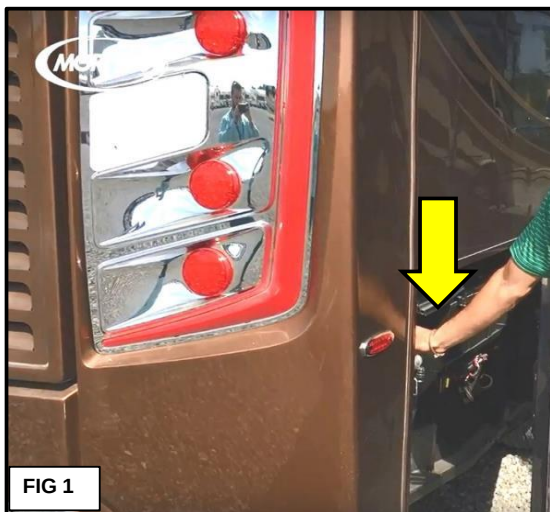
- 1 **Fig 1:** Open the rear engine cover.
- 2 **Fig 2:** Location of the left side actuator harness.

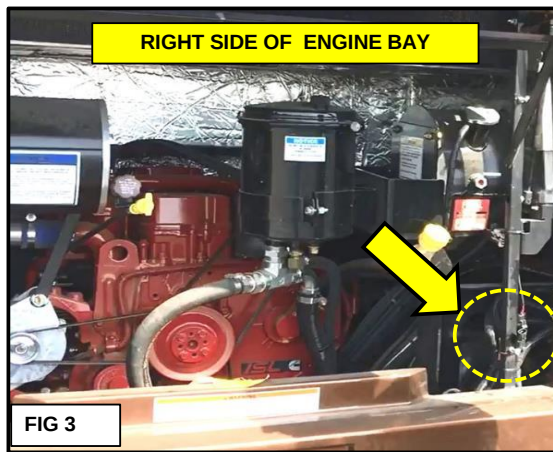
**Fig 3:** Location of the right side actuator harness.

- 3 Inspect the pins inside the connectors on both actuator harnesses (**Fig 2 & 3**)

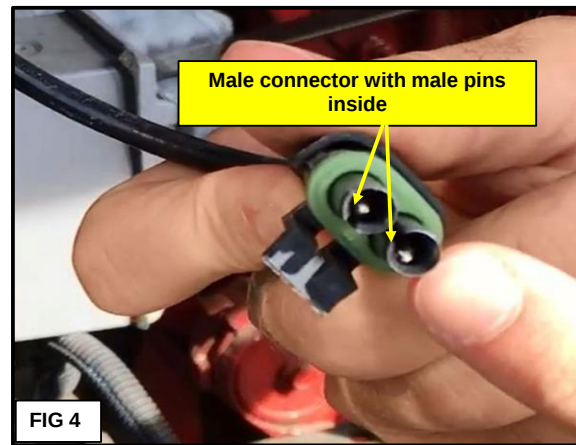
**Fig 4:** Inspect the male connector to confirm it has male pins inside the connector.

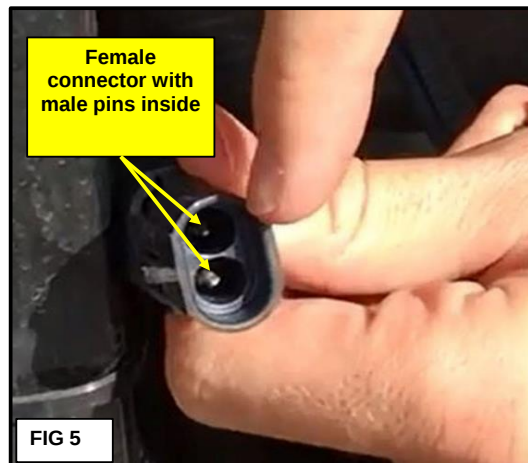
- 4 **Fig 5:** Inspect the female connector to confirm if incorrect male pins are present.

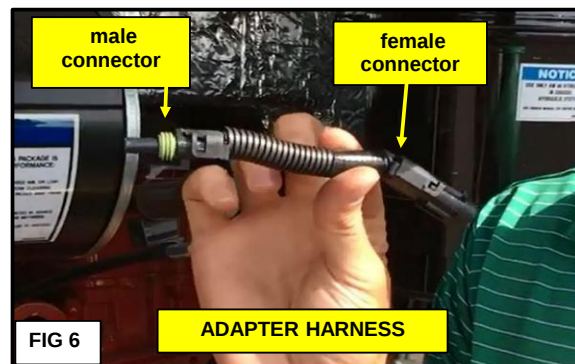
**Fig 6:** If male pins are located on female connector, the adapter harness is required.

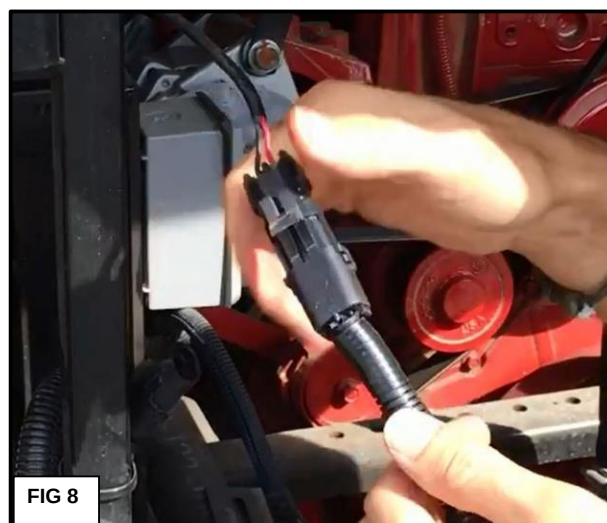
**Fig 8:** Shows connection of actuator harness and adapter.

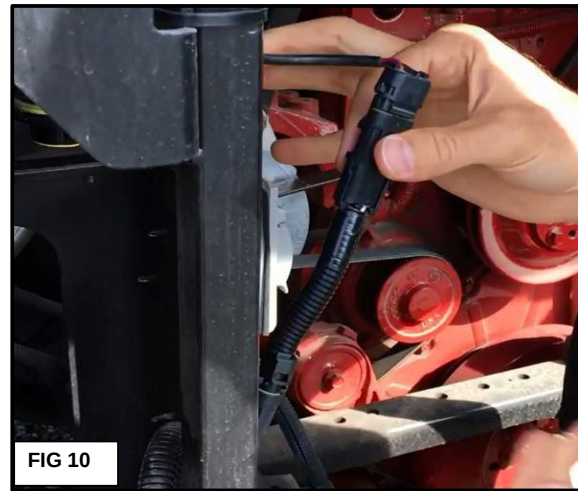
- 2 **Fig 9:** Plug the actuator harness female plug into the **adapter** harness **male** plug.  
**Fig 10:** Shows connection of actuator harness and adapter.

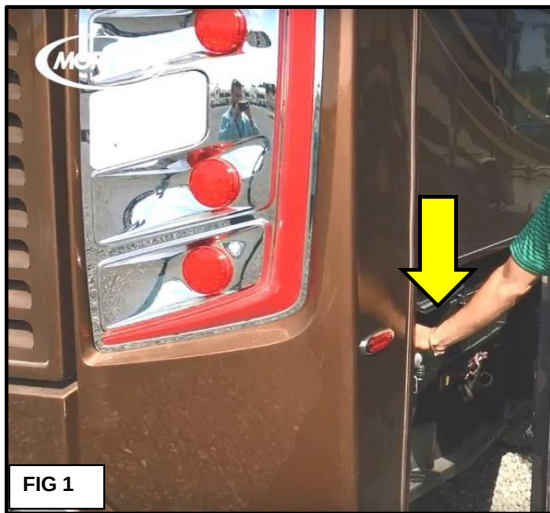
- 1 Fig 1: Open the rear engine cover.
- 2 Inspect actuator harness on each side of the engine compartment.

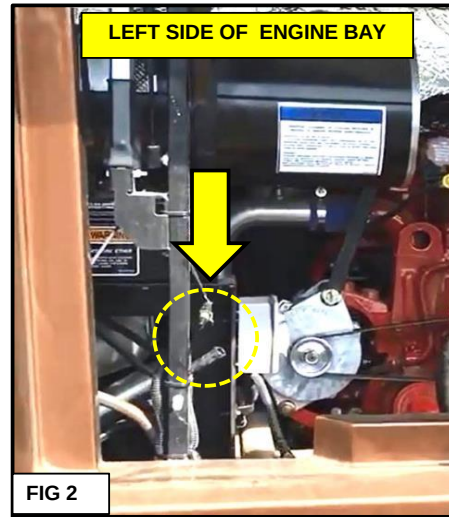
Fig 2: Location of the left side actuator harness.

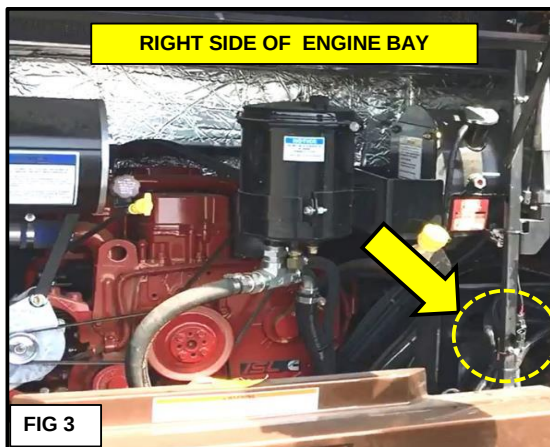
Fig 3: Location of the right side actuator harness.

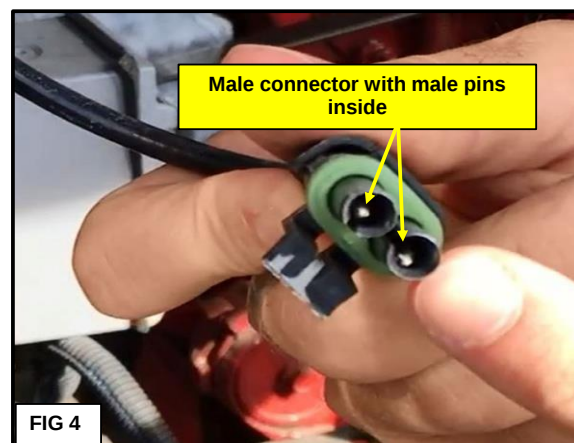
- 3 Inspect the pins inside the connectors on both actuator harnesses (Fig 2 & 3)
- Fig 4: Inspect the male connector to confirm it has male pins inside the connector.

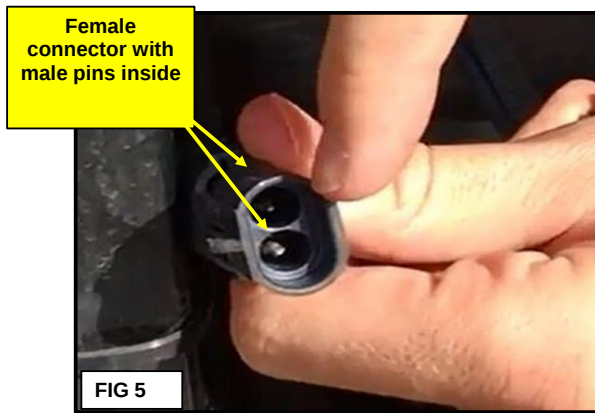
- 4 Fig 5: Inspect the female connector to confirm if incorrect male pins are present.  
 Fig 6: If both connectors of the actuator harness have male pins, the adapter harness is required.

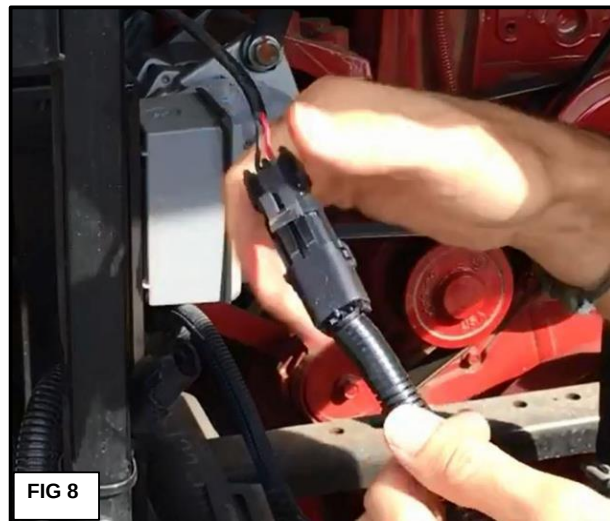
- 1 Fig 7: Plug the actuator harness male plug into the **adapter** harness female plug.  
 Fig 8: Shows connection of actuator harness and adapter.

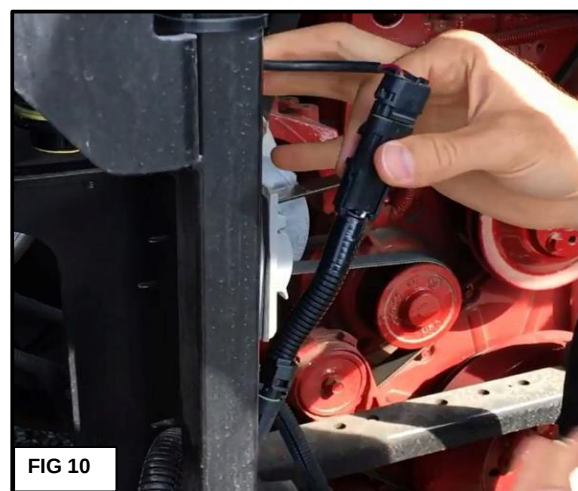
- 2 Fig 9: Plug the actuator harness female plug into the adapter harness male plug.  
 Fig 10: Shows connection of actuator harness and adapter.
