Model(s)	Year	Eng. Code	Trans. Code	VIN Range From	VIN Range To
Golf, Golf GTI	2015-2017	All	All	AU_FM082335	AU_HM012965

60 16 06 September 28, 2016 2045403

Water leak from the Panoramic Roof

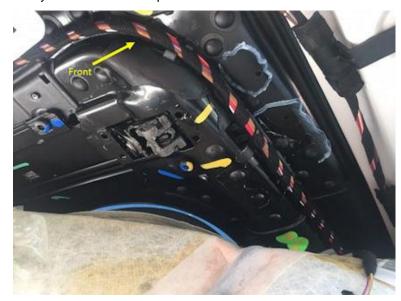
Verify the customer complaint. Water leaks occur near the A-Pillars in the corners of the sunroof water channel.

Figure 1 (Water leaking through corner of water channel)

Remove the wind deflector, inner sunroof seal and thoroughly clean the water channel with isopropyl alcohol, a microfiber cloth and compressed air prior to inspecting for cracks.

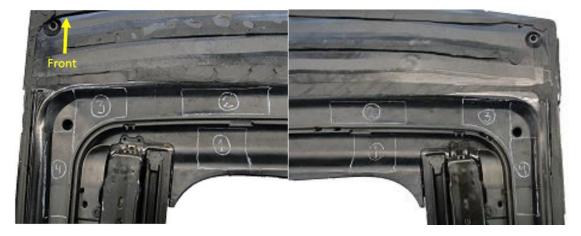
Inspect the sunroof water channel for stress cracks (see figure 2). There are a total of 8 areas to inspect for cracks which are outlined in Figure 3 below. (More than 1 crack may be found).

Figure 3 (Inspections zones for stress cracks / application zones and sequence for foil application)

A difference in the expansion rate between the plastic water channel and steel reinforcement plates may cause stress cracks to occur at the edges of the reinforcement plates.

12. Apply the foil tapes one at a time according to the sequence shown in Figure 14.

Foil tapes must be applied in all 8 positions regardless if there is a crack or not.

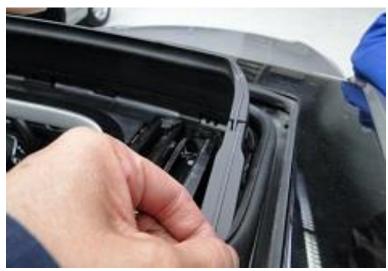
Figure 5 (Inner Sunroof Seal)

2. Remove the inner sunroof seal from around the front of the sunroof opening and lay it back over the sunroof glass (See figures 5 and 6).

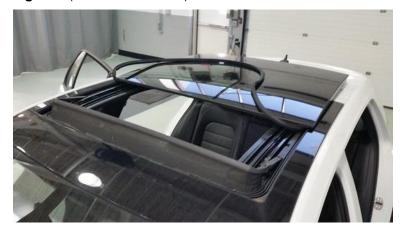
Figure 6 (Inner sunroof seal draped over sunroof glass)

Masking tape can be used to hold the seal in place on top of the sunroof glass for the duration of the repair.

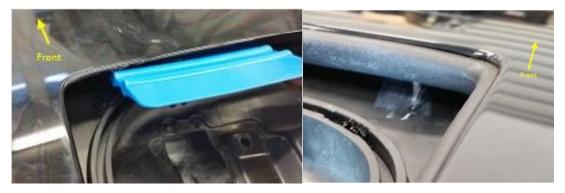
Figures 12 and 13 (Spread sealant working from sunroof opening to underneath the trim panel. Sealant should fill crack and there should be no excess sealant on the water channel.)

8. Using the squeegee supplied with the repair kit, spread the sealant pushing it underneath the trim panel from the inside edge of the roof opening to completely cover the crack.

9. Remove all excess sealant from the water channel. There must not be any excess sealant that may prevent the foils from being applied completely flat to the water channel. The crack should be filled with sealant with no excess sealant around the crack (See figures 12 and 13).

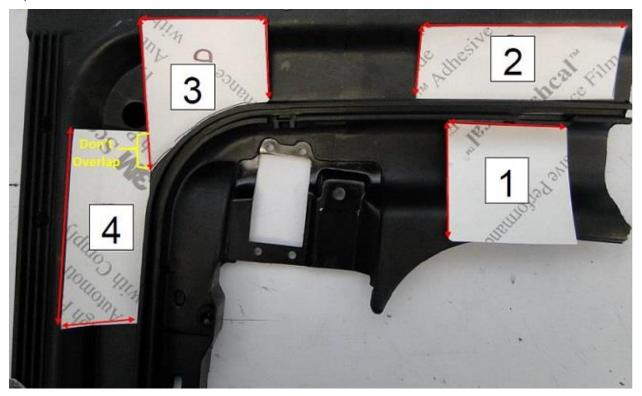
Figure 14 Foil application sequence (Both sides of water channel).

For foil positions 2 and 4, it is more important to apply the foil as far underneath the trim panel as possible then attempting to align the foil with the seal channel. Foil positions 3 and 4 <u>should not overlap each other</u>. DO NOT cover the water drain hole or the witness line around the water drain with the foil in positions 3 or 4 (See Figure 15).

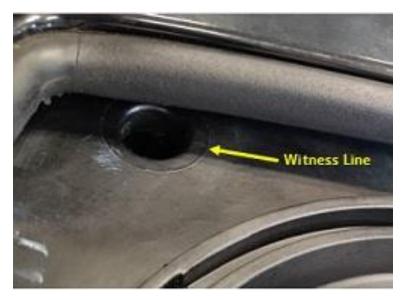
Figure 15 Drain hole and witness line.

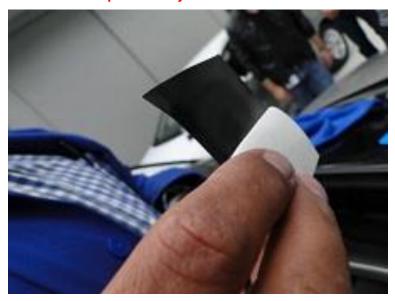
Figure 16 Peel half of backing tape off foil and fold in half to use to hold the foil as it is applied.

13. Starting in position 1, peel half of the backing tape off the foil and fold it over to use to hold the foil during application. Align the foil with the inner edge of the water channel and apply the foil, working it forward using the included squeegee to ensure there are no air bubbles, wrinkles and that there are no gaps under the foil. Peel backing tape off as you work forward. Use the squeegee to work the tape down as smooth as possible.

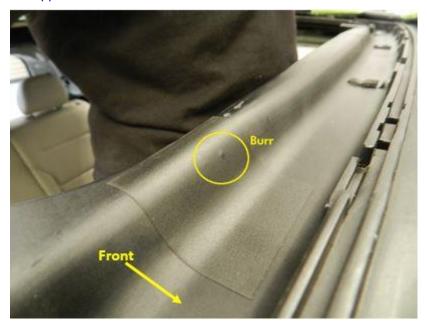
There may be a burr on the water channel in this location that appears to be an air bubble. This is normal and an acceptable condition after applying the foil (Figure 17).

The foil positions are designed to cover witness lines in the water channel. It is normal to see a line in the foil after it is applied.

Figure 17 Burr under foil position 1.

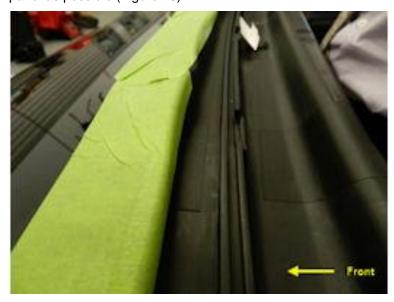
Figure 18 Foil positions 1 and 2 fully applied.

14. In position 2, peel half of the backing tape off the section of foil to be placed underneath the trim panel and fold it over to use to hold the foil during application. Ensure the tape is as far underneath the trim panel as possible before beginning to adhere it to the water channel. Apply the foil working it toward the rear using the included squeegee to ensure there are no air bubbles or wrinkles and that there are no gaps under the foil. Peel backing tape off as you work. Use the squeegee to work the tape down smooth and as far underneath the trim panel as possible (Figure 18).

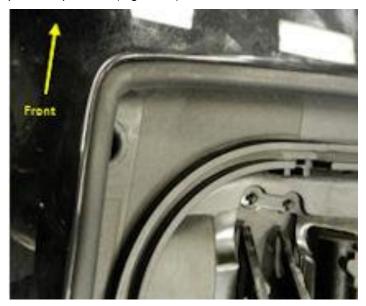
Figure 19 Foil position 3 fully applied.

15. In position 3, peel half of the backing tape off starting at the pointed edge in the radius and fold it over to use to hold the foil during application. Carefully align the radius of the foil to the radius of the seal channel and ensure the drain hole and witness mark around the drain will not be covered. Apply the foil working it forward using the included squeegee to ensure there are no air bubbles or wrinkles and that there are no gaps under the foil. Peel backing tape off as you work. Use the squeegee to work the tape down smooth and as far underneath the trim panel as possible (Figure 19).

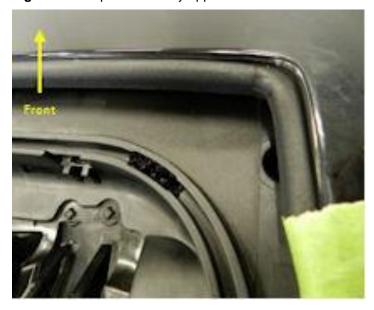
Figure 20 Foil position 3 incorrectly applied covering witness line around drain.

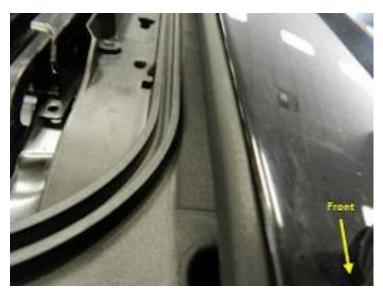
Foil position 4 is the most difficult position to install. The foil must not overlap the foil in position 3, it must not cover the witness line around the drain, and it is difficult to place under the trim due to the limited work space. This position is very easily folded over due to this.

Figure 22 Foil position 4 fully applied.

16. In position 4, peel half of the backing tape off the section of foil to be placed underneath the trim panel and fold it over to use to hold the foil during application. Use a pivoting motion to swing the foil underneath the trim. Ensure the tape is as far underneath the trim panel as possible before beginning to adhere it to the water channel. Apply the foil working it from underneath the trim toward the sunroof opening. Use the included squeegee to ensure there are no air bubbles or wrinkles and that there are no gaps under the foil. Peel backing tape off as you work. Use the squeegee to work the tape down smooth and as far underneath the trim panel as possible (Figures 21 and 22).

It is more important that the foil in position 4 be applied as far underneath the trim panel as possible versus attempting to align it to the edge of the seal channel.

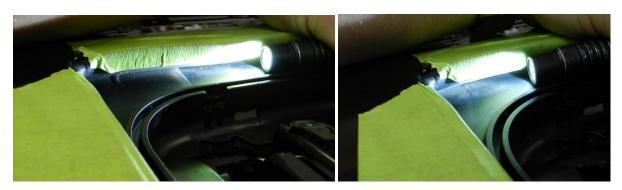
Figure 25 and 26 use a flashlight to help identify any air bubbles in the foils and use the squeegee to work out any defects.

Use a flashlight at different angles to help identify any air bubbles. If any foil needs to be removed and reinstalled, discard the foil and use a new piece (Figures 25 and 26).

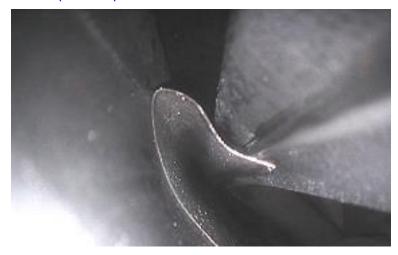
Figure 27 Foil folded and not adhered underneath trim panel

The foil must be fully applied underneath the trim panel. If the foil is folded over, it should be removed and a new piece applied (see figure 27). Use the squeegee to work the foil down on to the water channel as far underneath the trim panel as possible.
