Technical Bulletin

Model(s)	Year	Eng. Code	Trans. Code	VIN Range From	VIN Range To
Tiguan	2008-2017	All	All	All	All

55 16 14 September 28, 2016 2045277

Rear Lid - Possible Water Ingress, Rear Lid Cannot be Opened

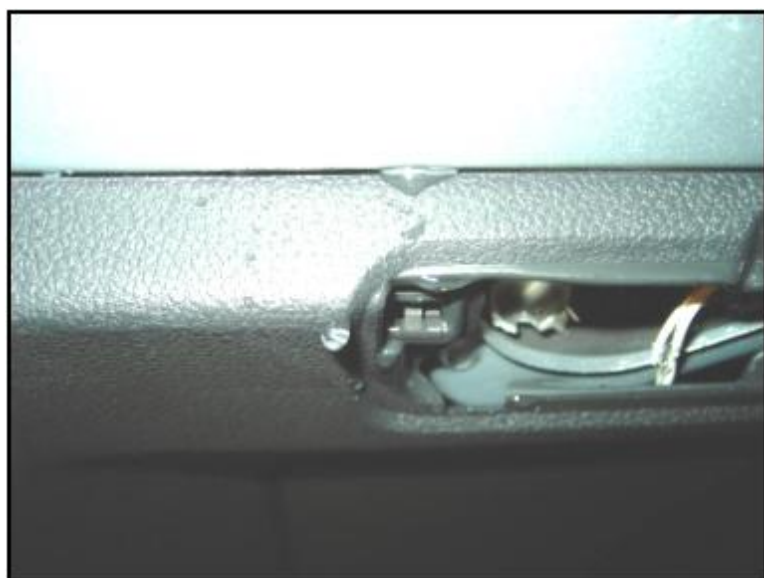
Figure 1

1. Rear lid does not open using the locking system.
2. Corrosion around license plate light.
3. License plate light inoperative.
4. When rear lid is opened, water dripping into the trunk from the rear lid (Figure 1).

Water may enter into the rear lid cavity via openings in the fine-seam seal around the inner taillight and causes the rear lid release button to malfunction.

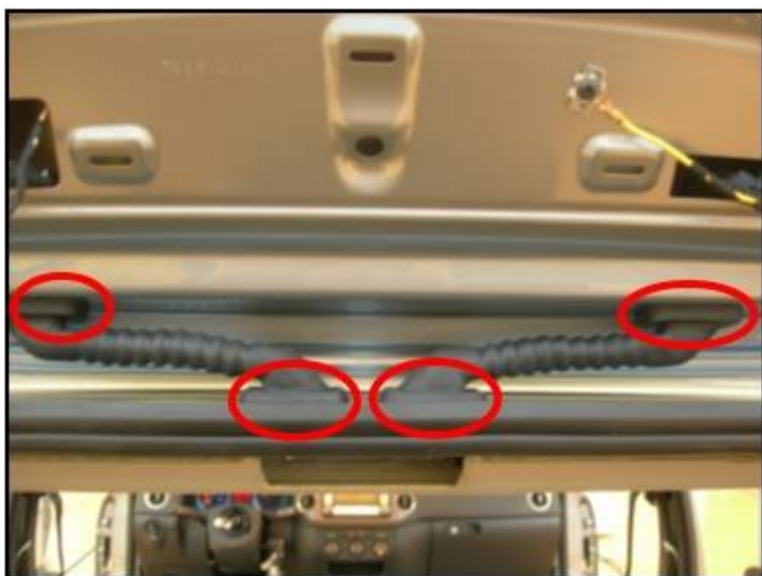
Figure 2

Water may enter into the rear lid via leaking wiring harness grommets or high mounted brake light (3rd brake light) seal.

- Inspect the rear lid wiring harness grommet(s) installation to the rear lid and the body to ensure that they are locked in position correctly (Figure 2, red ellipses).
- If loose, re-secure grommet(s) properly.
