# Special Bulletin

# SP16-316D

FUEL TANK FRAME FRONT SUPPORT WELD

Prevost vehicles

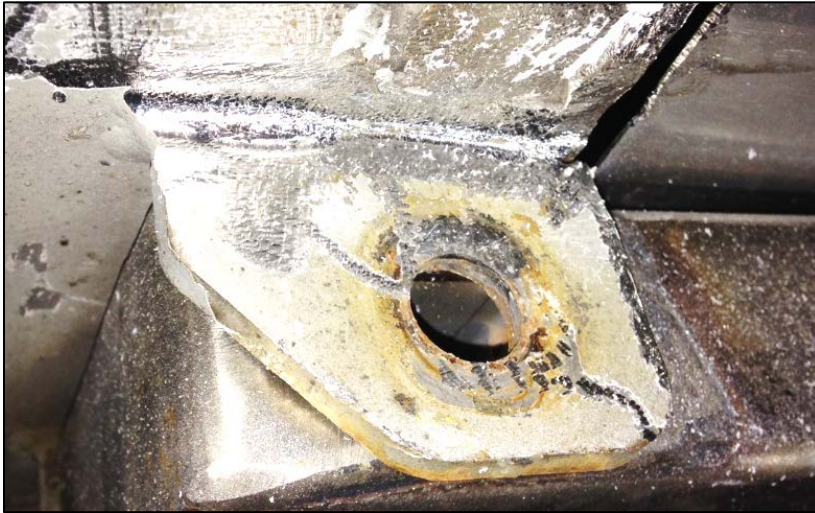
Figure 3 Weld removed.

5. Remove tank frame mounting hardware. Reserve for re-use.
6. Remove existing weld on the mounting ears by grinding. (Fig. 3). If a crack is visible, it needs to be cleaned and prepared to a depth that reaches the root of the crack.

7. Repair according to "Crack Repair" in *Appendix D*. All Weld must meet IT750004 requirement in *Appendix C*.

Weld cracks on the mounting ears must be grinded to the root and welded.

Grind to the root of the crack. Bevel angle between 45° and 90°.

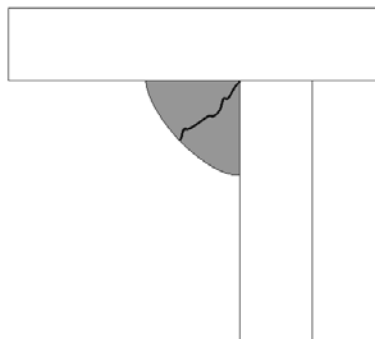
If the crack is visible;

Fillet Weld according to "welding parameters" above.
