## DISABLE WINDSHIELD UPPER DEFROST GRID

Prevost vehicles

On the vehicles affected by this bulletin, disable the windshield upper defrost grid by removing the electrical connections.

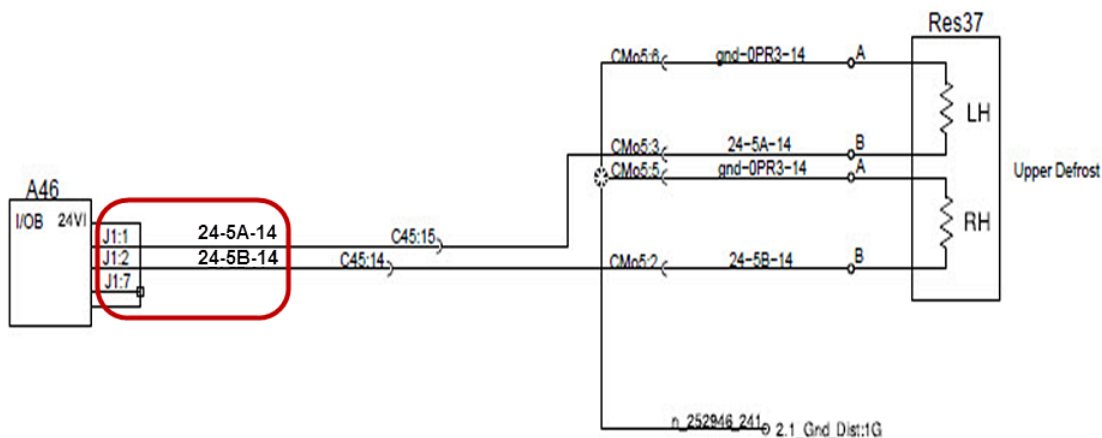
Figure 1

The following procedure will disable both the curb side/street side windshield upper defroster grid electronic circuits.

Disconnect wires **24-5A-14** and **24-5B-14** from Module **A46** to render the circuits completely inoperative.
