## Technical Bulletin 170

### 11.2016

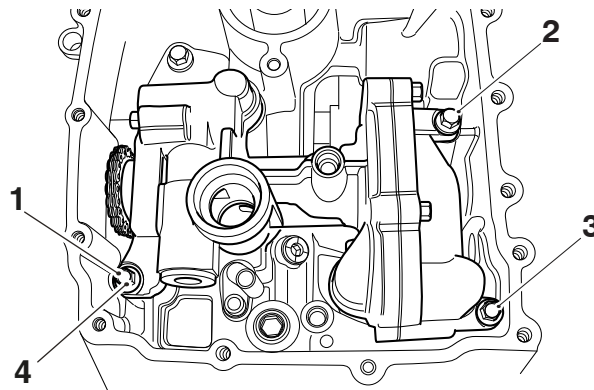
#### **Tightening sequence**

The oil and water pump tightening sequence has changed.

In addition to the instruction in the service manual, tighten the fixings in the sequence shown below to **10 Nm**.

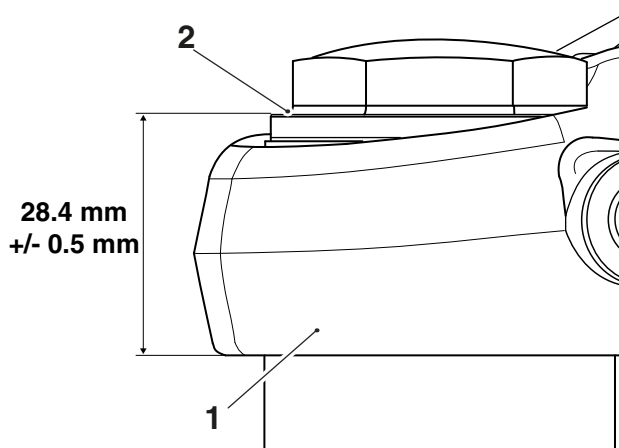
The front fork installation procedure does not reflect the information displayed in the suspension specification settings.

- 1. Upper yoke
- 2. Fork top cap

Therefore when measuring the fork pull through, step 3 should read:

Position the forks through the lower yoke, so that the flat portion of the top cap is 28.4 mm +/- 0.5 mm from the lower edge of the upper yoke.

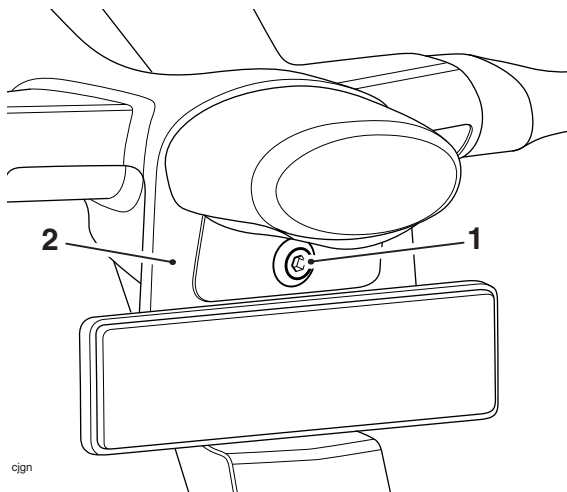
The lock nut fastening the licence plate light holder has been replaced with a captive nut on motorcycles from VIN 771857, therefore there is no longer a requirement to disassemble the licence plate assembly when replacing the licence plate bulb.

**1. Fixing**

**2. Licence plate bracket**

The torque figure remains unchanged at **2 Nm**.

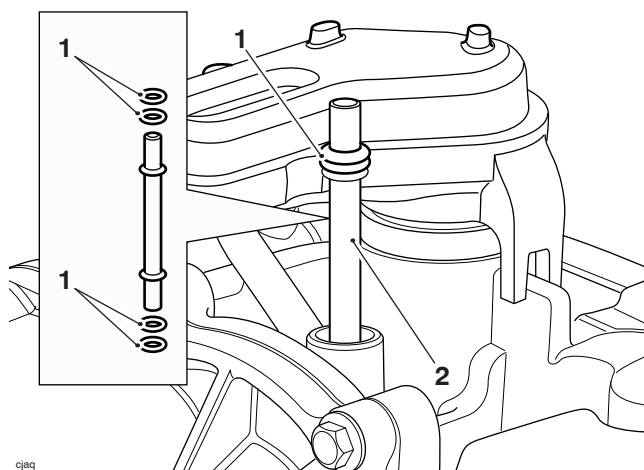
A soft petroleum jelly, is now used to lubricate the O-rings during installation of the coolant drain tube during manufacture. Triumph therefore recommend that if the sump or coolant drain tube are removed for any reason the O-rings must be replaced and coated with a commercially available soft petroleum jelly to aid installation.

- 1. O-ring**
- 2. Coolant drain tube**

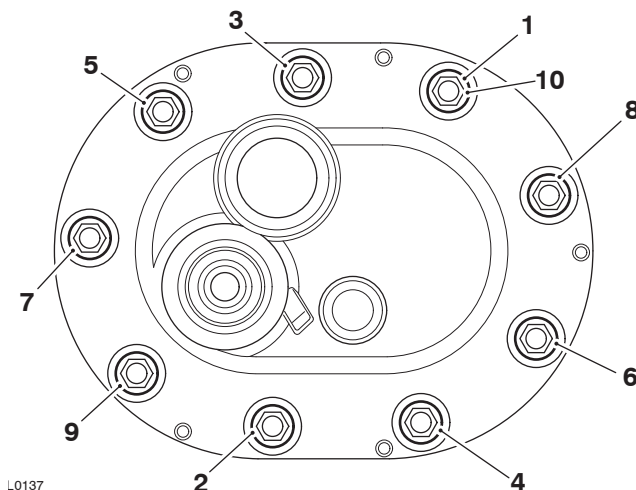
#### Fuel Pump Plate Tightening Sequence

A tightening sequence for the fuel pump plate has been introduced.

Installation is as described in the Service Manual with the addition of the tightening sequence.

Tighten the fixings to **5 Nm** in the sequence shown.

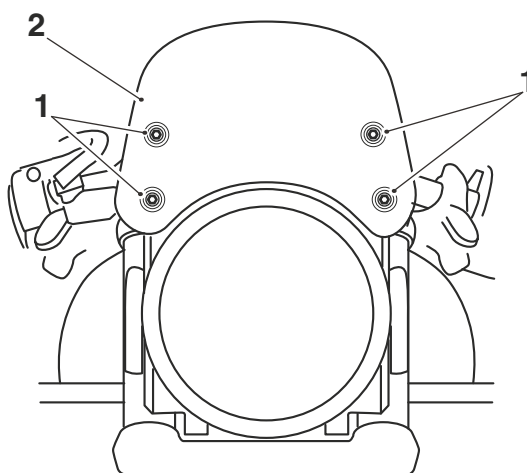
On models from VIN 798537 nylon washers are no longer used to secure the flyscreen to it's brackets as a cosmetic feature during manufacture.

- 1. Fixings
- 2. Flyscreen

The torque figure remains unchanged at 1 Nm.

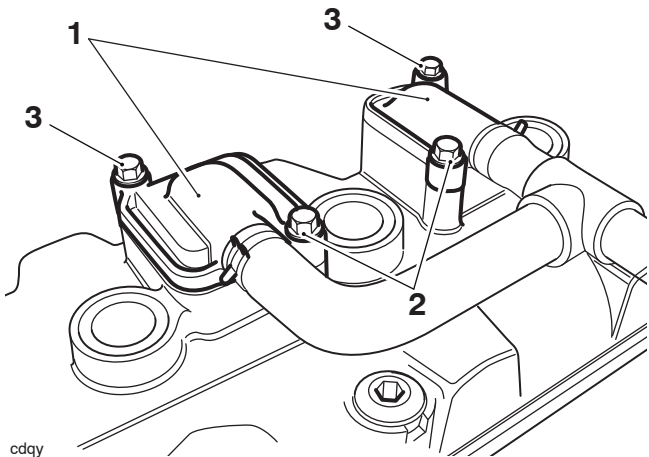
The two front fixings for the secondary air injection valve covers have increased to 25 mm from engine number 791976 (all markets except Brazil) or 792241 (Brazil only) and are not retrofittable. The rear fixings remain unchanged at 20 mm.

- 1. Reed valve cover
- 2. 20 mm fixings (rear)
- 3. 25 mm fixings (front)

Therefore if the camshaft cover is replaced on models up to engine number 791975 (ROW) or 792240 (Brazil only), discard the two front 20 mm fixings and replace with new 25 mm fixings.

The torque figure remains unchanged at **9 Nm**.

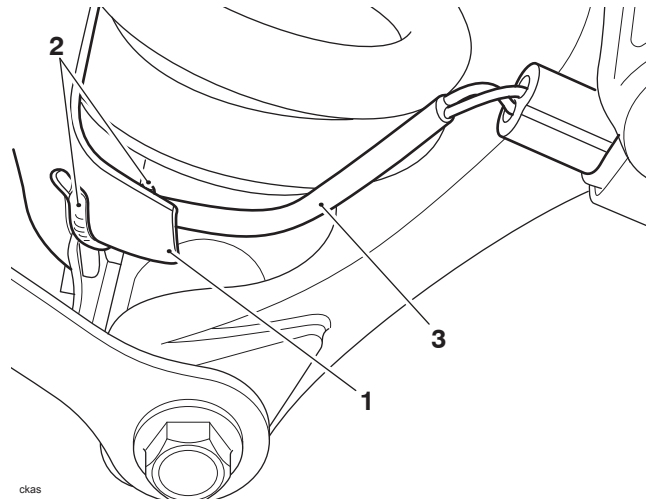
The Rear Suspension Unit (RSU) flylead is secured to the splashguard with a cable tie, part number T3700015 from VIN number 777835 (ROW) or 778620 (Brazil only).

- 1. Splashguard
- 2. Cable tie (T3700015)
- 3. Flylead

Therefore when refitting the flylead or RSU, secure the flylead with a cable tie as shown in the illustration.

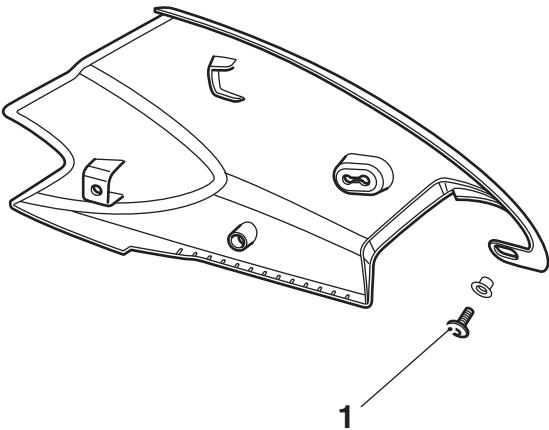
The torque figure has changed. If loosened or removed for any reason the fixing(s) must be torqued as required.

**1. Fixing**

| Application | Torque (Nm) | Notes |
|---|---|---|
| Side bodywork fixings | 5 Nm | |

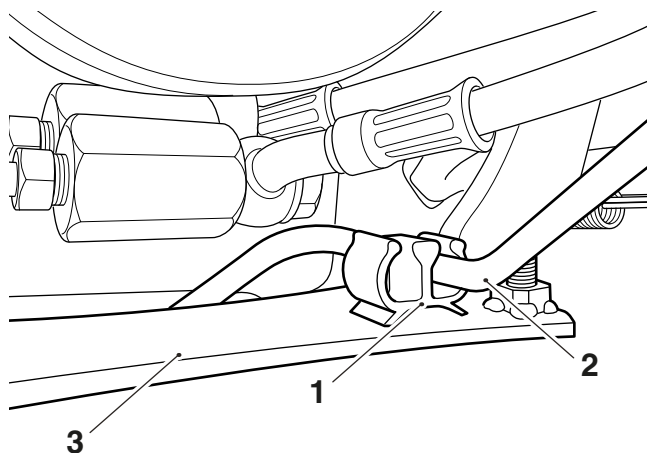
1. Clip
2. Brake line
3. Header pipe strap

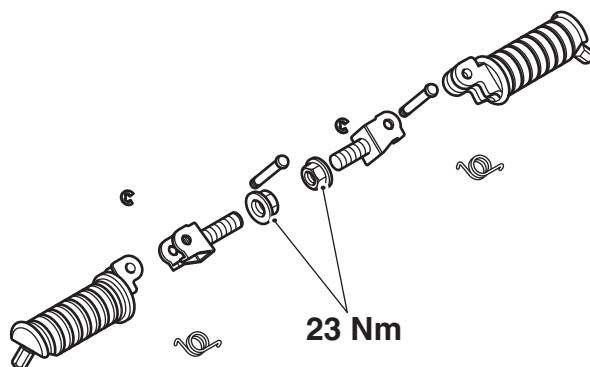
The torque figure has changed. If loosened or removed for any reason the fixing(s) must be torqued as required.

Tighten the fixings to **23 Nm**.
