## CCU Software Enhancements

### Enhanced HVAC Control Board software is NOW AVAILABLE

Only applicable to Controls, HVAC with H/W REV 03C, boards with screw down 12V fork terminals

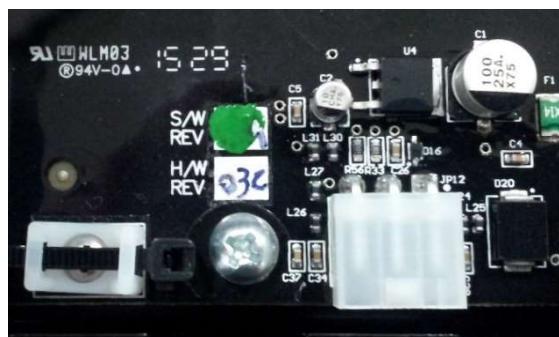
Units manufactured with updated software are identified by the S/W revision 04 or higher on the board.  
Service HVAC Control Boards with the updated software are identified by a green dot on the software revision label Figure 1 or indicated by software revision 04 on the board, Figure 2.
