# TECHNICAL SERVICE BULLETIN

TSB#: **16-001** Job Code: **9801276** Flat Rate: .5 hr  
Date of Publication: **January 2016**

Inspect bolts on the 78" bed slide at the front off door side for proper tension setting.  
Adjust the bolts for proper tension when required

| 2016 Jay Flight Bungalow | 40DBTS | G1 | 1G0066 |

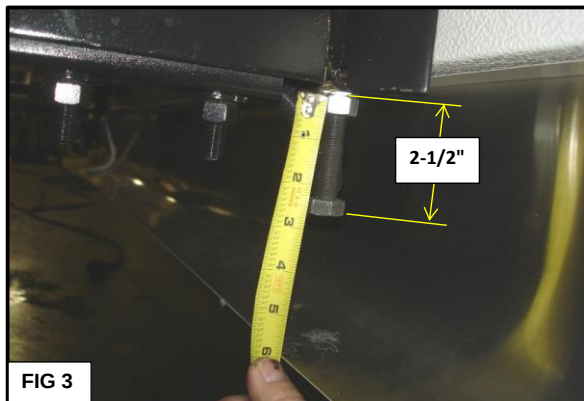
FIG 3

- Fig 3:** Measure the length of the bolt from the slideout nut as shown here. **If the length of the bolt measured from the top of the nut down to the head of the bolt is NOT at 2" then the slideout requires adjusting.**  
Measure the bolt on the other end of the slideout as well.  
**Fig 4:** To begin the adjustment procedure, use the ratchet and 3/4" socket to loosen the two nuts shown.
