Service Update

35740 Thermal Sleeve Missing From Lamp Wire Harness Connector

Reference Number: N16204566
GWM Number:

Models: 2016 Chevrolet Camaro Equipped with 2.0L Turbo Engine (LTG)

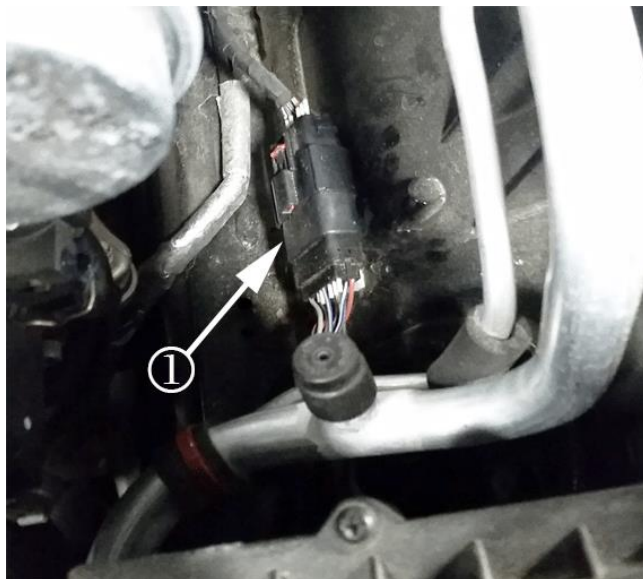
4578904

2. Locate the main body wiring harness to forward lamp wiring harness connector (1).
3. Using an appropriate retainer removal tool, disengage the connector retainer from the body.
