Customer Satisfaction Program

26180 Incorrect Value Indicated for Trunk Release Fuse

Reference Number: N15202618

Release Date: December 2016
Revision: 01

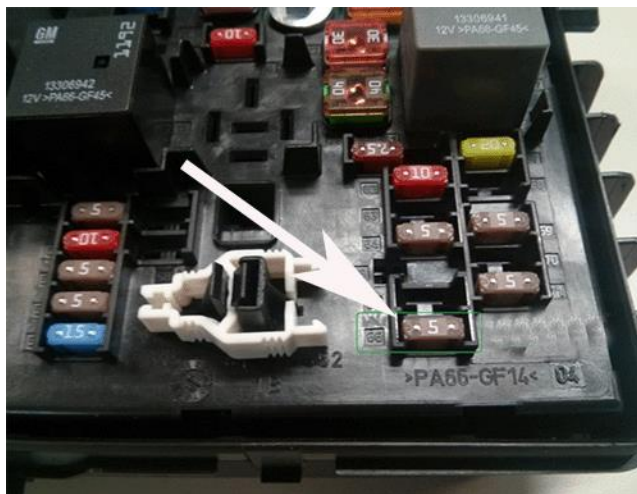
4623947

1. Remove the front compartment fuse block cover.

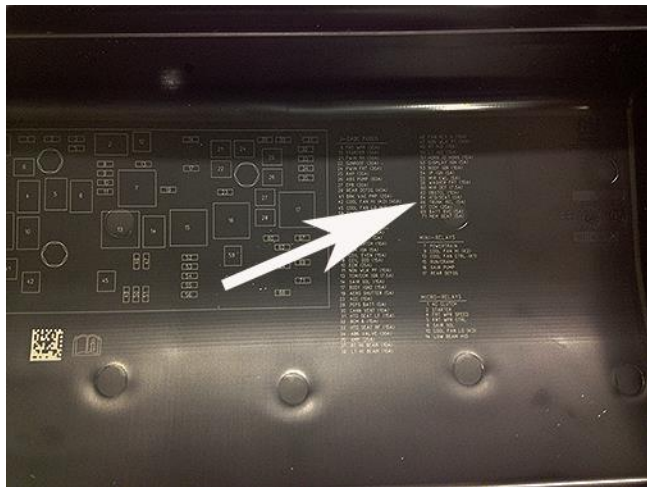
4623926

2. Verify that the fuse value for the fuse in location F66 (Trunk Release) is 5 Amp. If the fuse value is not correct, replace the fuse with the proper fuse.

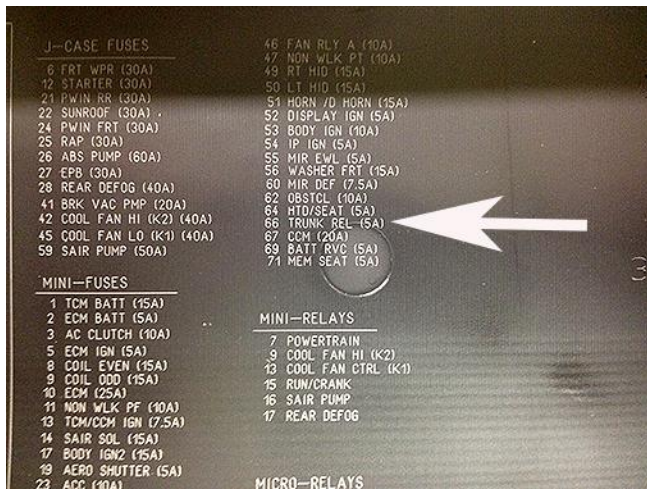
4623927

- Inspect the front compartment fuse block cover. Verify that the fuse value for location F66 (Trunk Release) is 5 Amp.

- If the value is correct (5 Amp), no further action is required.
- If the value is not correct (10 Amp), replace the fuse block cover as follows:
