Service Update

53170 B+ Battery Cable Chafing

Reference Number: N162053170 Release Date: December 2016

Models: 2017 GMC Acadia

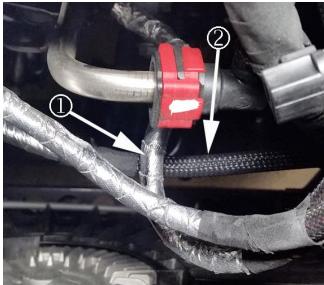
4640609

- 2. Inspect the battery positive cable (1) for damage due to contacting or chafing on the battery negative cable (2).
 - If there are NOT signs of damage to the battery positive cable, proceed to the next step.
 - If there are signs of damage to the battery positive cable, replace the battery positive cable and proceed to the next step. Refer to *Battery Positive Cable Replacement (LGX)* in SI.
