Service Update

16167 Missing Cotter Pin on Front Lower Control Arm to Knuckle Ball Joint

Reference Number: N162066530

Make	Model	Model Year		RPO	Description
		From	To		
Chevrolet	Equinox	2017	2017

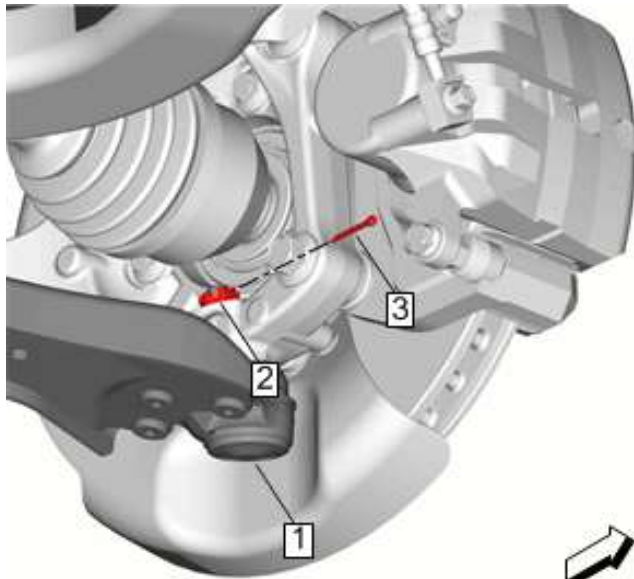
3999404

2. Verify the lower ball stud nut cotter pin (3) is present on both front lower control arm ball studs (1).
 - If the lower ball stud nut cotter pin is present on both sides, proceed to step 8.
 - If either lower ball stud nut cotter pin is NOT present, proceed to step 3.
3. Loosen the front lower control arm ball stud nut (2) until it is level with the top of the front lower control arm ball stud.
