GLOBAL SAFETY FIELD INVESTIGATIONS  
DCS4043  
URGENT - DISTRIBUTE IMMEDIATELY

Subject: 14520B – Special Coverage  
Fractured Leaf Springs  
Revised Part Information

**SUBJECT:** Special Coverage Adjustment – Fractured Leaf Springs

**MODELS:** 2008-2009 Chevrolet Silverado LD  
2008-2009 GMC Sierra LD  
Currently Registered or Previously Registered in Maine, New Hampshire, New York, Vermont and Canada

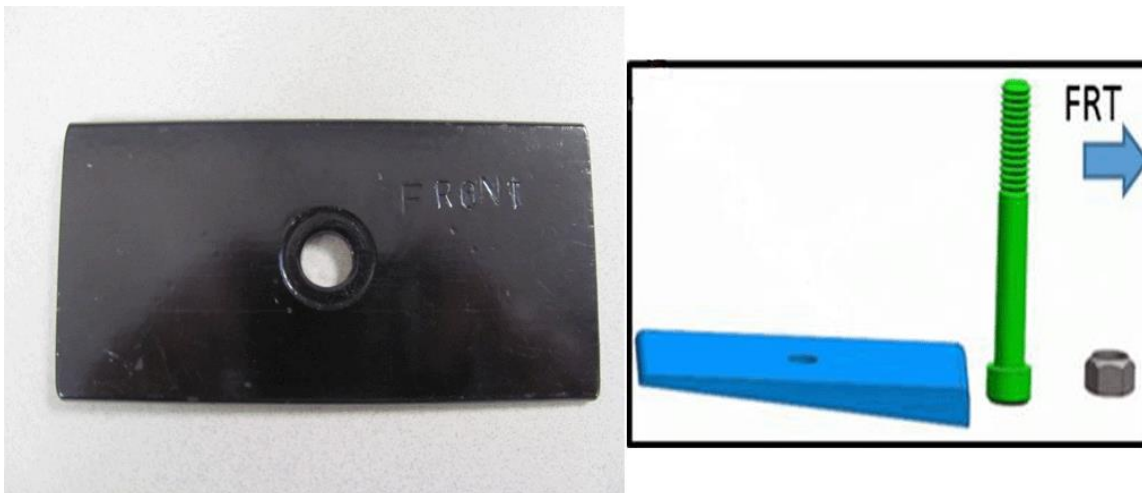
4372465

**Caution:** Incorrect orientation of the shim will cause an improper driveline angle of the rear axle.

5. Install shim in the direction OPPOSITE of its marking; specifically, install the thinner end of the shim with the word “FRONT” stamped on it toward the rear of the vehicle between the leaf spring (1) and the spacer (2) on both sides of the vehicle.
6. Install the new center bolt and nut that was included in the shim kit into the new leaf springs and tighten to 100 Nm (74 lb ft).
7. Install the new leaf springs on both sides of the vehicle. Refer to *Leaf Spring Replacement* in SI.
