Subject: 41060 - Service Update
Sealer Bead Quarter Panel Seam Not Fully Covered

Models: 2016 Buick Enclave
2016 Chevrolet Traverse

41060 Sealer Bead Quarter Panel Seam Not Fully Covered

Reference Number: N16204106
GWM Number: 2041060

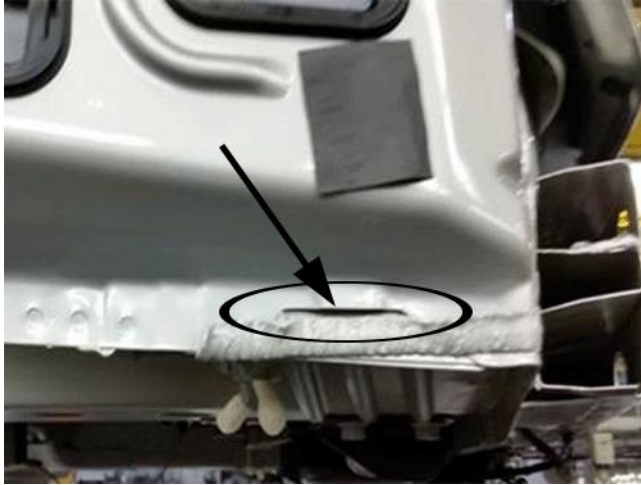
4514382

Condition	There may be a gap in the sealer bead for the seam that is located at the LH lower rear quarter panel, which could allow water intrusion into the vehicle. Water intrusion is most likely to occur during high pressure underbody washing and may result in the vehicle acquiring a musty smell over time.
Correction	Apply urethane sealant and butyl patch over void.

2. Apply a solid bead of Kent clear seam sealer over the void to uniformly cover the seam.
