Customer Satisfaction Program

26170 Water Intrusion to Fan Module Connector

Reference Number: N152026170
GWM Number: 2026170

Release Date: August 2016
Revision: 00

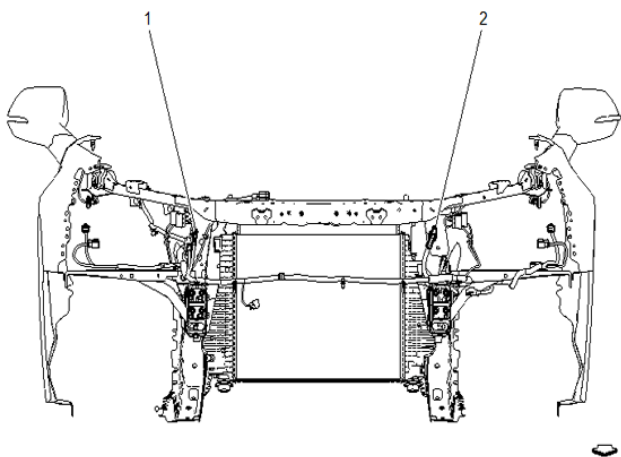
4529722

2. Inspect the forward lamp harness and fan connectors for the presence of moisture and/or corrosion.

- If the presence of moisture and/or corrosion is NOT found, apply adhesive and a deadener patch to G101 (2) and G102 (1) and apply dielectric lubricant to the forward lamp wiring harness connector and fan control module (LGX engine without RPO Y4Q) or engine coolant fan connector (LGX engine with RPO Y4Q or a LTG engine). Refer to steps 9-12, 16-20, and 22-23 below.
- If the presence of moisture and/or corrosion is found, the forward lamp wiring harness and the fan control module assembly will require replacement on vehicles equipped with a LGX engine WITHOUT RPO Y4Q or the engine coolant fan will require replacement on vehicles equipped with a LGX engine with RPO Y4Q or a LTG engine. Proceed to step 3.

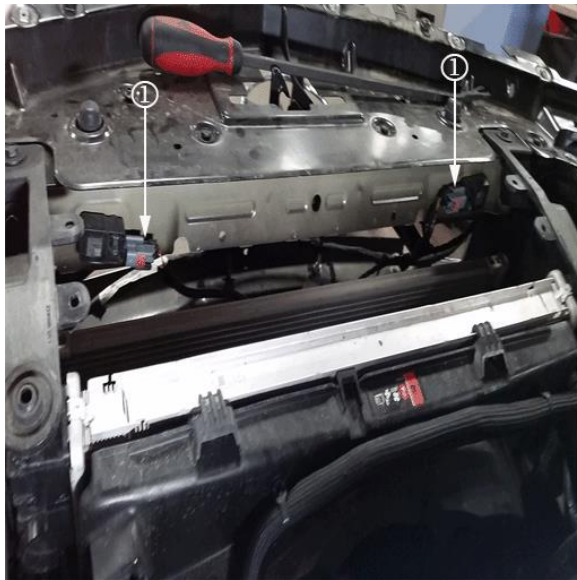
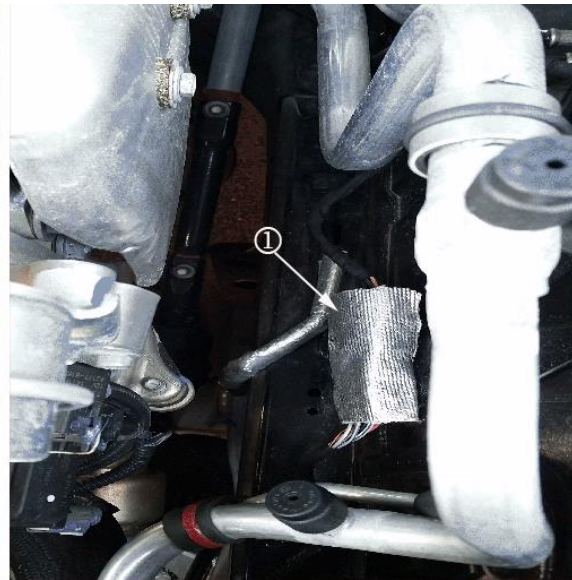
4529735

Caution: Note the routing of the forward lamp harness prior to removing it. Harness chafing and/or damage could occur if the forward lamp harness is routed improperly when reinstalling.

14. Remove the forward lamp harness (1).

Caution: Route the forward lamp harness in the exact same location as noted prior to removing it. Harness chafing and/or damage could occur if the forward lamp harness is routed improperly.

15. Install the new forward lamp harness.

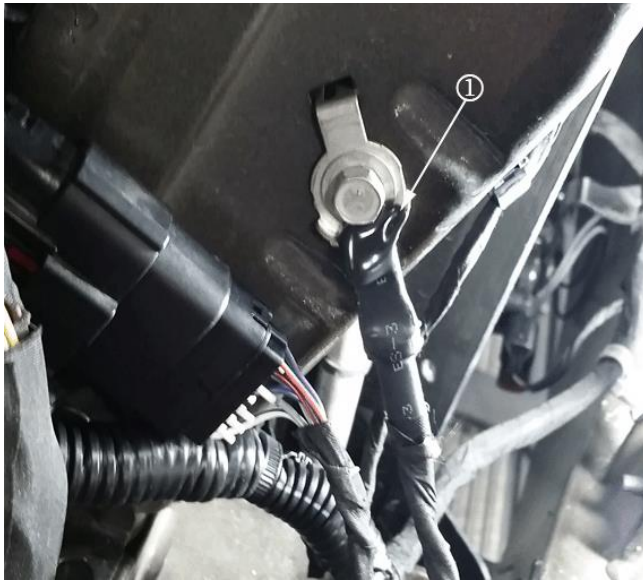
4529747

G102 is shown. G101 is similar.

16. Apply adhesive (1) to the G101 and G102 ground cables making sure to completely coat the end of the cable.

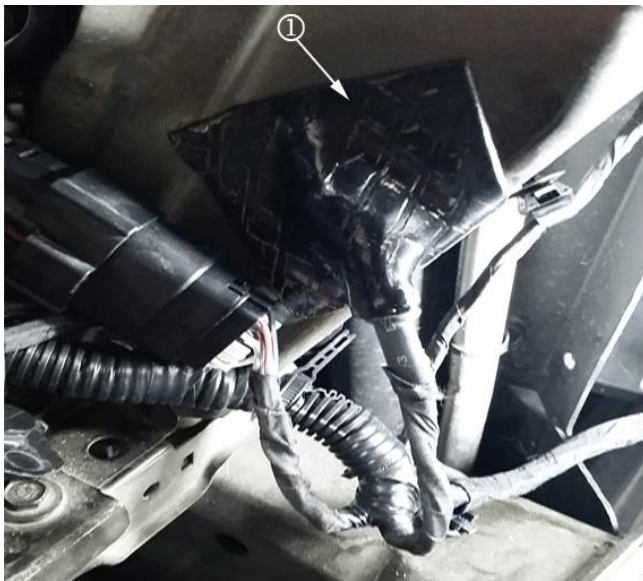
4529752

G102 is shown. G101 is similar.

17. Apply a 6 x 6 cm (2.5 x 2.5 in) square patch of deadener (1) over top of the G101 and G102 connections.
18. Install the driver side front fender front brace. Refer to *Front Fender Front Brace Replacement* in SI.
19. Install both intake air baffles. Refer to *Intake Air Baffle Replacement* in SI.
20. Install both front headlamp assemblies. Refer to *Headlamp Replacement (HID)* or *Headlamp Replacement (Halogen)* in SI.
21. Depending on vehicle content, perform one of the following:
 - If the vehicle is equipped a LGX engine with RPO Y4Q or a LTG engine, replace the engine coolant fan. Refer to *Engine Coolant Fan Replacement (LTG without V18)*, *Engine Coolant Fan Replacement (LTG with V18)*, *Engine Coolant Fan Replacement (LGX With V03)*, or *Engine Coolant Fan Replacement (LGX Without V03)* in SI.
