# Customer Satisfaction Program

## 50120 Positive Battery Cable Bolt Torque

Reference Number: N162050120  
 GWM Number: 2050120

Release Date: August 2016  
 Revision: 00

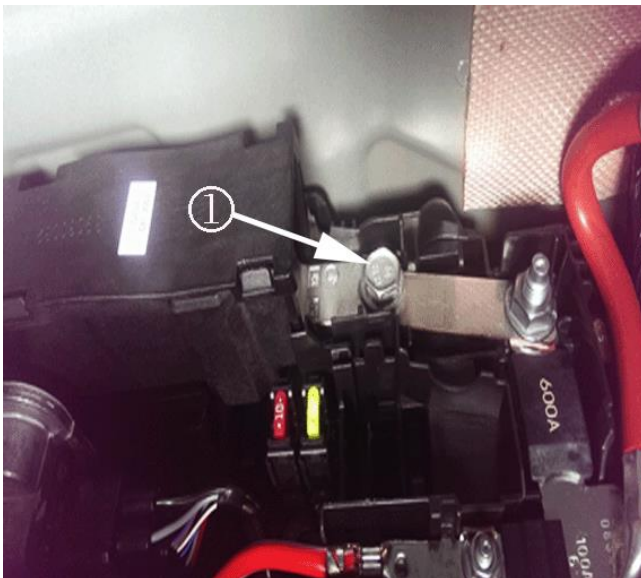
4563134

8. Visually inspect the battery positive cable bolt (1).
  - If the battery positive bolt appears to be loose, proceed to the next step.
  - If the battery positive bolt appears to be tight, proceed to step 19.

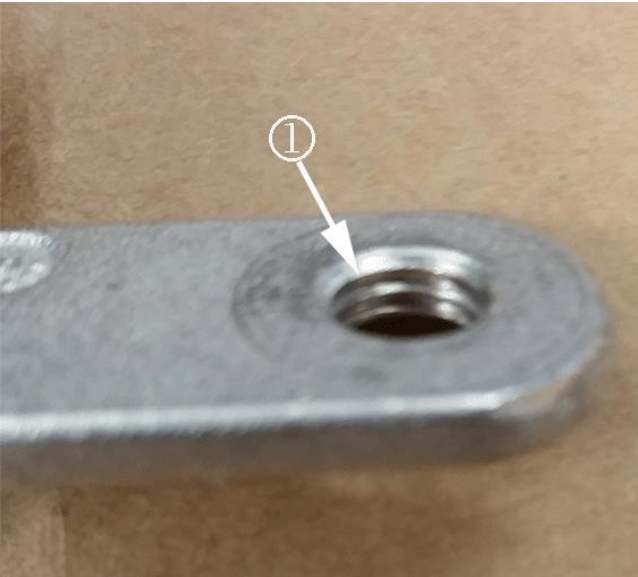
4563140

11. Verify the battery positive cable bolt passes freely through the battery positive cable terminal hole (1).
  - If the battery positive cable bolt passes freely through the battery positive cable terminal hole, proceed to step 17.
  - If the battery positive cable bolt does NOT pass freely through the battery positive cable terminal hole, proceed to the next step.

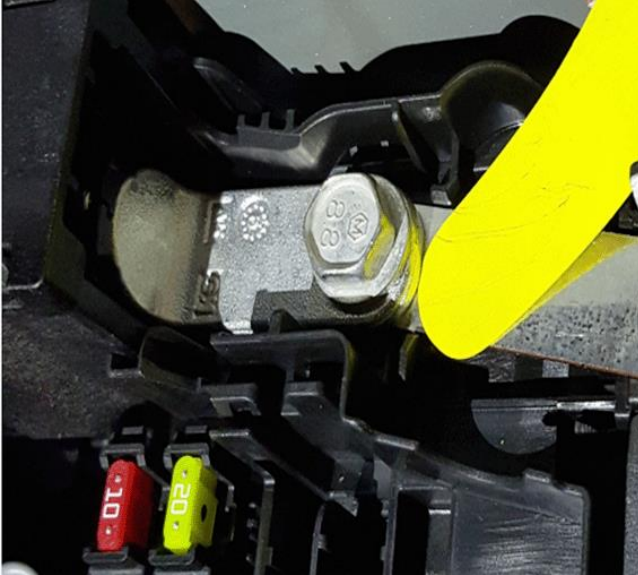
20. Attempt to slide a 0.5mm (0.020 in) feeler gauge between the battery positive cable terminal and the bus bar.
- If the 0.5 mm (0.020 in) feeler gauge will slide between the battery positive cable terminal and the bus bar, go to step 9.
  - If the 0.5 mm (0.020 in) feeler gauge will NOT slide between the battery positive cable terminal and the bus bar, proceed to the next step.
