Customer Satisfaction Program

50120 Positive Battery Cable Bolt Torque

Reference Number: N162050120
GWM Number: 2050120
Revision Description: This service procedure was revised to add step 7 and modify steps related to a battery disconnect. Please discard all previous copies of bulletin 50120.

Release Date: August 2016
Revision: 01

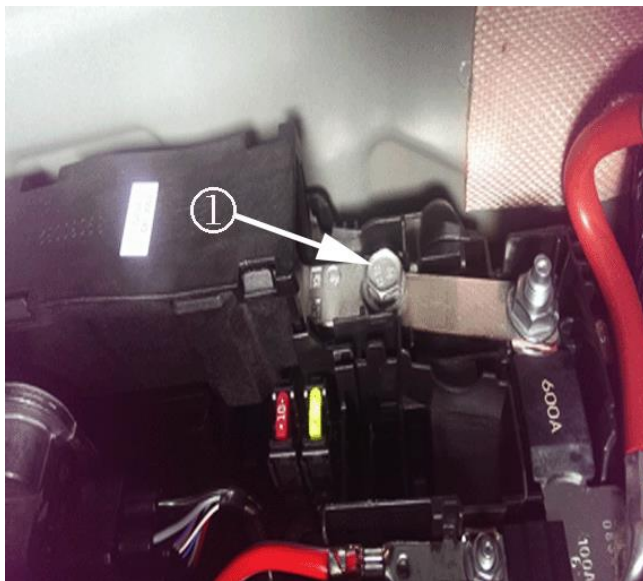
4563134

9. Visually inspect the battery positive cable bolt (1).
 - If the battery positive bolt appears to be loose, proceed to the next step.
 - If the battery positive bolt appears to be tight, proceed to step 20.

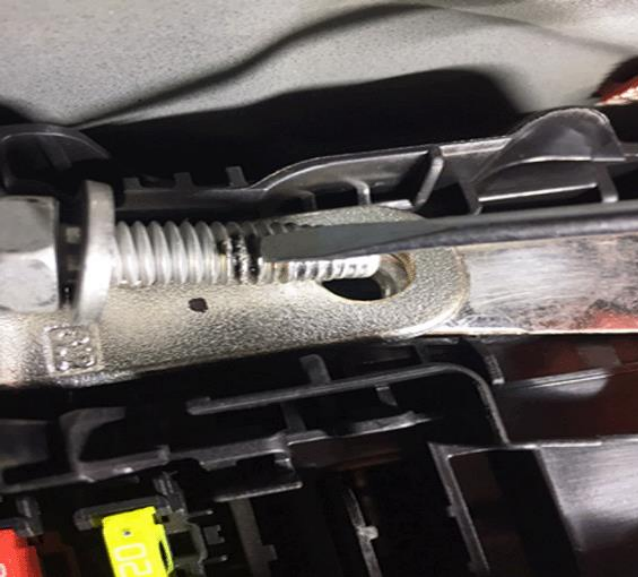
4563136

11. Inspect the battery positive cable bolt for evidence of cross-threading or thread damage.

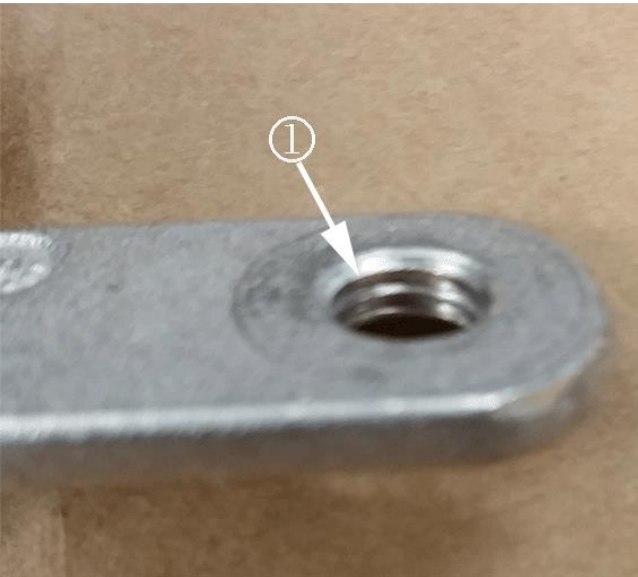
4563140

12. Verify the battery positive cable bolt passes freely through the battery positive cable terminal hole (1).
- If the battery positive cable bolt passes freely through the battery positive cable terminal hole, proceed to step 18.
 - If the battery positive cable bolt does NOT pass freely through the battery positive cable terminal hole, proceed to the next step.

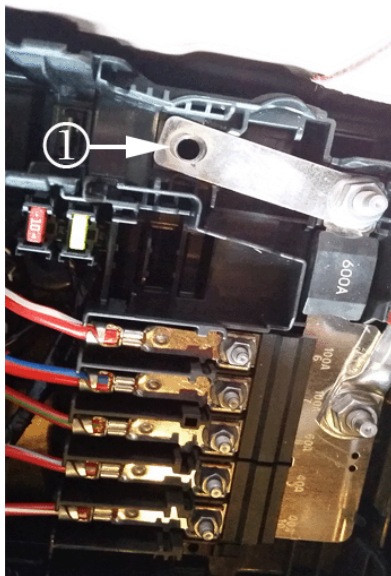
4563149

18. Inspect the threads in the battery fuse block for evidence of damage and attempt to hand thread the bolt into the battery fuse block.
 - If the threads in the battery fuse block are damaged, replace the battery fuse block. Refer to *Fuse Block Replacement* in SI.
 - If the threads in the battery fuse block are NOT damaged, proceed to the next step.
19. Replace the battery positive cable bolt and torque to 16 Nm (12 lb ft).

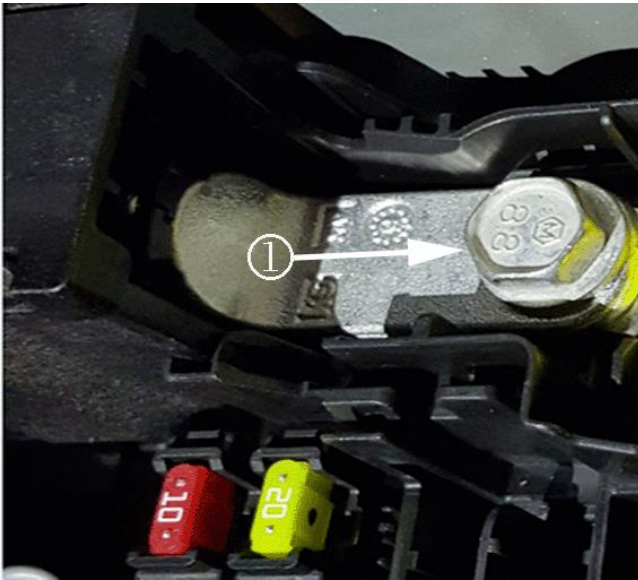
4563158

20. Attempt to slide a 0.5mm (0.020 in) feeler gauge between the battery positive cable bolt washer (1) and the battery positive cable.
- If the 0.5 mm (0.020 in) feeler gauge will slide between the battery positive cable bolt washer and the battery positive cable, go to step 10.
 - If the 0.5 mm (0.020 in) feeler gauge will NOT slide between the battery positive cable bolt washer and the battery positive cable, proceed to the next step.

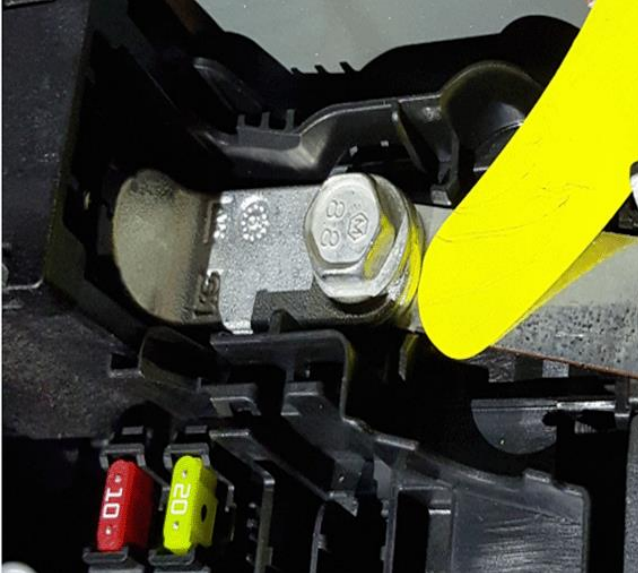
4563152

21. Attempt to slide a 0.5mm (0.020 in) feeler gauge between the battery positive cable terminal and the bus bar.
- If the 0.5 mm (0.020 in) feeler gauge will slide between the battery positive cable terminal and the bus bar, go to step 10.
 - If the 0.5 mm (0.020 in) feeler gauge will NOT slide between the battery positive cable terminal and the bus bar, proceed to the next step.
