# Service Update

## 60070 Front Control Arm Mounting Bolt

**Reference Number:** N162060070  
**GWM Number:** 2060070

**Release Date:** August 2016  
**Revision:** 00

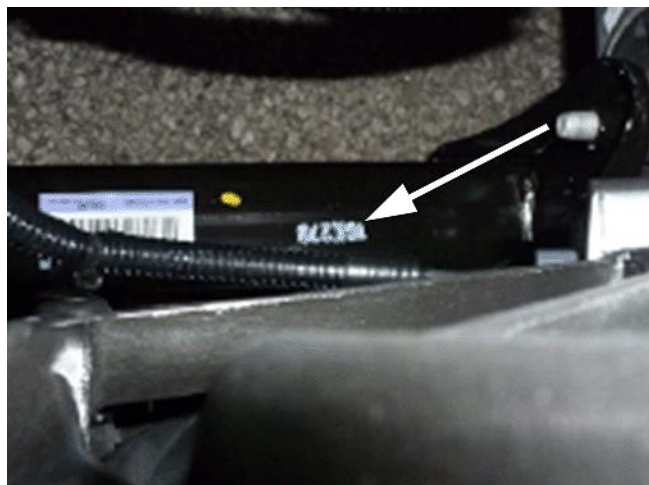
4573826

2. Locate the black painted engine cradle centered directly below the radiator and engine.

3. Visually inspect the assembly lot code stamped in white paint.
  - If the white painted assembly lot code is not legible or reads 6K26D, 6K26E or 6K26F, proceed to the **Bolt Replacement** section below.
  - If the serial number is not 6K26D, 6K26E or 6K26F, no further action is required.

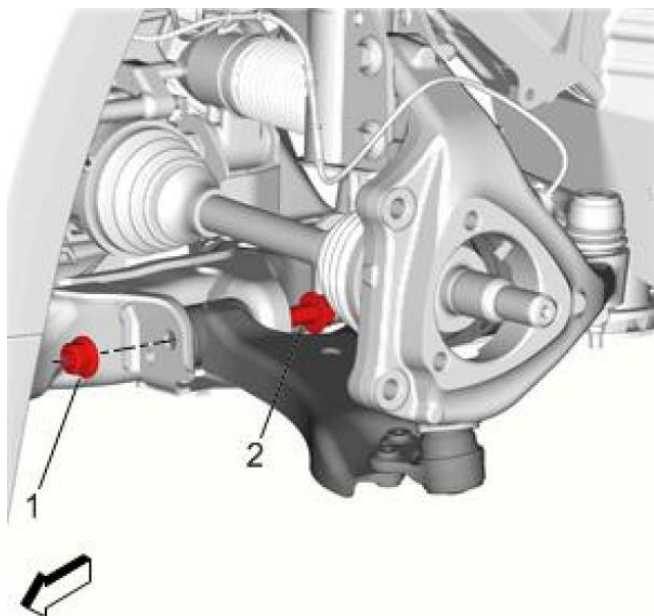
3999409

<b>Condition</b>	Certain 2017 model year Chevrolet Equinox and GMC Terrain vehicles have been built with front control arm mounting bolts which were produced with the wrong material, which may cause the lower control arm front bushing to separate from the cradle assembly.
<b>Correction</b>	Dealers are to inspect the front cross member assembly lot code, and, if necessary, replace the nuts and bolts.

2. Remove the front lower control arm nuts (1) and bolts (2). **DISCARD** the nuts and bolts.
3. Install the new front lower control arm nuts (1) and bolts (2).
4. Tighten the NEW front lower control arm front nuts (1). **Tighten:**
  - a. First Pass: **100 Nm (74 lb ft)**
  - b. Second Pass: **Loosen one to two revolutions**
  - c. Third Pass: **115 Nm (85 lb ft)**
  - d. Final Pass: **(90–105 degrees)**
5. Lower the vehicle.
