# Service Update

## 16067 Incorrect Strut to Shock Tower Bolt Attachment

Reference Number: N16205408

Make	Model	Model Year		RPO	Description
		From	To		
Chevrolet	Malibu	2016	2016

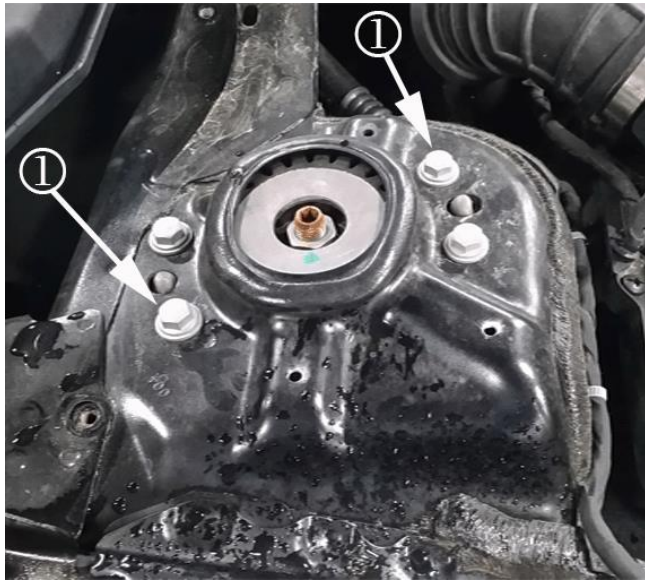
4614483

**Note:** The incorrect bolts will NOT have serrations on the washer and will be longer than the correct bolt.

3. Remove the two passenger side front suspension strut mount bolts (1) and DISCARD.
4. Using an inspection mirror through the wheel well, verify the front suspension strut mount bolts did not contact the coil spring and nick the coating.
