Service Update

16037 Seat Harness Pinch

Reference Number: A16205288

Models: 2016-2017 Chevrolet Malibu
Equipped with Vented Seat (KU9)

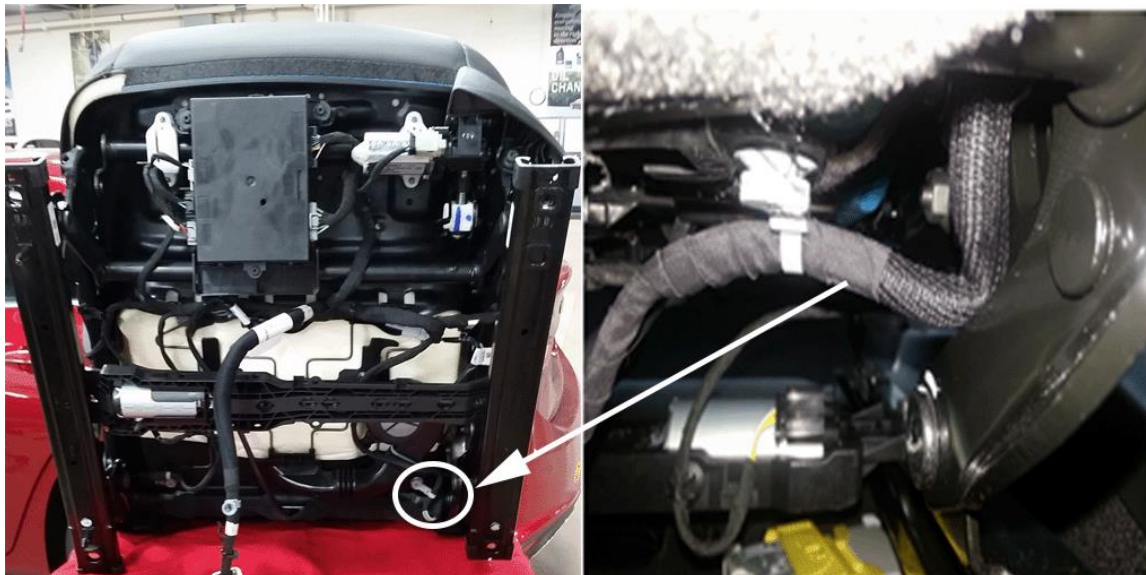
4620744

- Inspect driver and passenger front seats to see if the front seat wiring harness has been damaged from making contact with the seat recliner gear mechanism. Seat is removed from vehicle for illustrative purposes only.
 - If the front seat wiring harness is NOT damaged, proceed to step 3.

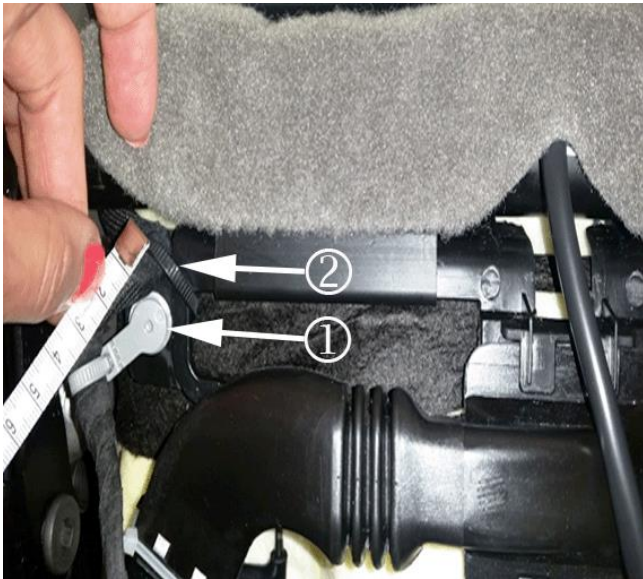
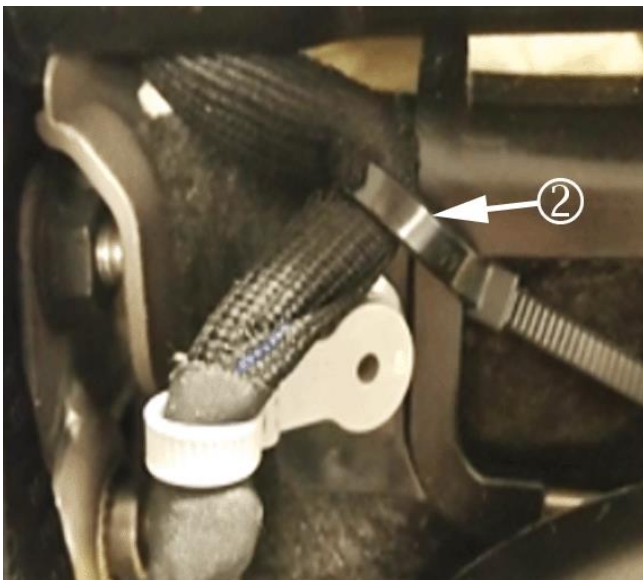
Driver (LH) seat shown. Passenger (RH) seat similar.

3. Measure 40mm (1.58 in) from the offset clip (1) toward the seat back harness and install a zip tie (2) around the harness and cushion spring.
