# Customer Satisfaction Program

## 48040 - Wire Harness To TCM Controller Wear-Thru Causing DTCs To Set

Reference Number: N16204804

Release Date: November 2016

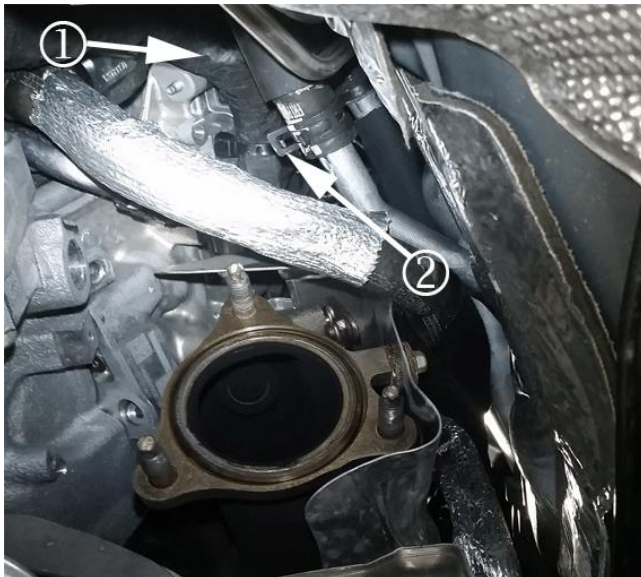
4626696

3. Verify the engine harness (1) is NOT contacting the heater inlet hose clamp (2).
  - If the engine harness is NOT contacting the heater inlet hose clamp, proceed to step 4.
  - If the engine harness is contacting the heater inlet hose clamp, proceed to the Engine Harness Repair Procedure in this bulletin.

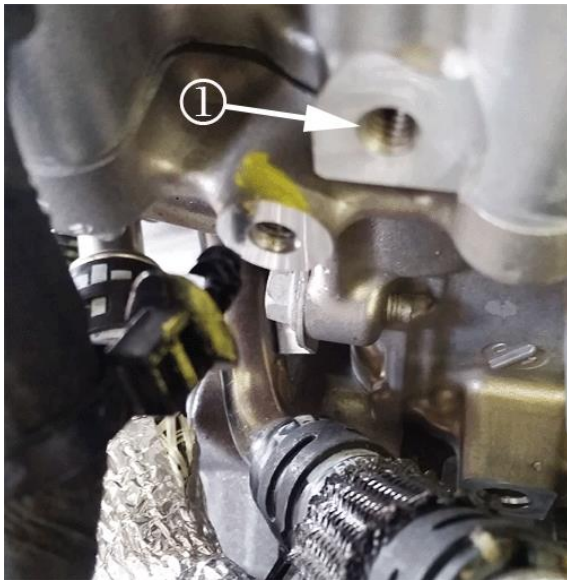
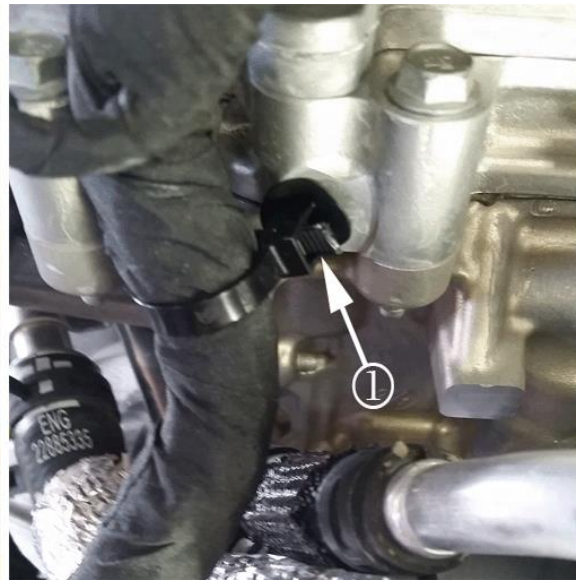
4626703

4. Verify the engine harness clip is secured in the correct location (1).
  - If the engine harness clip is secured in the correct location, proceed to the next step.
  - If the engine harness clip is NOT secured in the correct location, replace the engine harness clip and secure it in the upper hole as shown above.

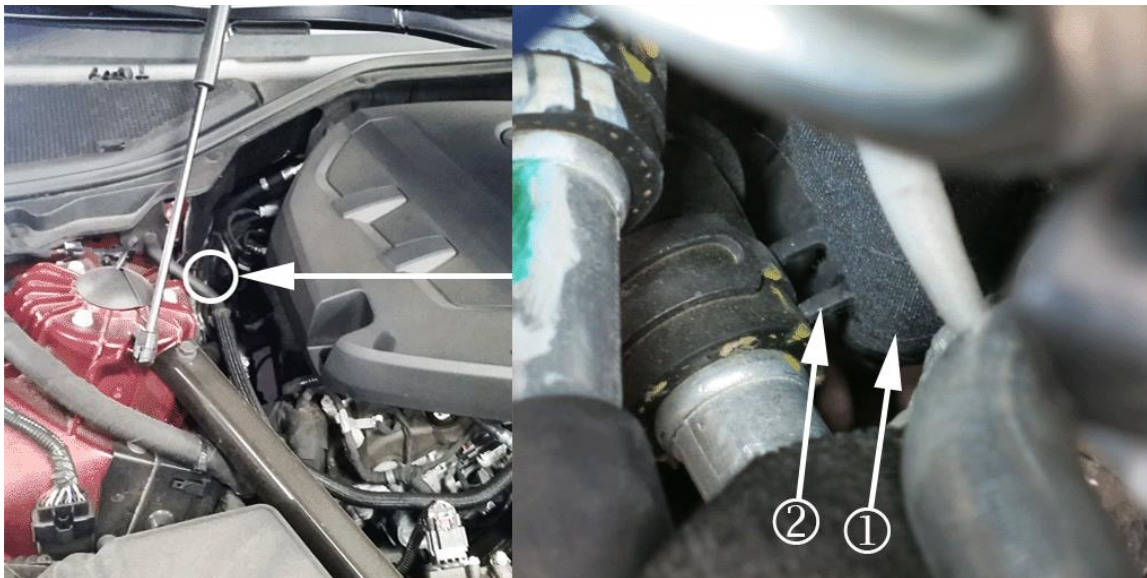
4626710

3. Verify the engine harness (1) is NOT contacting the heater inlet hose clamp (2).
  - If the engine harness is NOT contacting the heater inlet hose clamp, proceed to step 4.
  - If the engine harness is contacting the heater inlet hose clamp, proceed to the Engine Harness Repair Procedure in this bulletin.

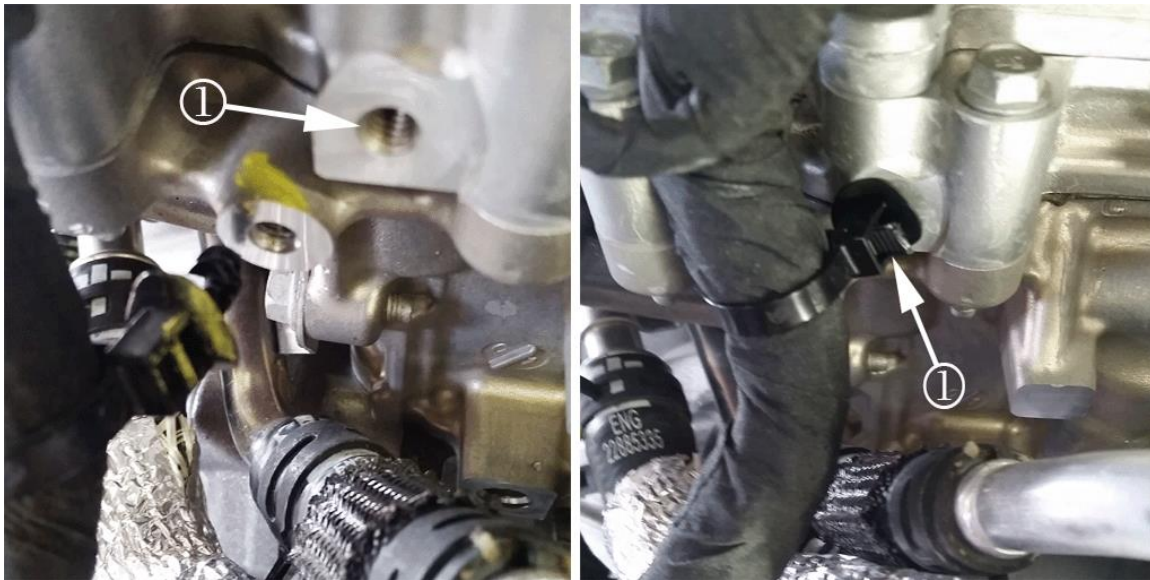
4626703

4. Verify the engine harness clip is secured in the correct location (1).
  - If the engine harness clip is secured in the correct location, proceed to the next step.
  - If the engine harness clip is NOT secured in the correct location, replace the engine harness clip and secure it in the upper hole as shown above.
5. Raise and support the vehicle. Refer to *Lifting and Jacking the Vehicle* in SI.
