Special Coverage Adjustment

23520 Passenger Presence Sensor (PPS) Module

Reference Number: N15202352

Make	Model	Model Year		RPO	Description
		From	To		
Buick	Verano	2012	2016

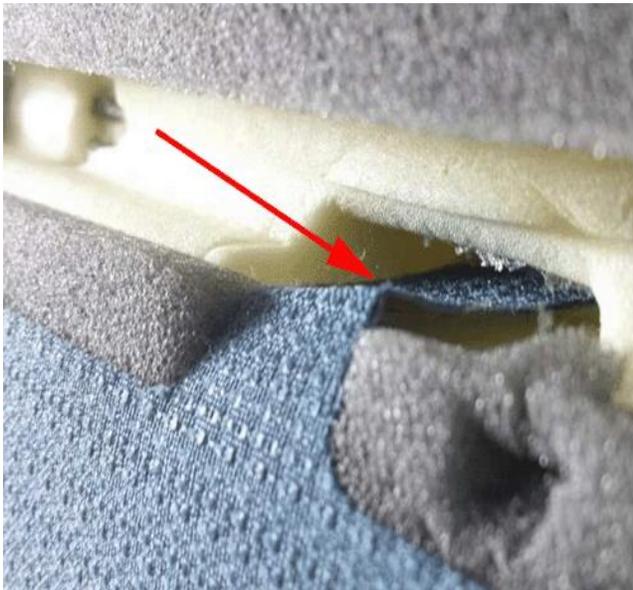
4502711

Note: Crease observed in tail area from top side.

2. Upon inspection of the sensor after trim removal, a sharp crease in the passenger presence sensor in the area where the sensor tail exits through to the bottom of the seat cushion assembly may be observed.

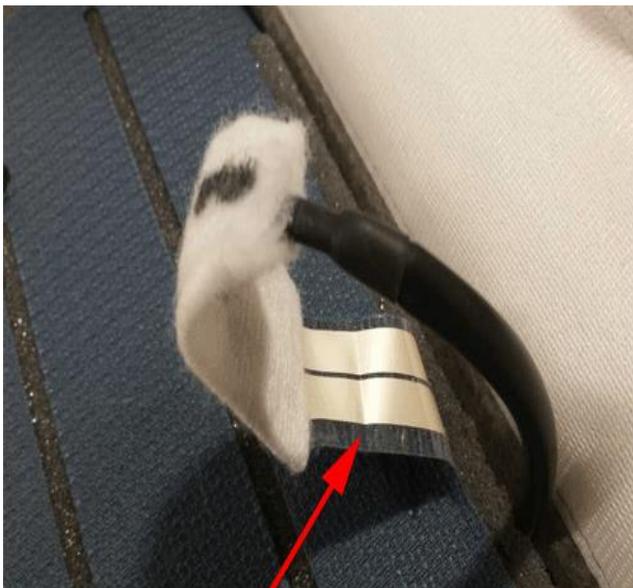
4505464

Note: Crease observed in tail area from bottom side.

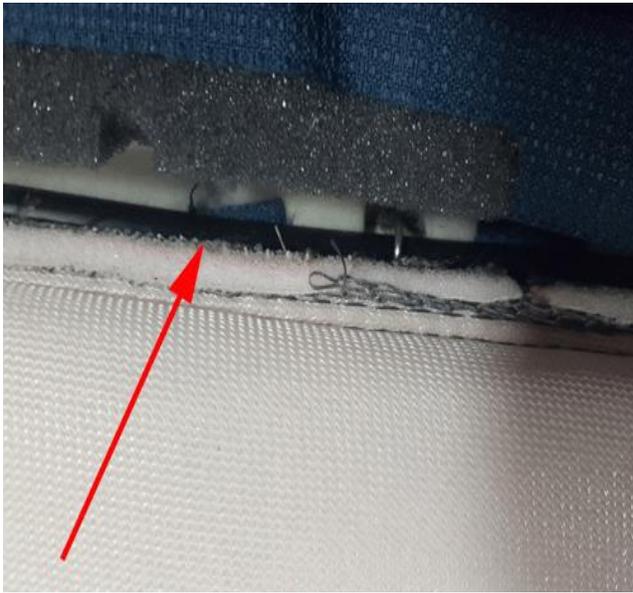
4505465

Note: Sensor tail observed trapped between seat trim tiedown feature and cushion pad.
