## 33530 Engine Ground Cable In Contact With Half-Shaft

**Reference Number:** N16203353

**Release Date:** November 2016

Make	Model	Model Year		RPO	Description
		From	To		
Cadillac	ATS	2016	2016	F46 KL9 LTG	AWD Stop/Start System 2.0L Engine
Cadillac	CTS	2016	2016	F46 KL9 LTG	AWD Stop/Start System 2.0L Engine

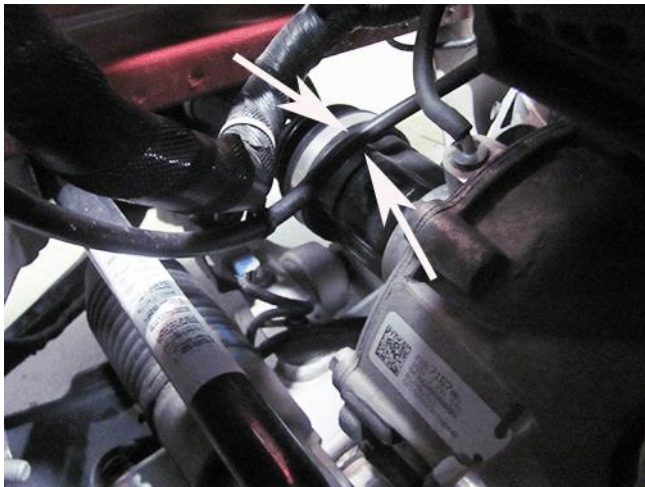
4596027

2. Locate the engine ground cable, positioned directly above the right front axle shaft.

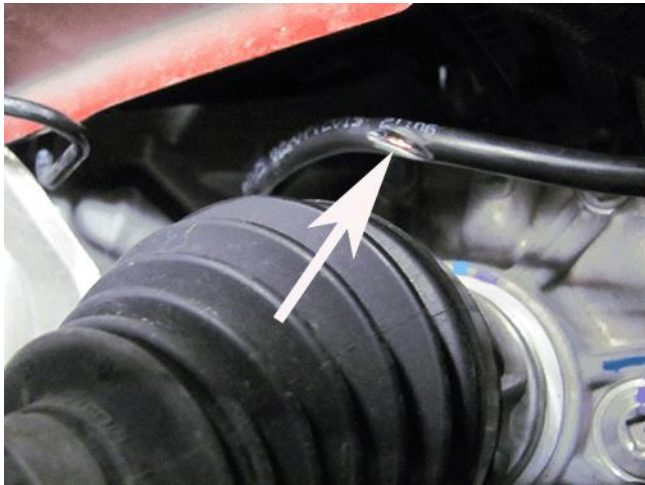
4596031

3. Inspect the cable and determine if it is making contact with the axle shaft or CV boot.

- If the cable is making contact and the **cable insulation is damaged**, proceed to the Battery Cable Inspection and Repair section below.
  - If the cable is not making contact and the **insulation is not damaged**, proceed to step #4.
4. Raise the engine ground cable up to the main harness.
  5. Loosely install the wire tie strap midway between the existing two cable locators.

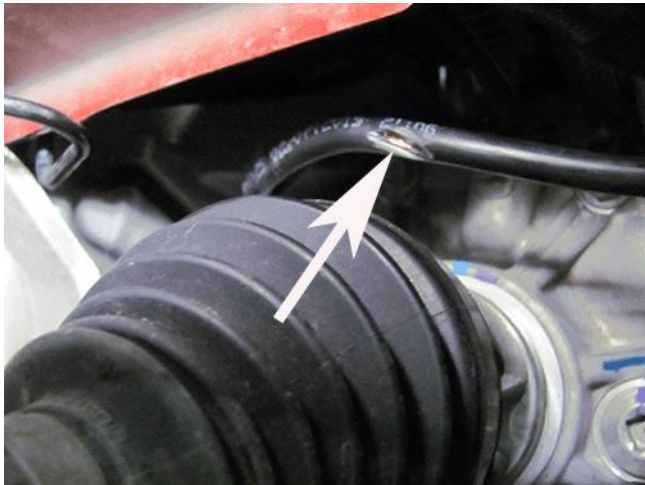
4. Inspect the engine ground cable and determine the extent of the damage.
  - If **only the cable insulation is damaged** and no copper conductors are worn through, proceed to step #5 below.
  - If the **insulation is damaged and any copper conductors are worn through**, proceed to the Engine Wiring Harness Replacement section below.
5. Clean the repair area on the ground cable with a general purpose adhesive cleaner.
6. Peel the paper backing off of the super sealant patch.
